EXPERIENCE ON OPERATION AND MAINTENANCE OF CFBC BOILER AT KLTPS- KUTCH GUJARAT

CFBC BOILER AT KLTPS- KUTCH GUJARAT

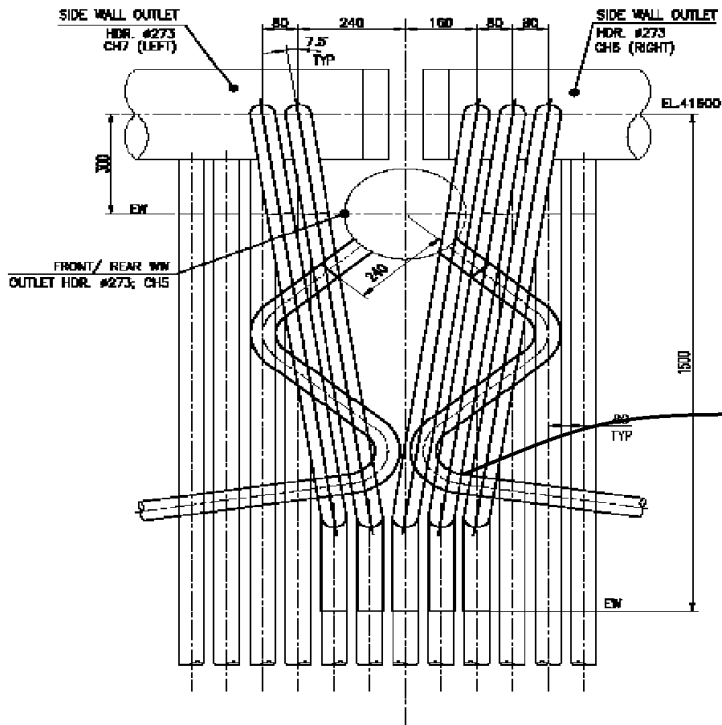
WATER WALLS TUBE FAILURES (AT PENT HOUSE AREA)

Tube Failure Due to Accumulation of high temp. Bed material. Because leakage at roof sealing

- × Main causes for tube failures were:
- × Maximum tube failures occurs at Lignite and SUB entry area due to refractory damages at the entry of the lignite and SUB.
- × Tube failures occurs at pent house due to accumulation of bed material in pent house of combustor
- × Accumulation of bed material in pent house due to damages in sealing of combustor at roof
- × Remedial actions :
- × Thickness of refractory and numbers of anchors welded are increased at Entry of Lignite and SUB.
- × Material of sealing at combustor roof changed from MS to SS and refractory poured at empty area on sealing plate.

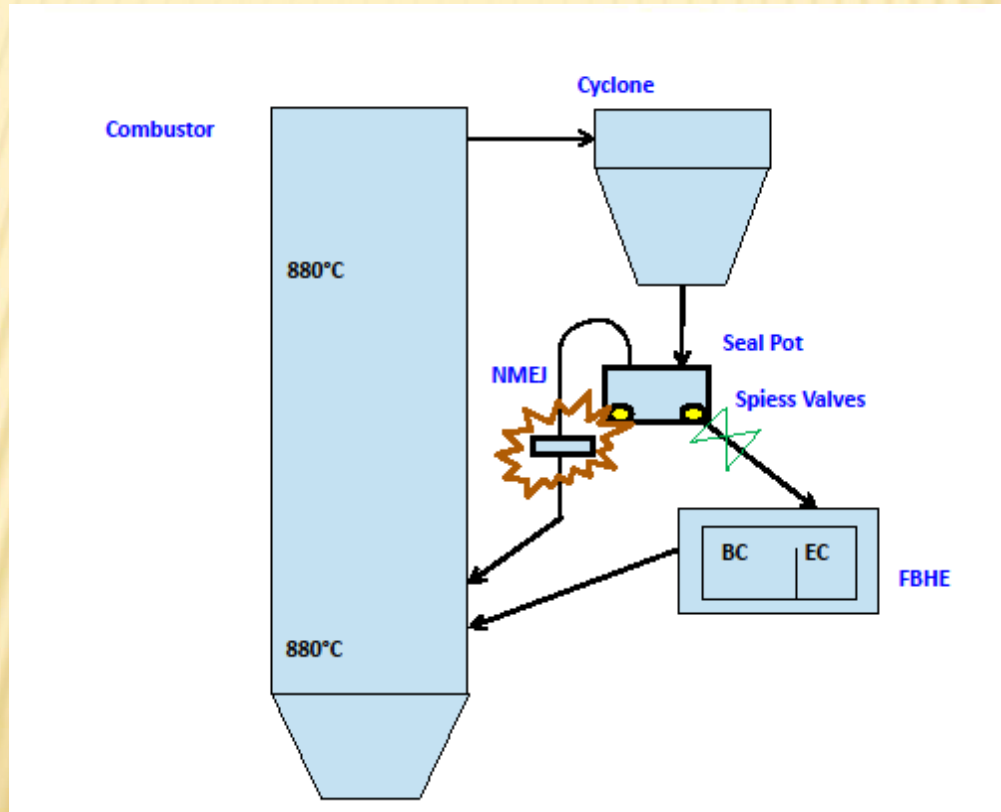
NMEJ DAMAGES

✘ Frequently damages of NMEJ

- ✘ NMEJs at flue gas path are critical in nature and failure of which leads to Boiler shutdown
- ✘ Problem:
 - + Failure of Seal Pot to Combustor NMEJ frequently
- ✘ Root Causes:
 - + High sealing gap between male & female duct
- ✘ Remedial Action Taken:
 - + Changes in design of NMEJ(Harmonic layer)
 - + Sealing gap was reduced
 - + Dust Trap provided

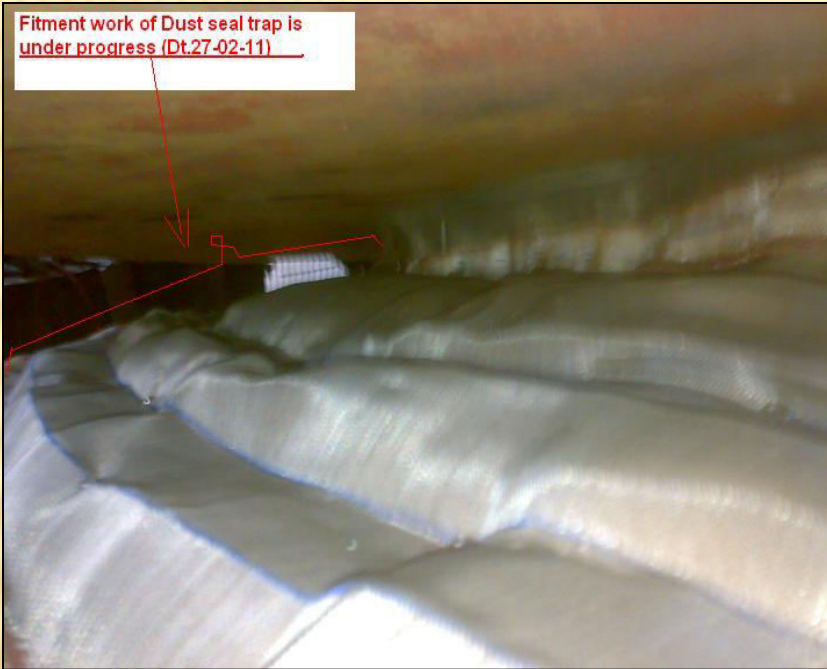
FITTING OF DUST SEAL TRAP

Fitment work of Dust seal trap is under progress (Dt.27-02-11)

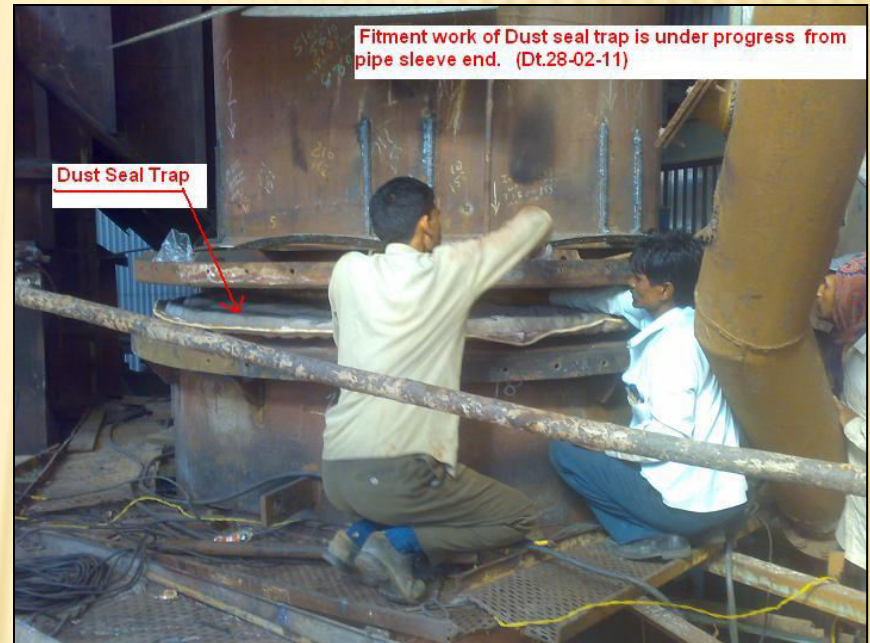
Fitment work of Dust seal trap is under progress from pipe sleeve end. (Dt.28-02-11)

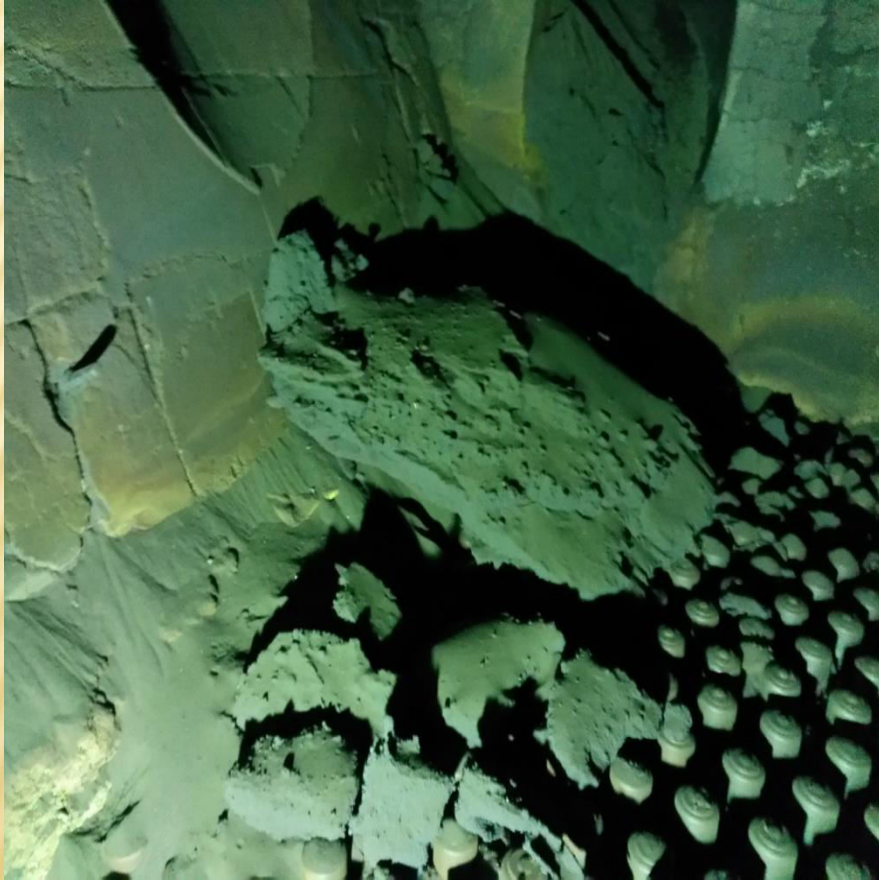
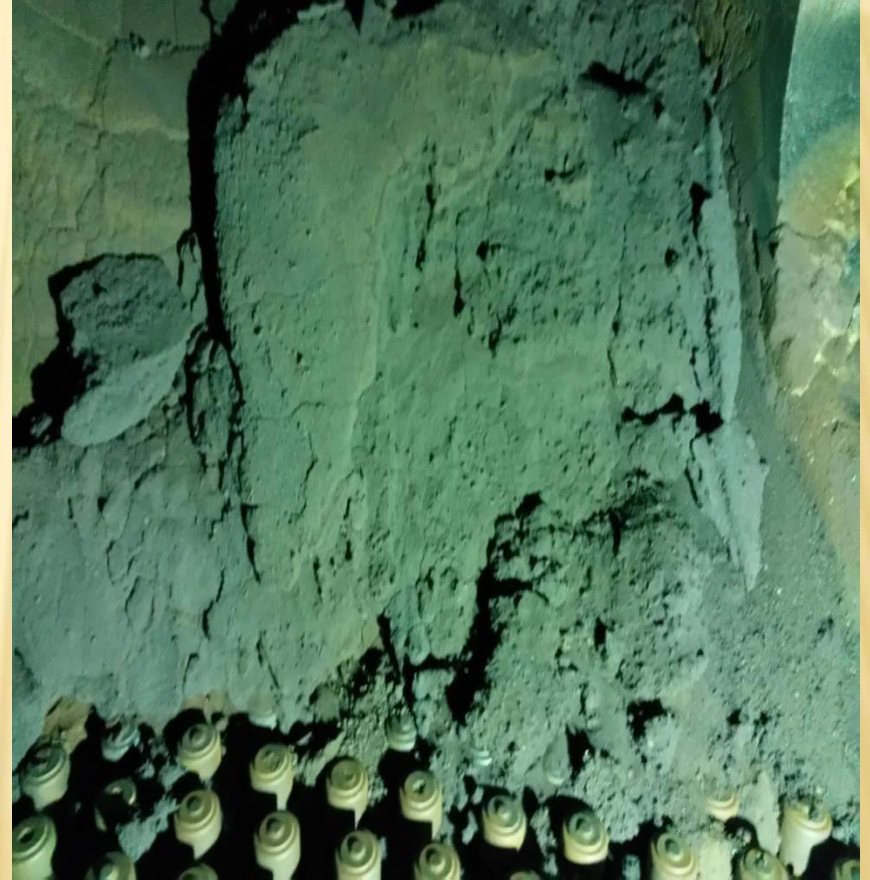
CLINKER NEAR PA FAN NOZZLES

- × Main cause of Clinker
- × Clinker Formation at low combustor temperature < 700 deg C during mixed fuel (solid + oil) operations .
- × Oversize of the lignite.

- ✘ Restricted Operations on mixed fuel .
- ✘ Maintaining Combustor temp. during very high fluctuation on load.
- ✘ Resized the lignite as per designed value.

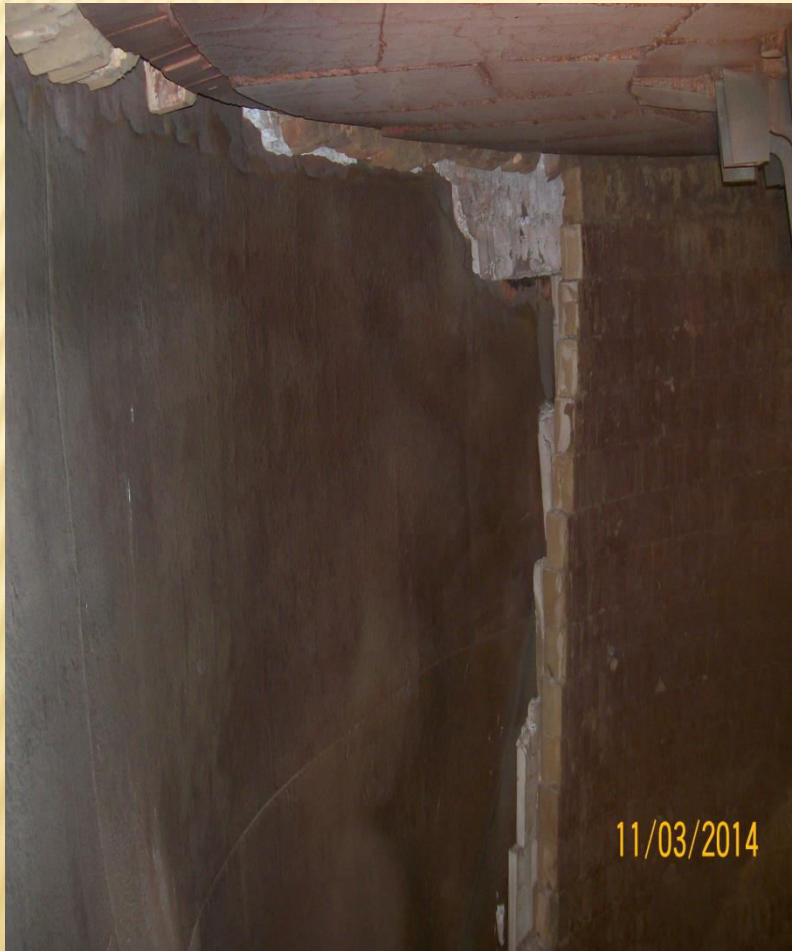
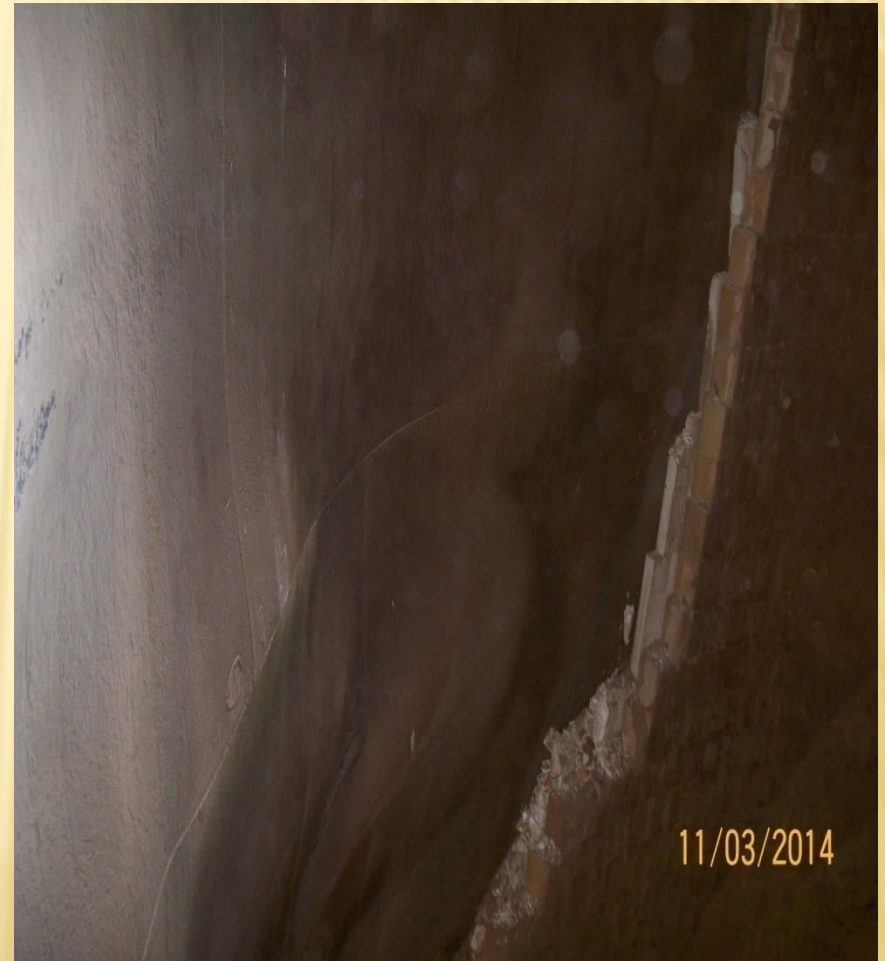
REFRACTORY DAMAGES IN CYCLONE.

- + Frequent failures of refractory at Target area, Bull Nose Area

- + Use of low abrasion resistance refractory material

- + Refractory (Alumina Content – 80%) was introduced in cyclone bull nose area, Target Wall Area in place of existing dense refractory (Alumina Content – 45%)

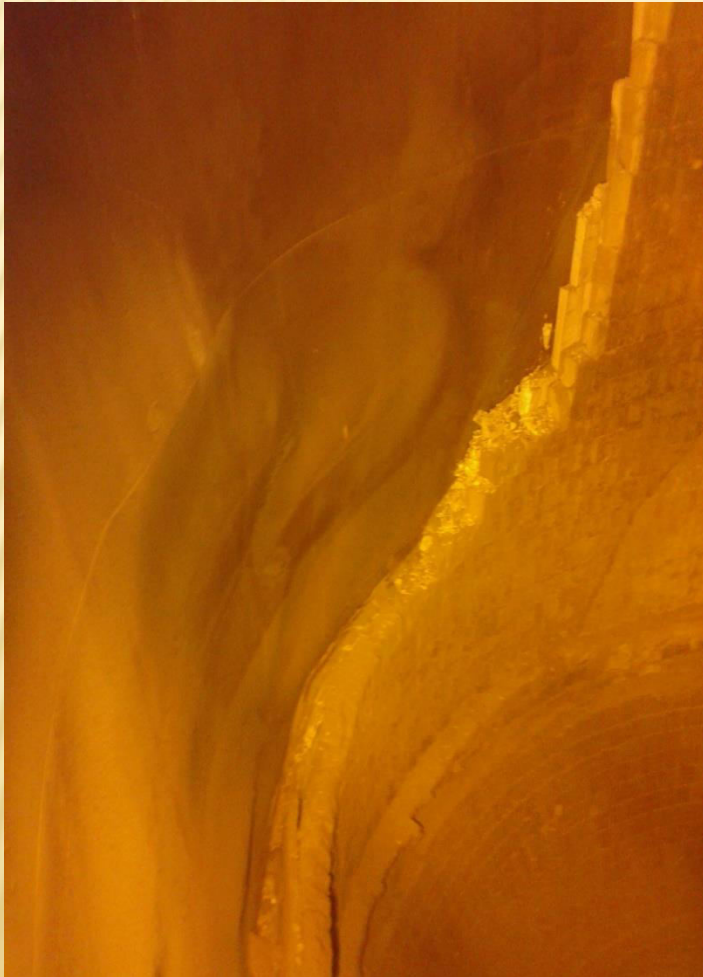
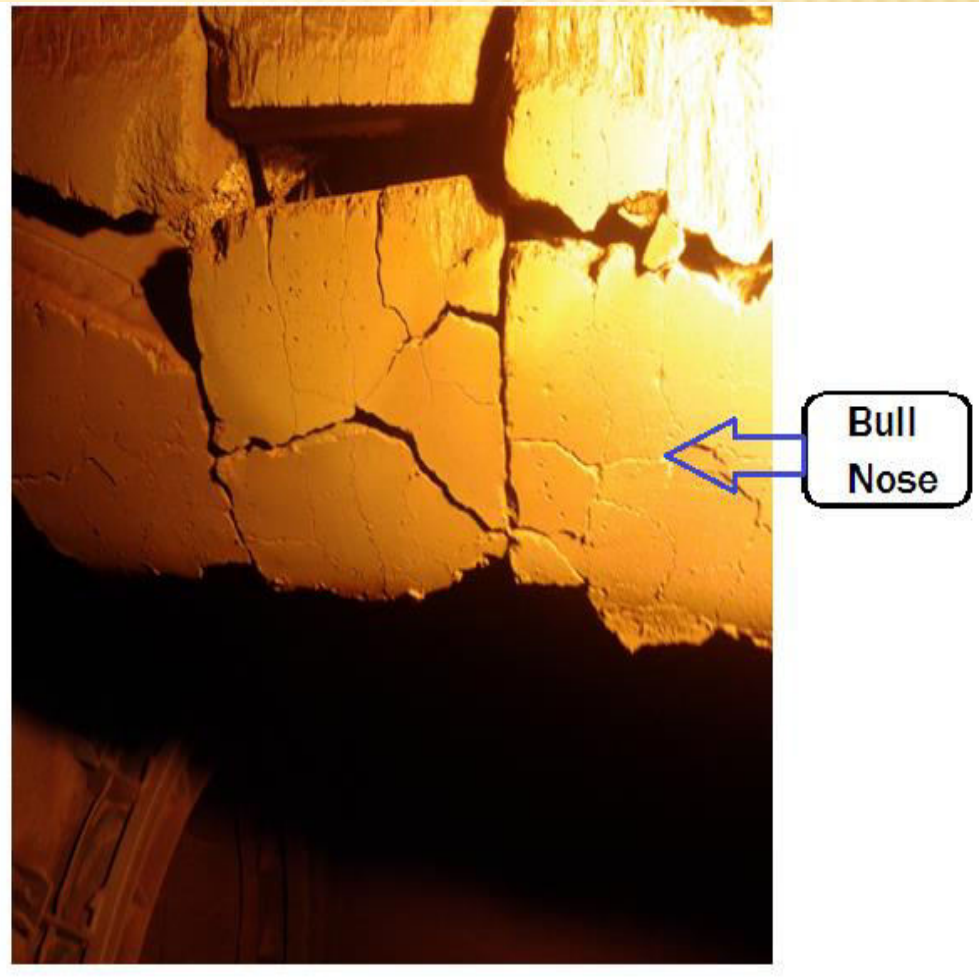
REFRACTORY DAMAGES IN CYCLONE.

Bull
Nose

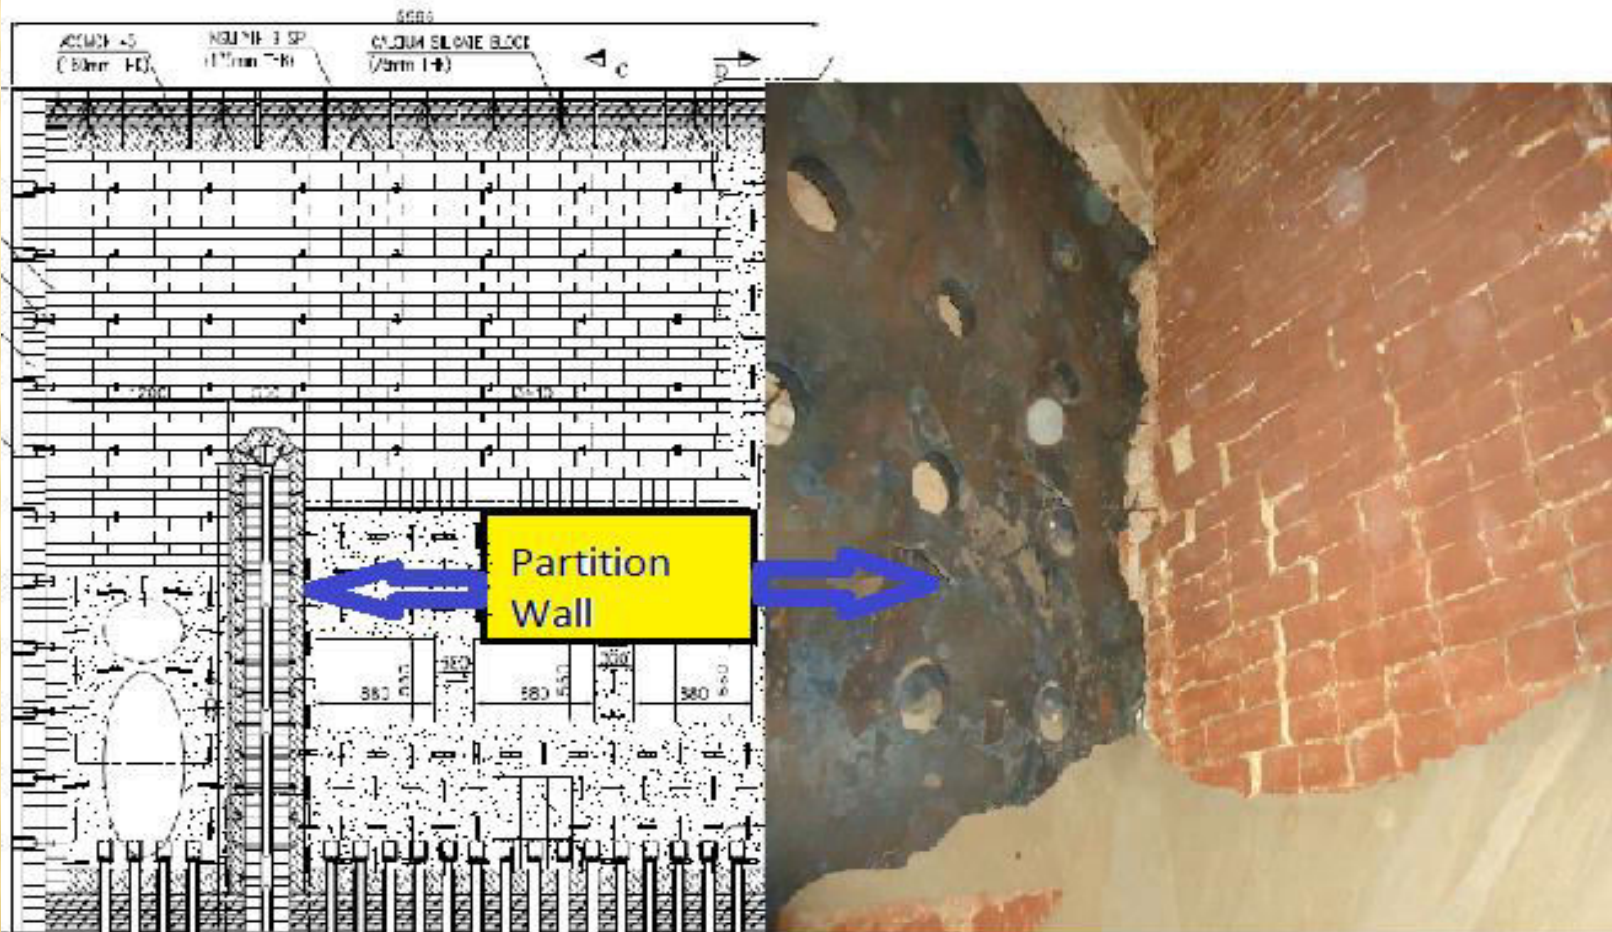
REFRACTORY DAMAGES AT FBHE AREA

- ❖ **Problem:**
 - Failures of refractory at partition wall & Empty Chamber side walls
- ❖ **Causes:**
 - + Use of low abrasion resistance refractory material
- ❖ **Actions taken:**
 - + Castable refractory of high alumina content
 - + (high abrasion resistance) introduced in place of existing castable Refractory
 - + Numbers of Anchors are increased

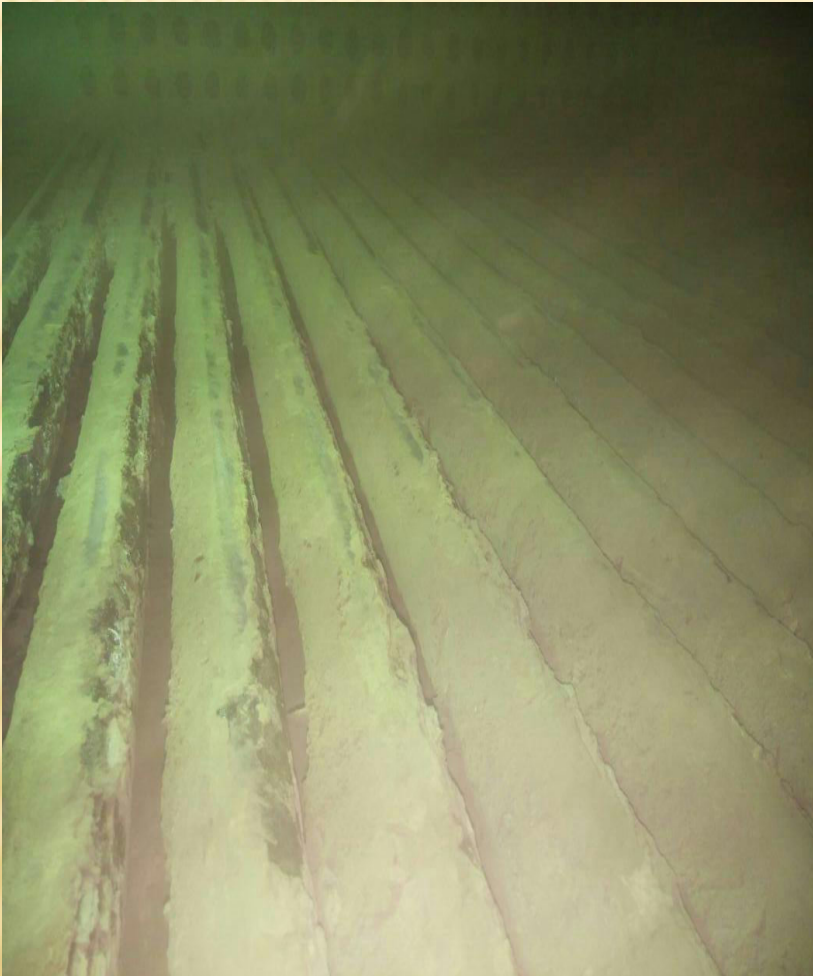
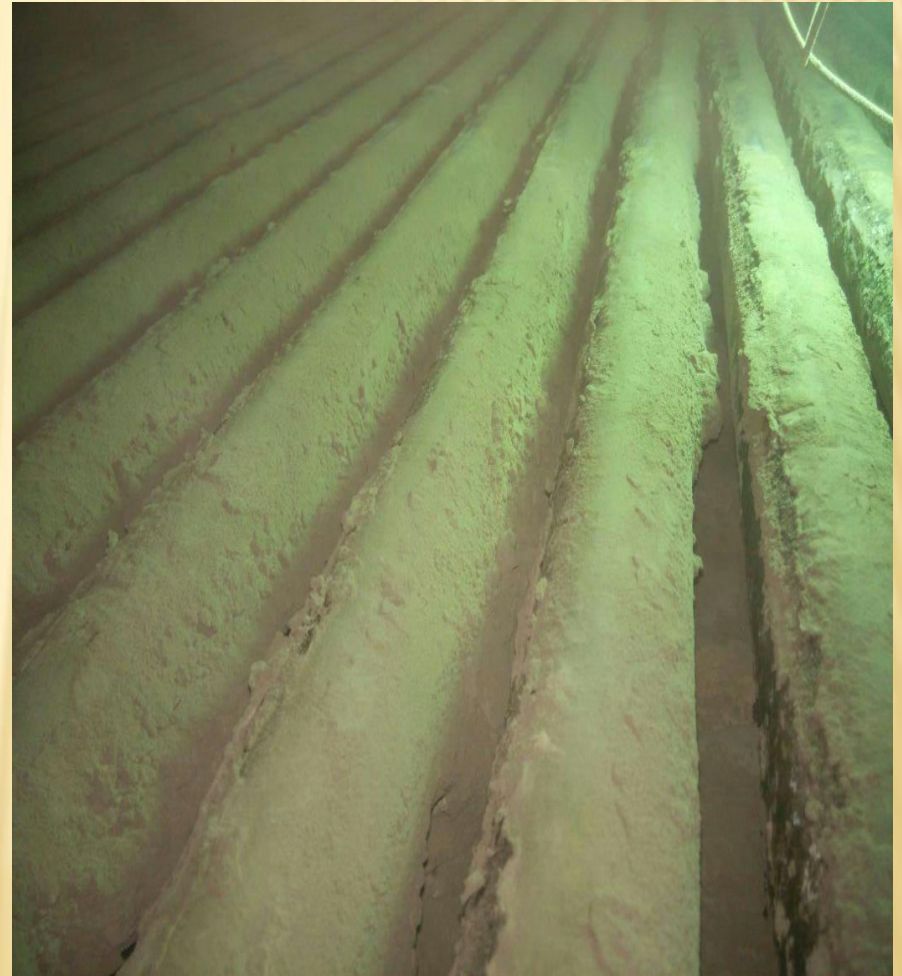
CHOCK-UP IN APH

- Currently we are facing problem of chock-up of APH. Which leads the suction pressure of ID fan very- very low ie. Upto -35mbar. Hence machine is compelled to run at reduced load. Hence there is still question that how to overcome this problem.
