GREETINGS FROM NEYVELI LIGNITE CORPORATION LIMITED

November 14, 2014

NLC TPS-II EXPANSION PROJECT 2 X 250 MW – LIGNITE FIRED CFBC BOILERS

OPERATION EXPERIENCES IN 125 MW AND 250 MW CFBC BOILERS

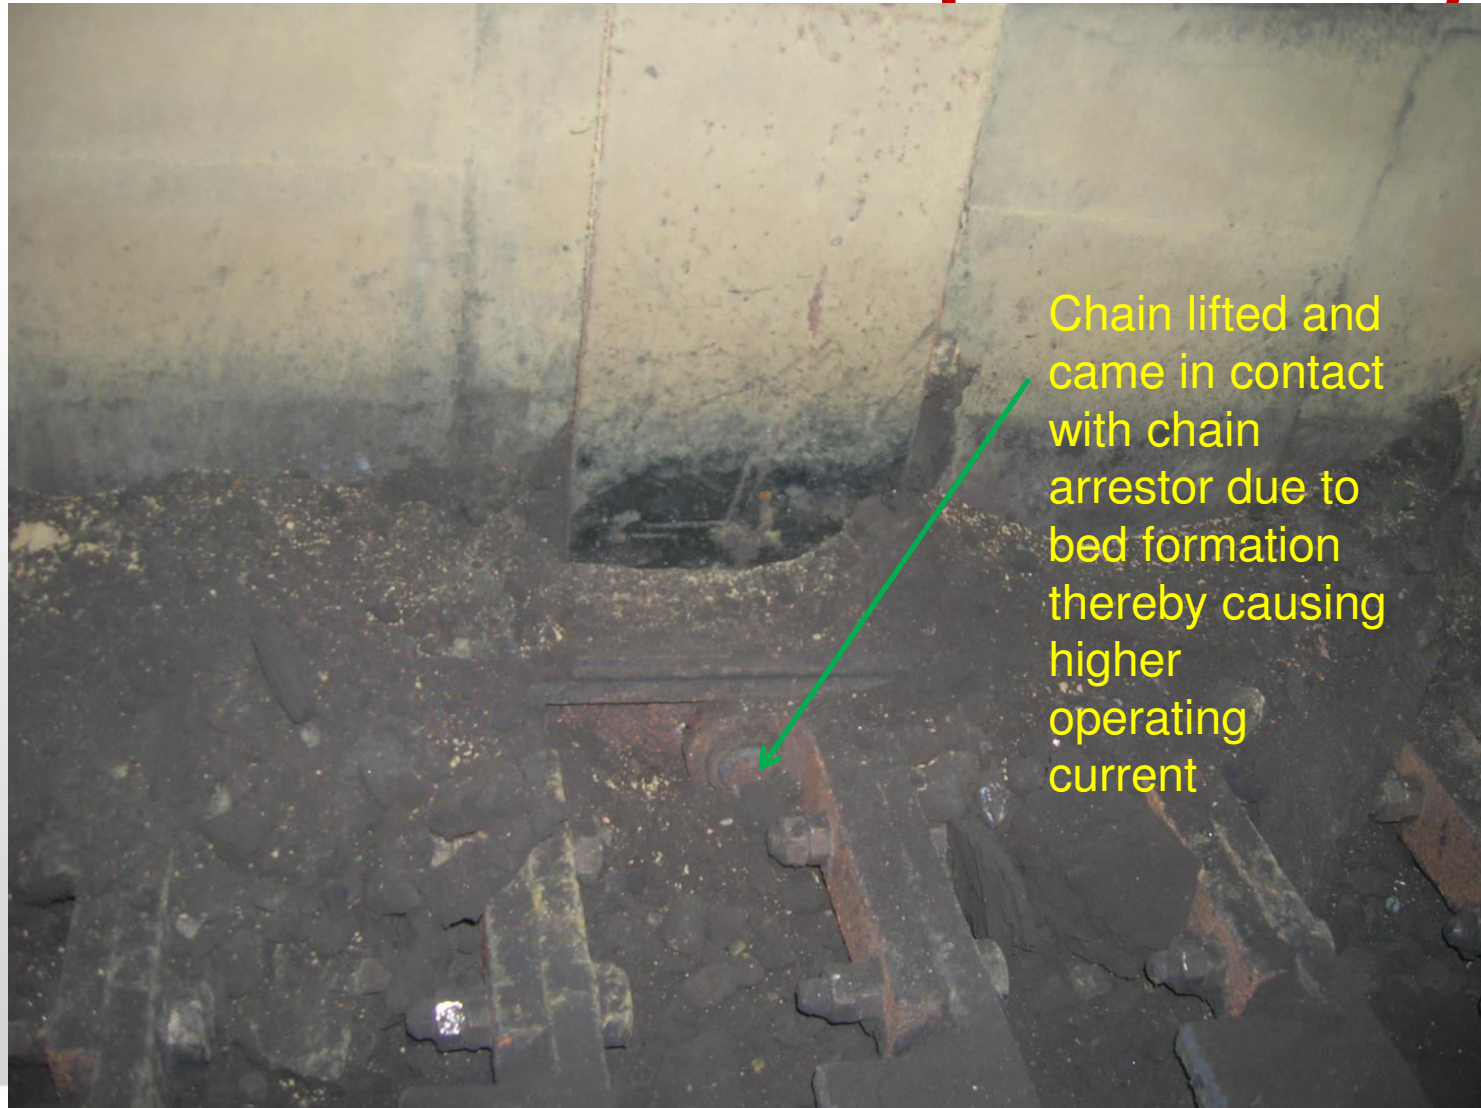
Bed Formation in Transport conveyor

Chain lifted and came in contact with chain arrestor due to bed formation thereby causing higher operating current

Problems faced	Action taken
a) Failure in PA fan 'A' impeller b) Failure of PA duct Metallic Expansion Joint.	a) PA fan Impeller shaft modified with higher diameter b) MEJs were modified.
Bed Formation & Choking in the Lignite Transport and Extraction feeders	❖ Chain Arrestors erected in transport conveyor and Extraction feeder chains to arrest the lifting up of chain. ❖ Serrated flights introduced in both Extraction and Transport feeders. ❖ Transport Conveyor A and B Motor Capacity raised.

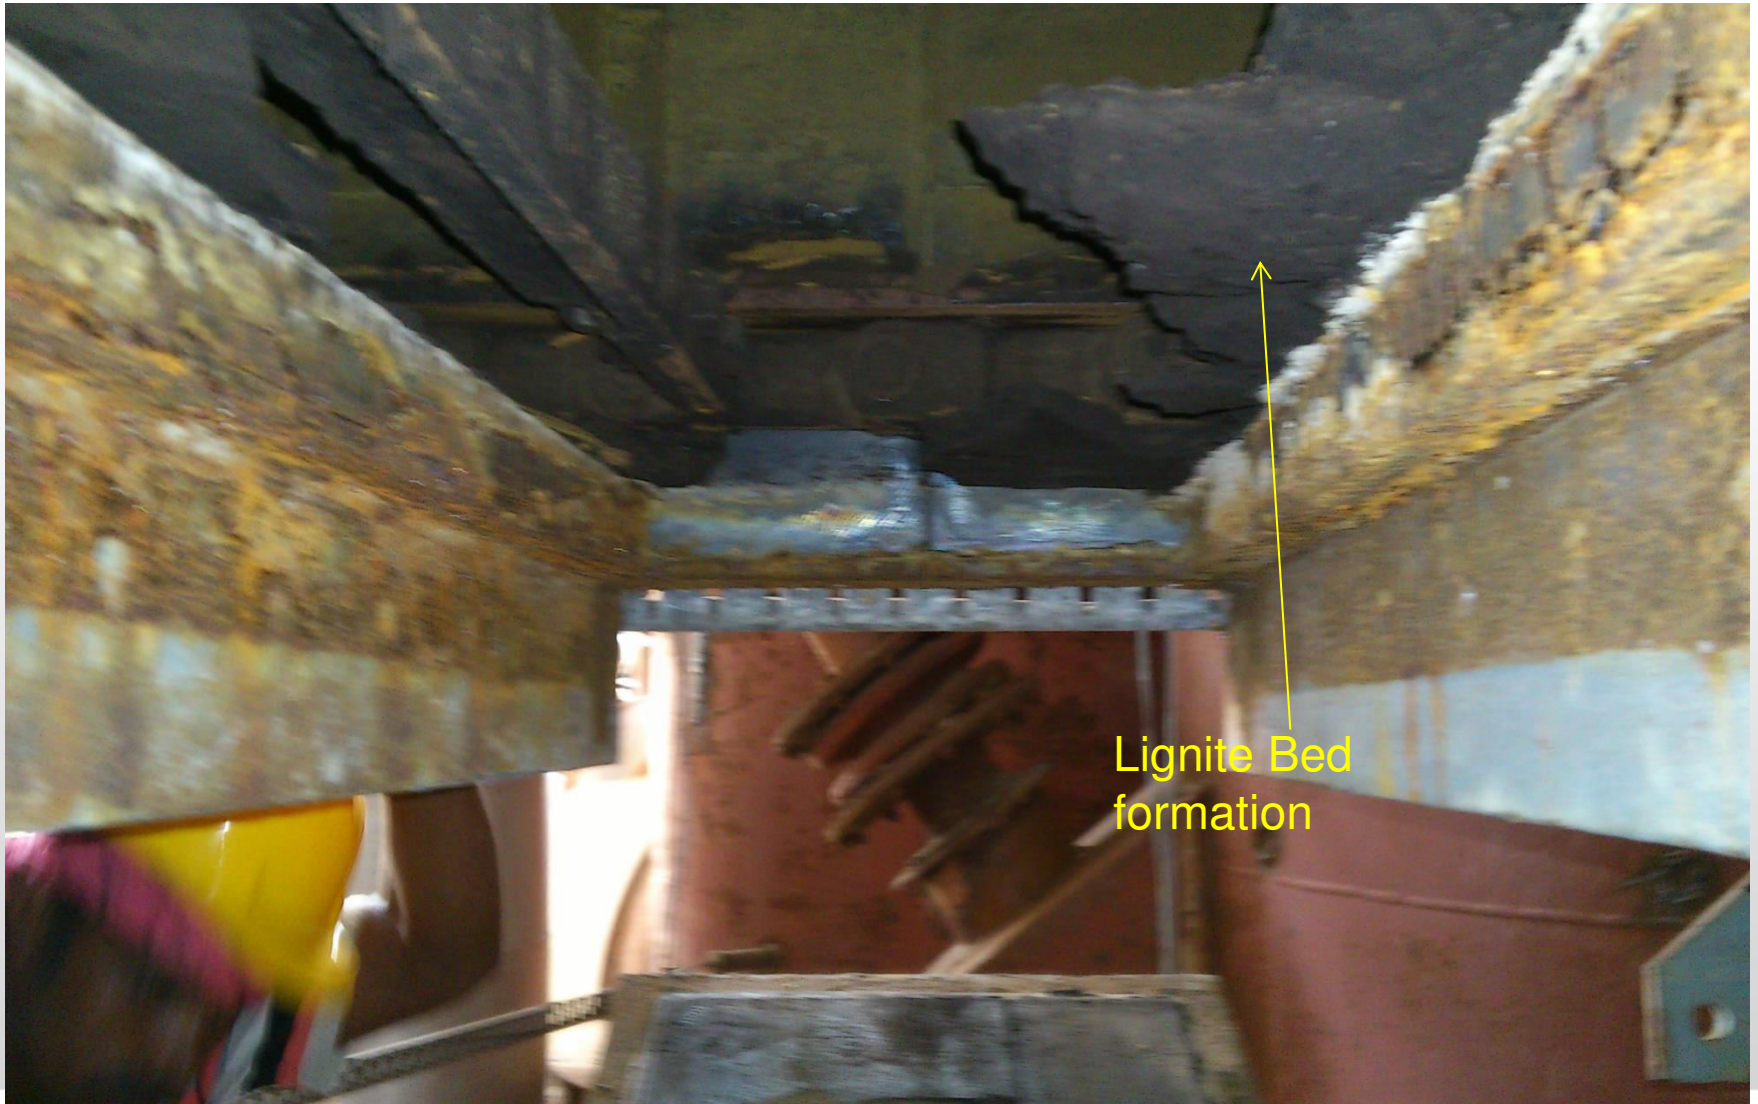
Bed Formation in Transport Feeders (View from the bottom)

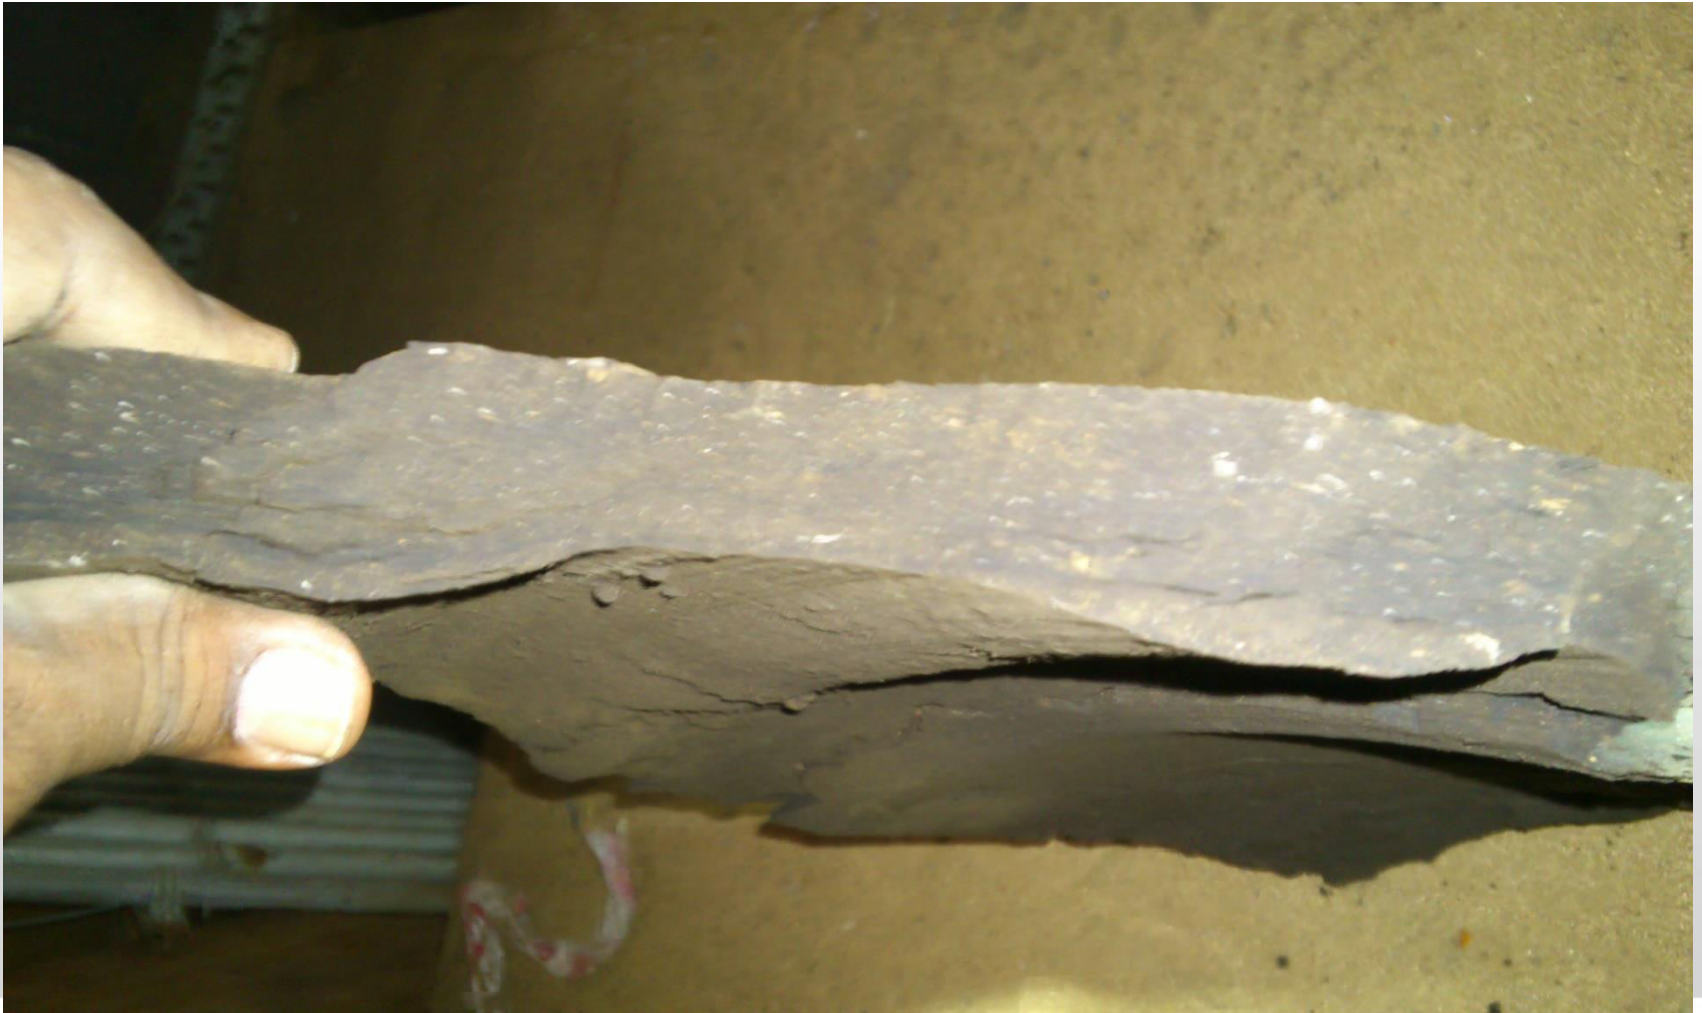
Bed Formation in Transport Feeders

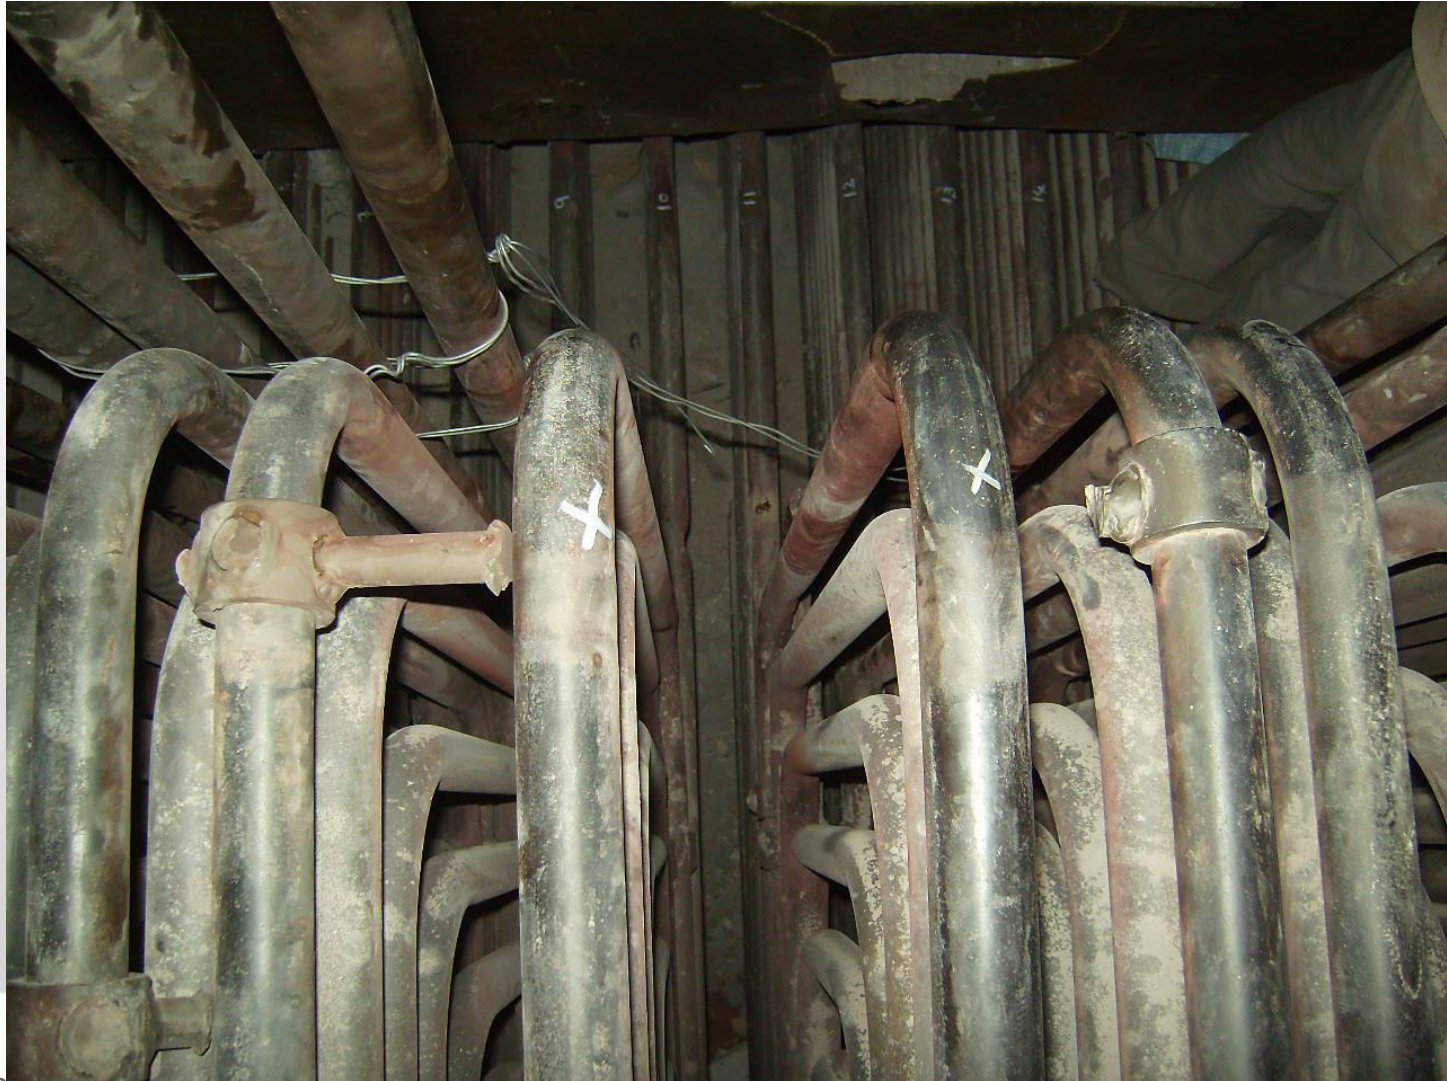
Problems faced	Action taken
<p>FBHE SH/RH Coil support system failure</p> <ol style="list-style-type: none">1. Stresses in the rods were very high compared to allowable limits at operating temperatures.2. Natural frequency of tube bundle matches with excitation frequency during operation resulting in fatigue failure.	<p>FBHE Coil supporting arrangements modified with steam cooled Hanger tubes and Dog bone arrangement</p>

FBHE Coils Supports Spacer rods failure

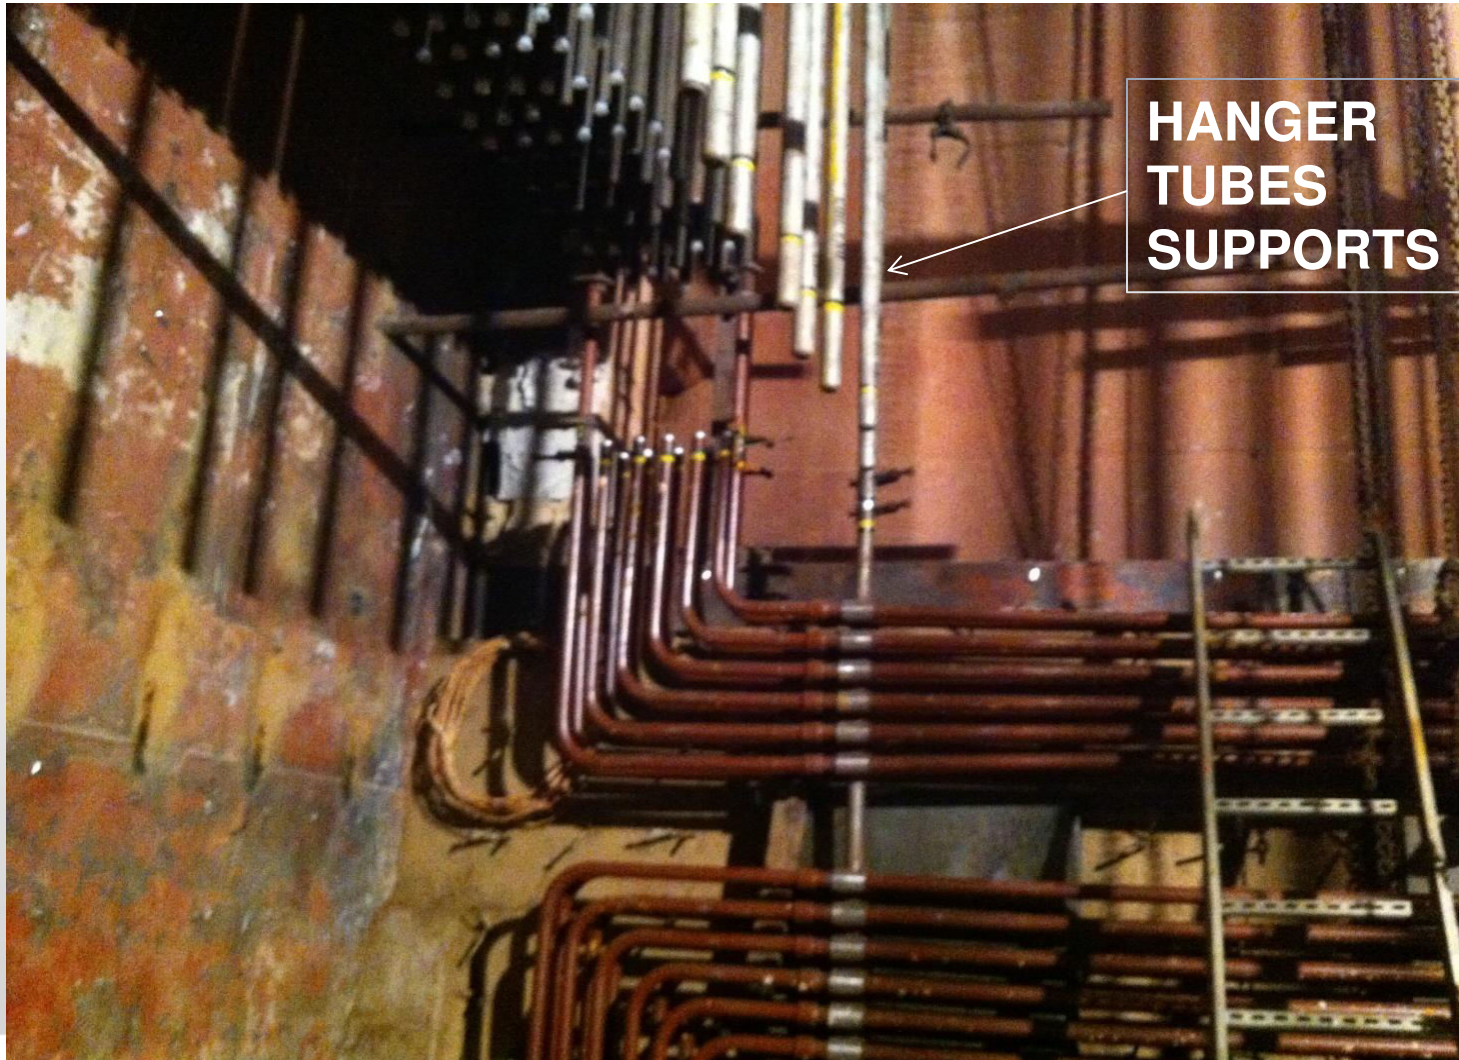
HANGER TUBE FORGED BLOCK ASSEMBLY

FBHE MODIFICATION

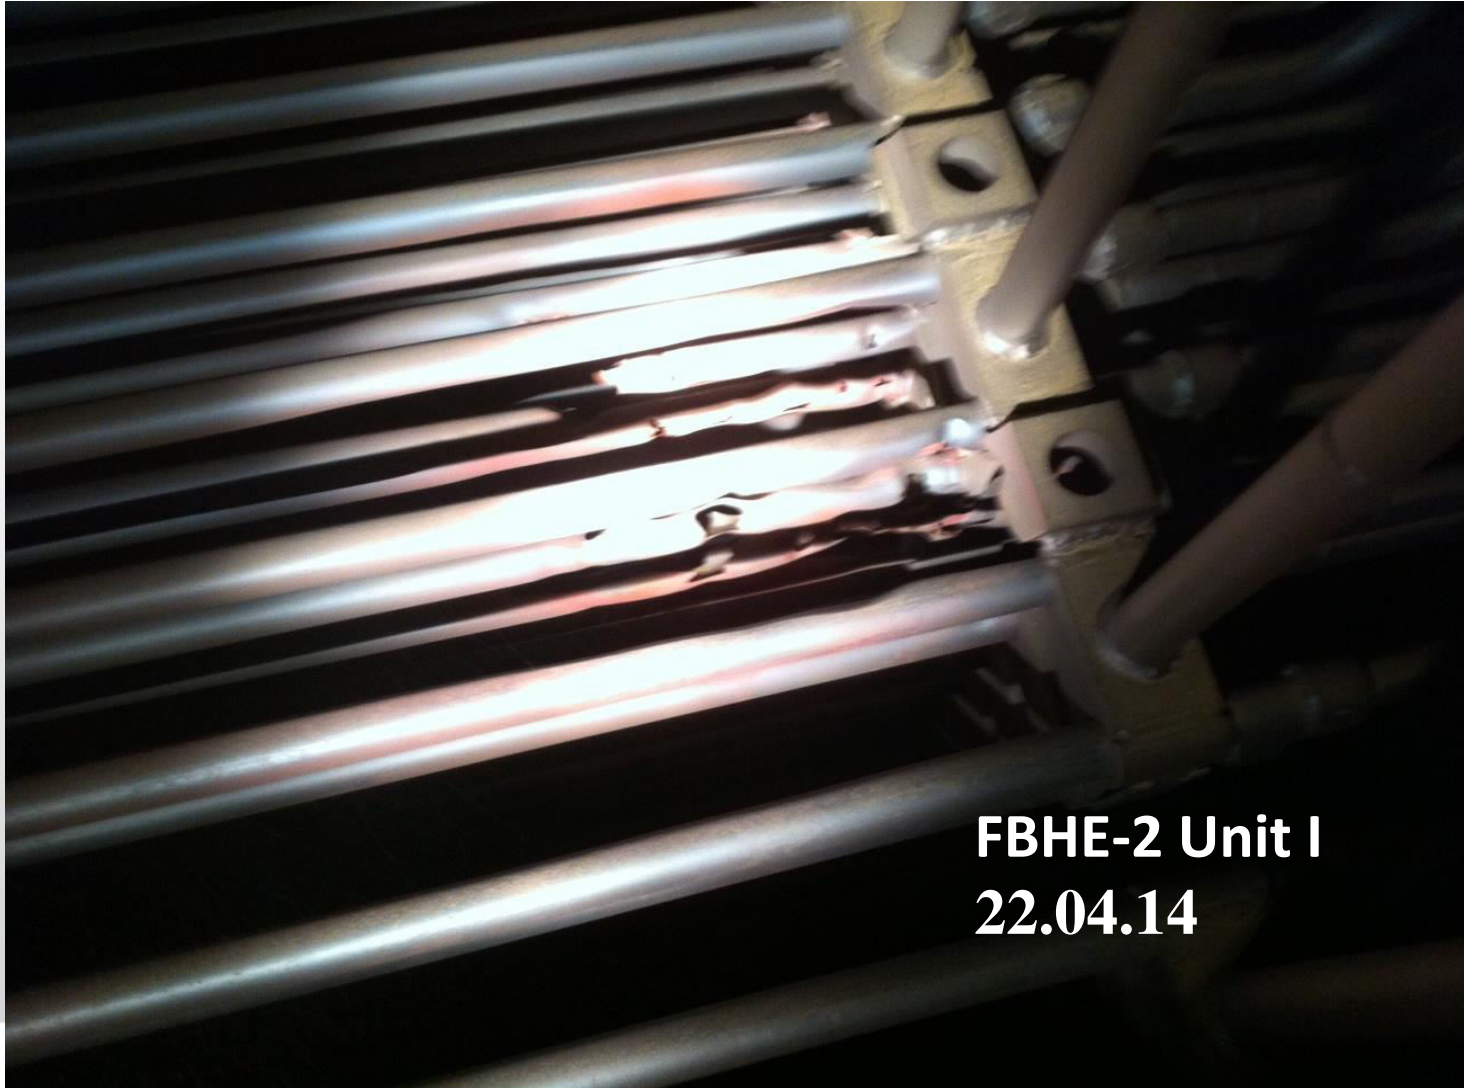
**FBHE-2 Unit I
22.04.14**

FAILURE OF SH COILS & HANGER TUBE ASSEMBLY

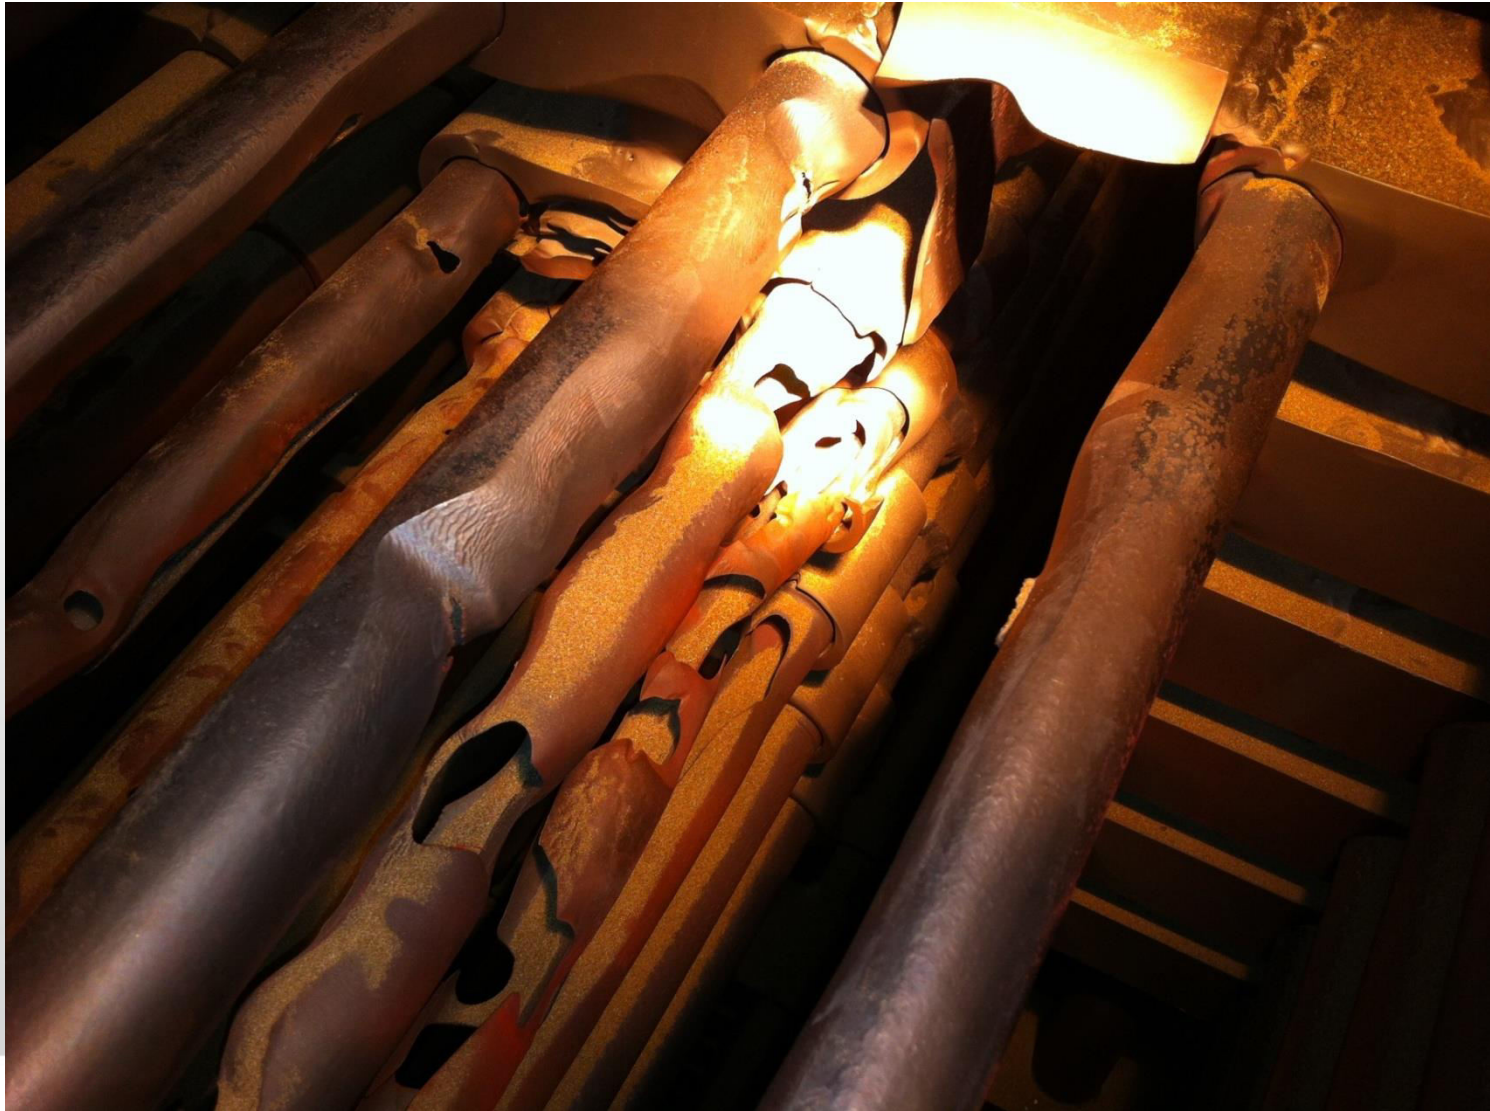
FAILURE OF SH COILS & HANGER TUBE ASSEMBLY

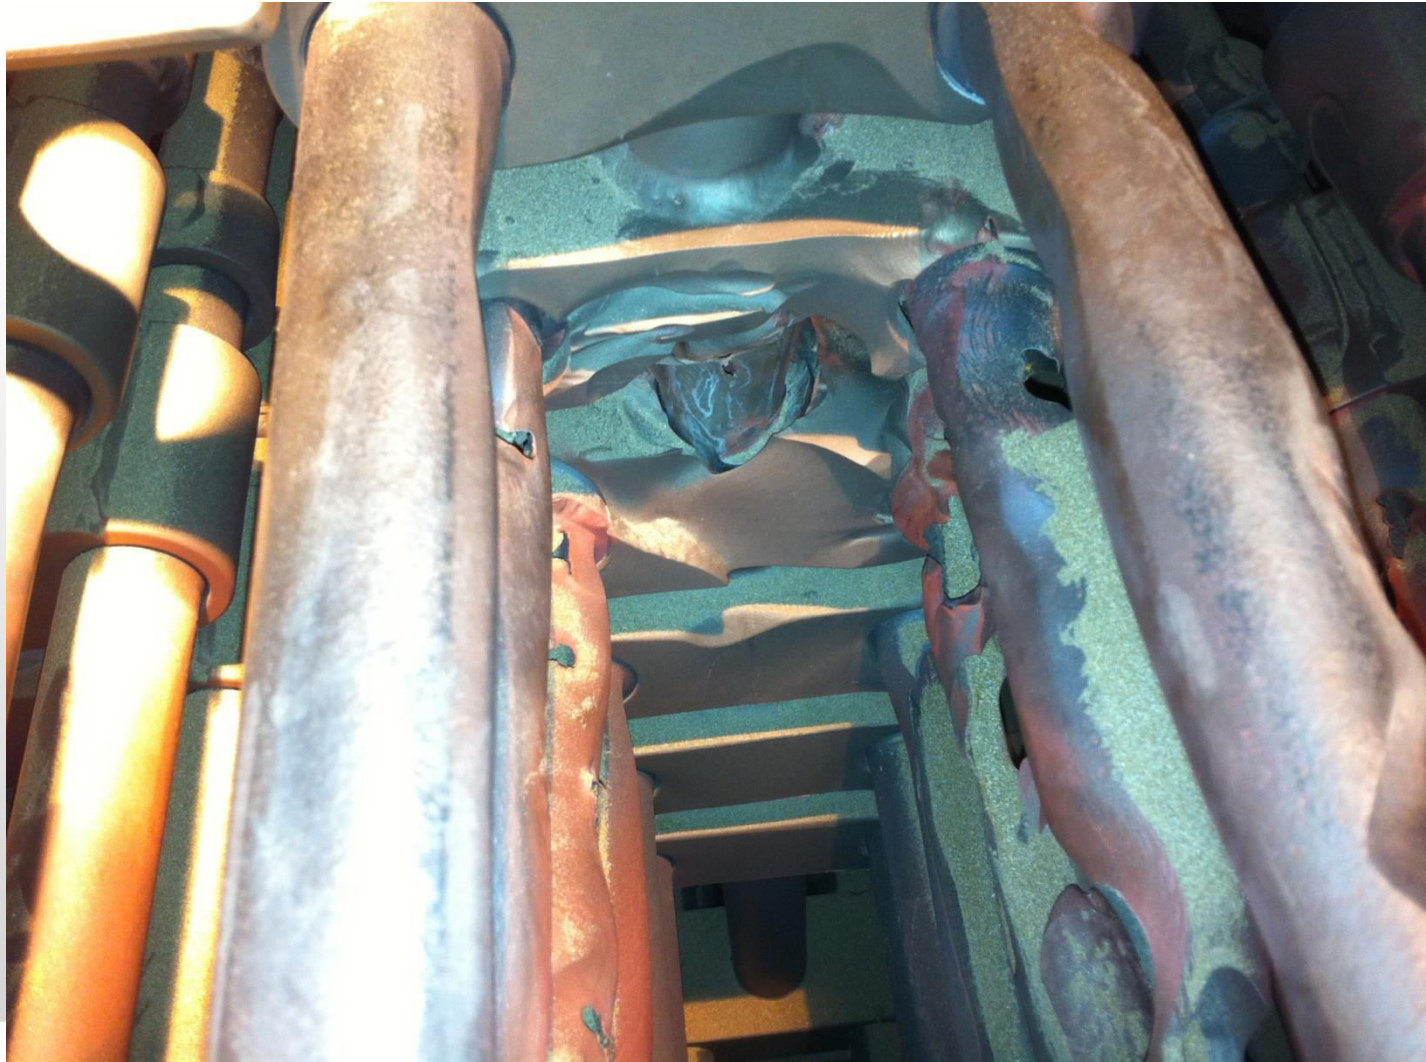
FAILURE OF SH COILS & HANGER TUBE ASSEMBLY

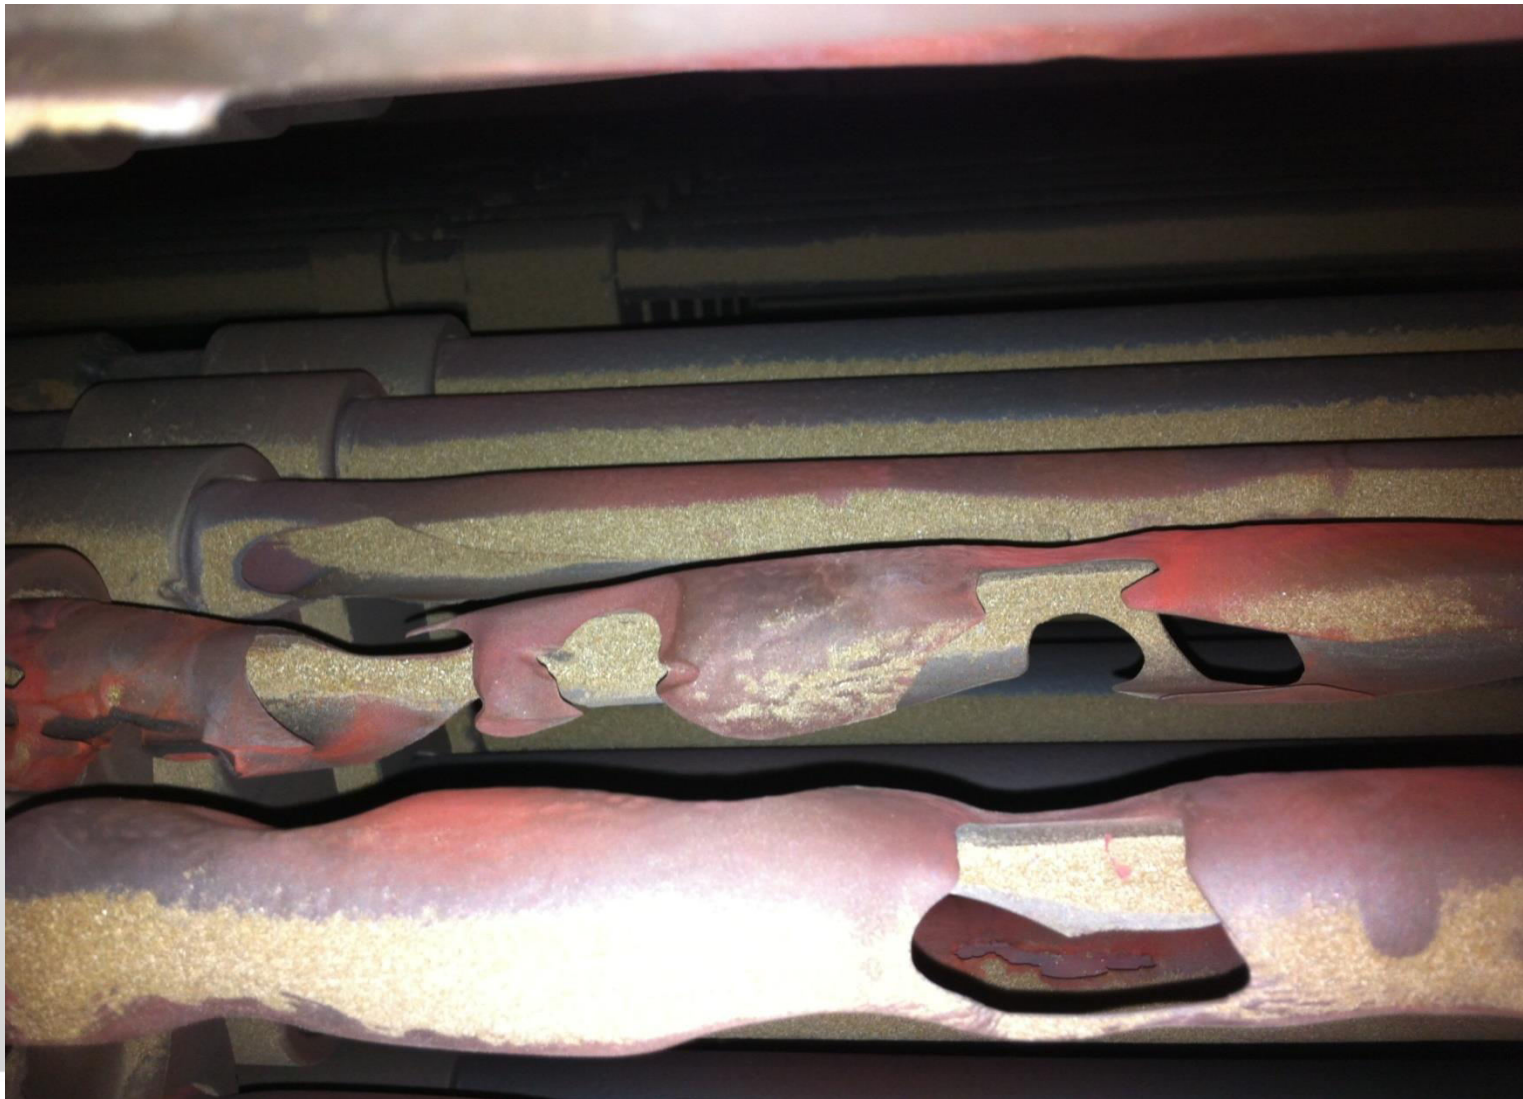
FAILURE OF SH COILS & HANGER TUBE ASSEMBLY

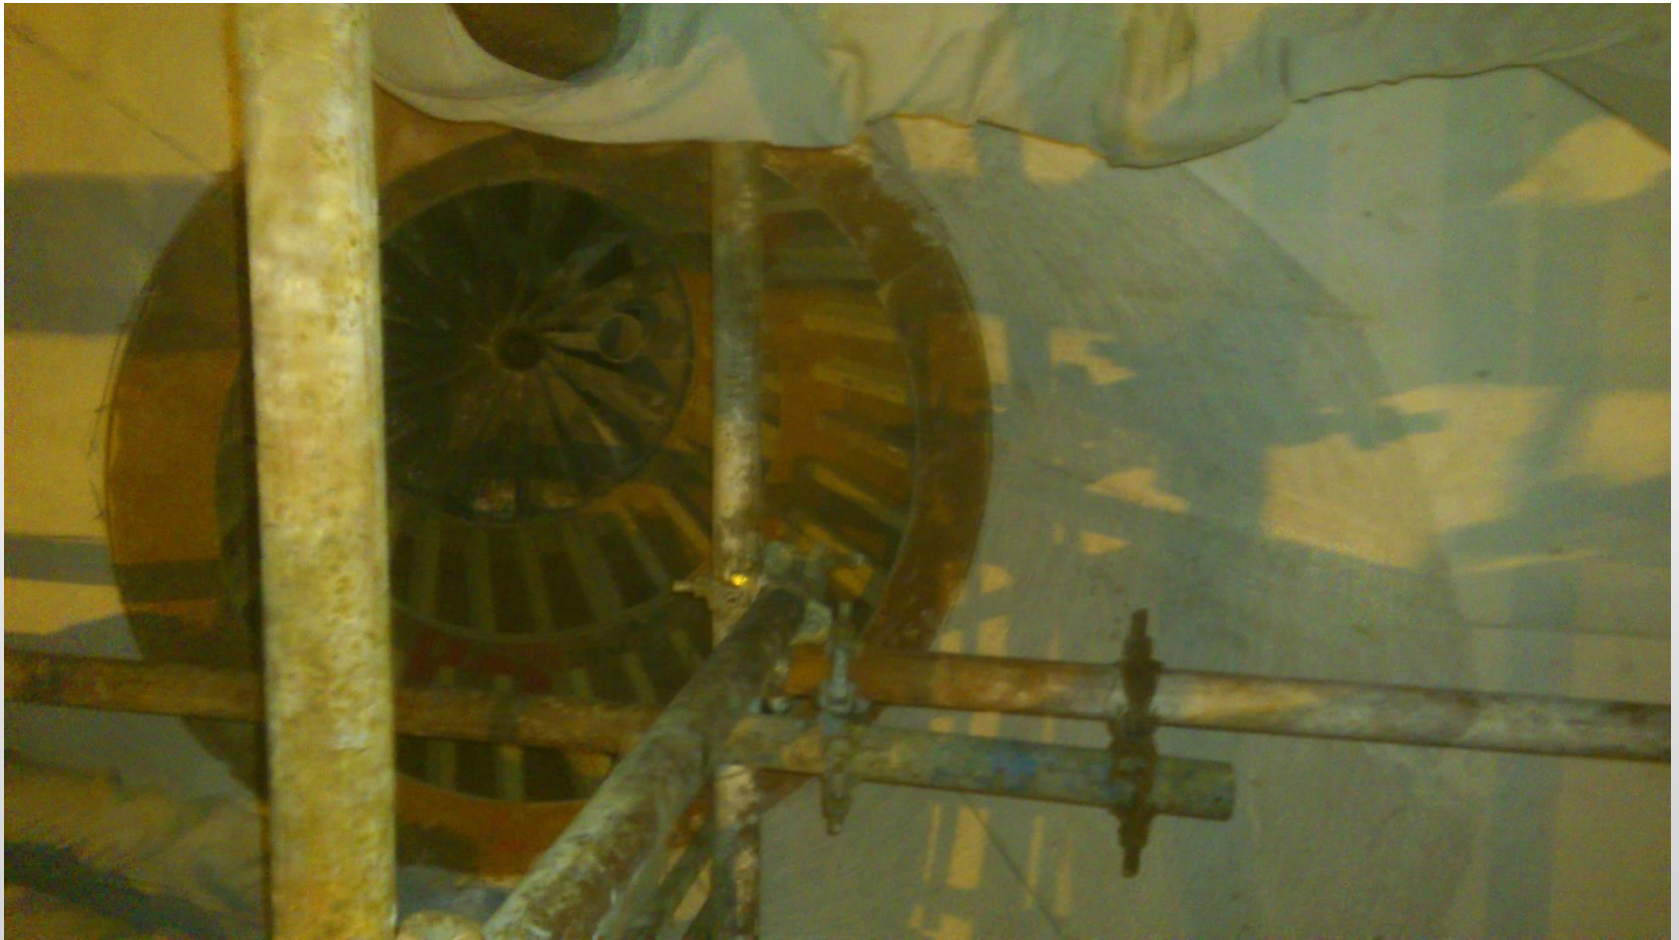
START UP BURNER – REFRACTORY CHANGED TO PLASTIC REFRACTORY

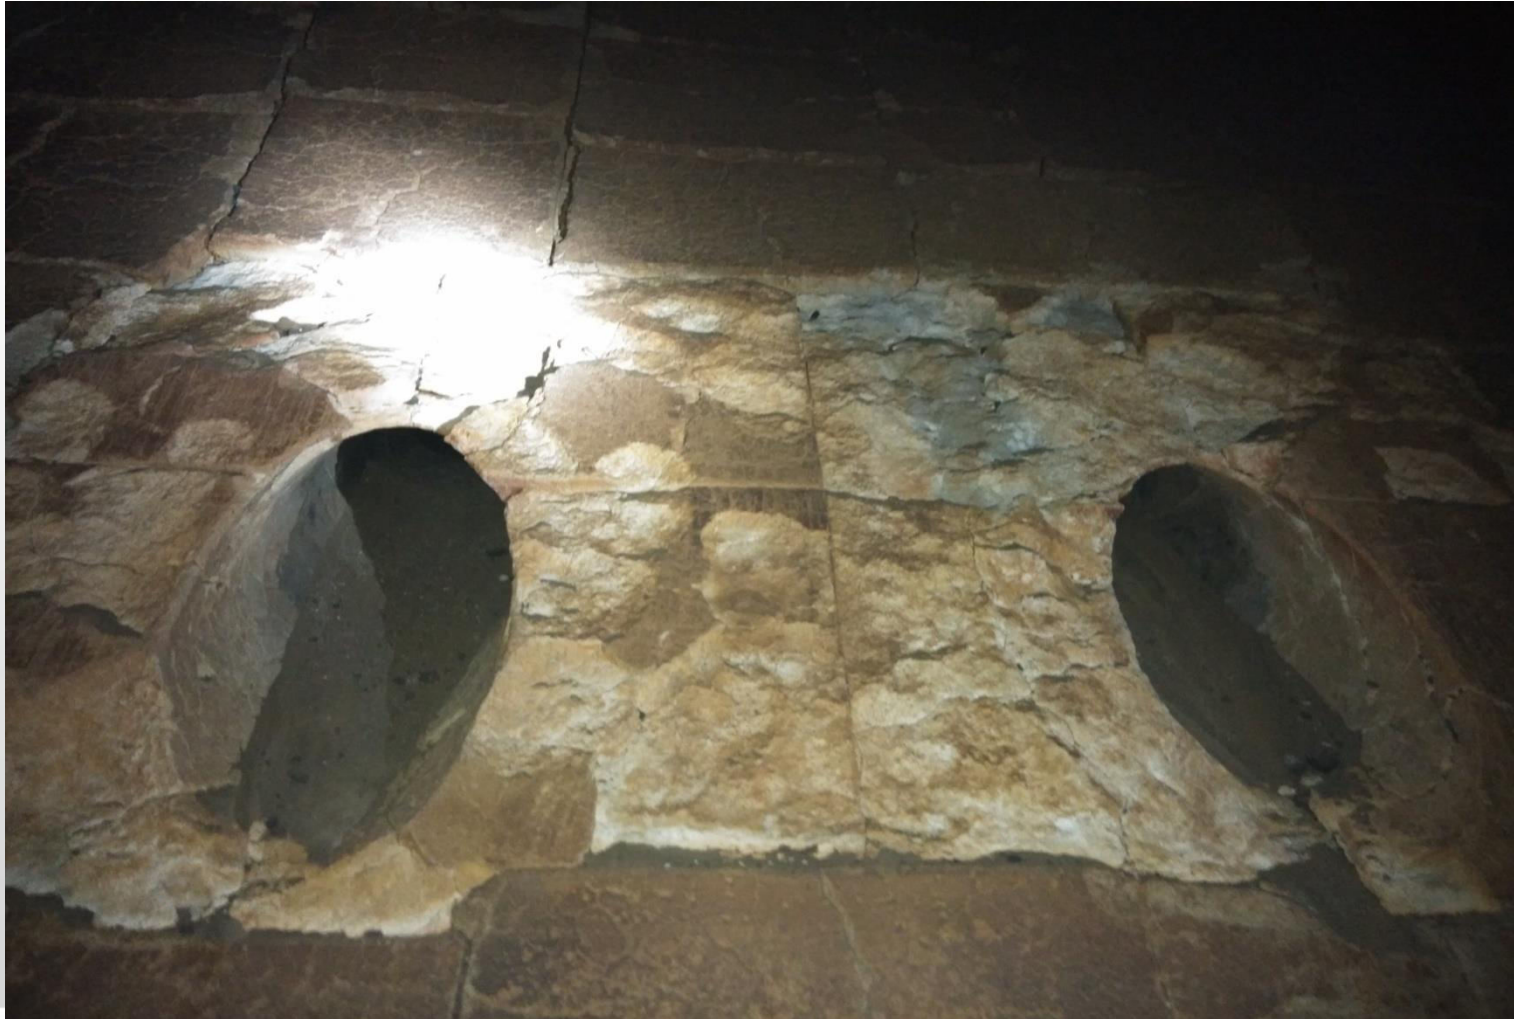
Secondary air openings refractory were modified with Plastic Refractory

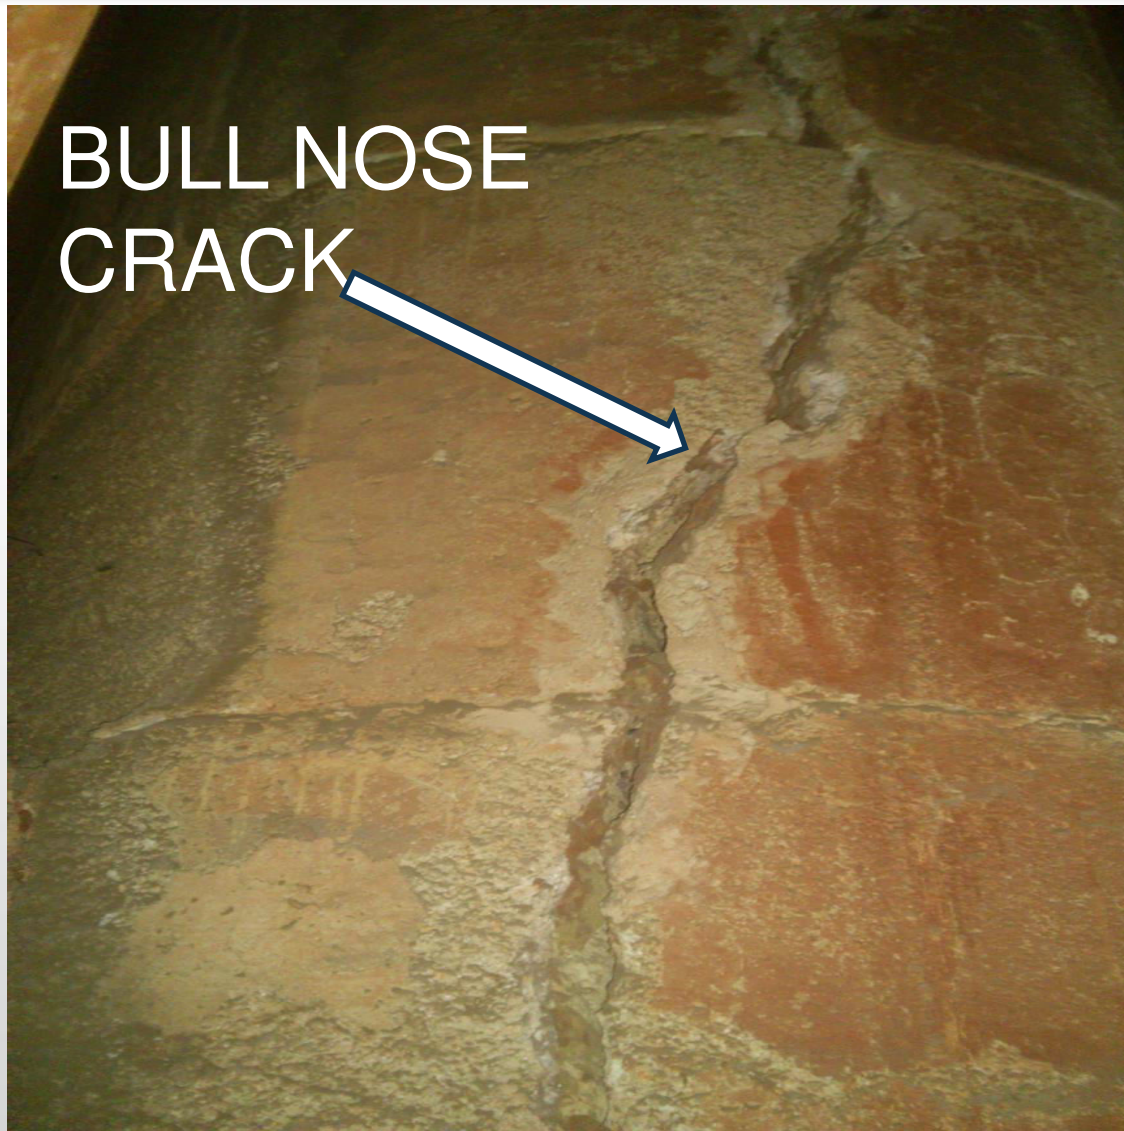
BULL NOSE
CRACK

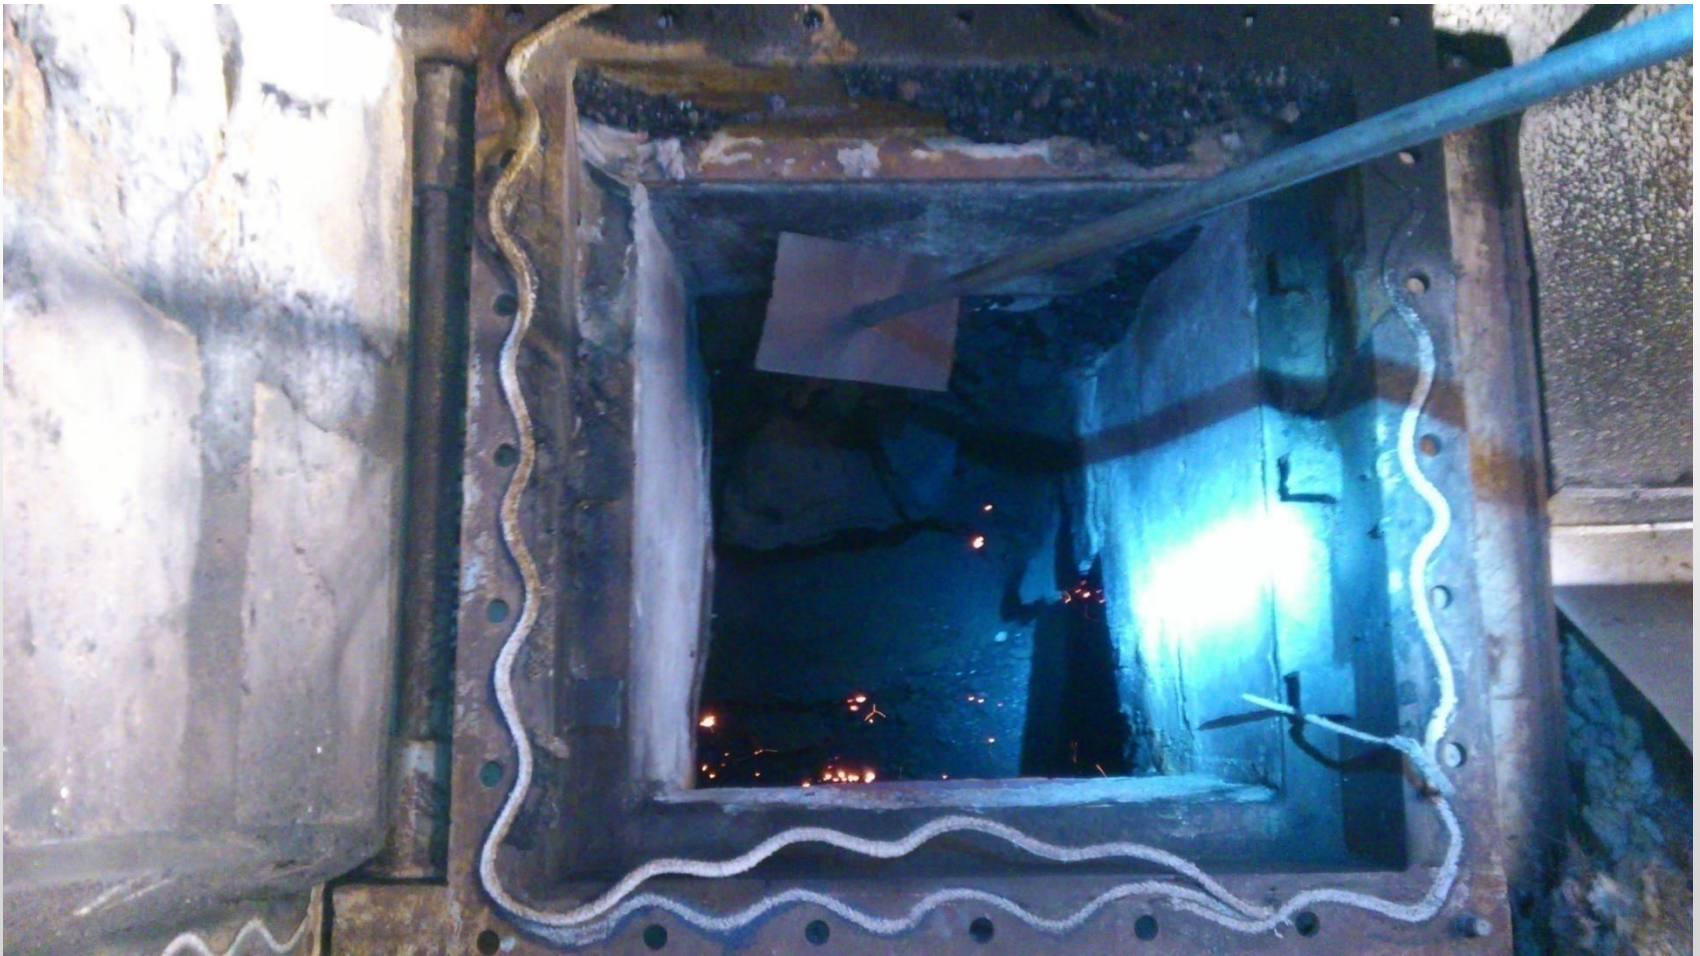
DUE TO THE ABOVE REASONS, SHIFTING OF BED INVENTORY FROM ONE PANT LEG TO OTHER AND CLINKER FORMATION IN COMBUSTOR PANT LEGS WERE EXPERINCED.

Non- Fluidisation in Combustor leading to Clinker formations

The problem was resolved by suitable correction in the control system

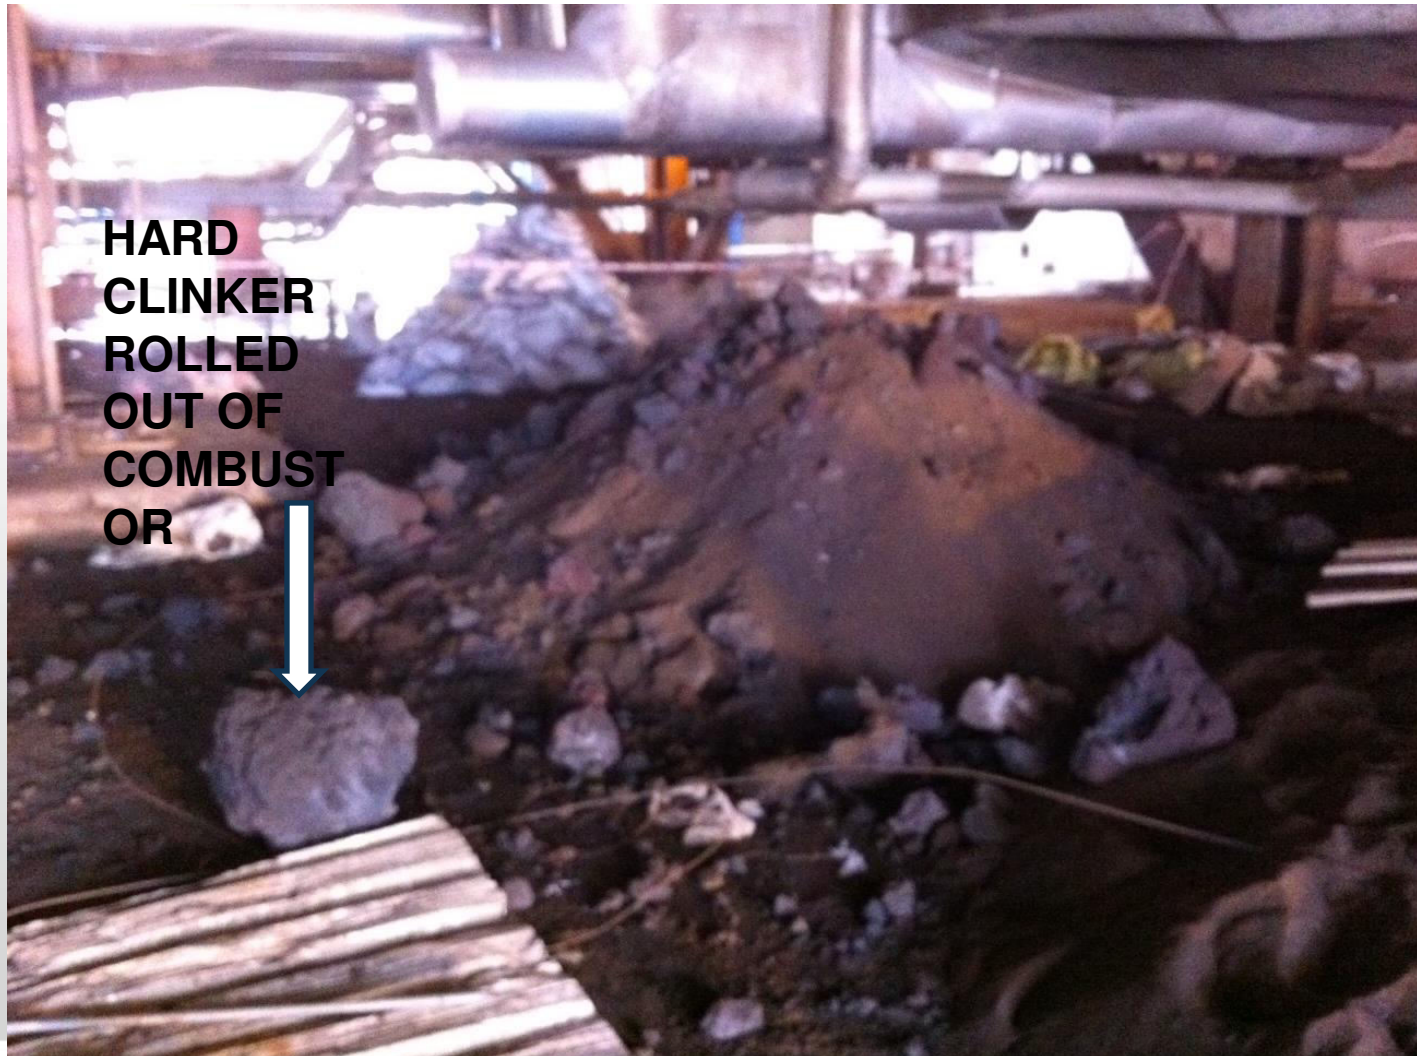
Non- Fluidisation in Combustor leading to Clinker formations
