GREETINGS FROM NEYVELI LIGNITE CORPORATION LIMITED

November 14, 2014

NLC TPS-II EXPANSION PROJECT 2 X 250 MW – LIGNITE FIRED CFBC BOILERS

OPERATION EXPERIENCES IN 125 MW AND 250 MW CFBC BOILERS

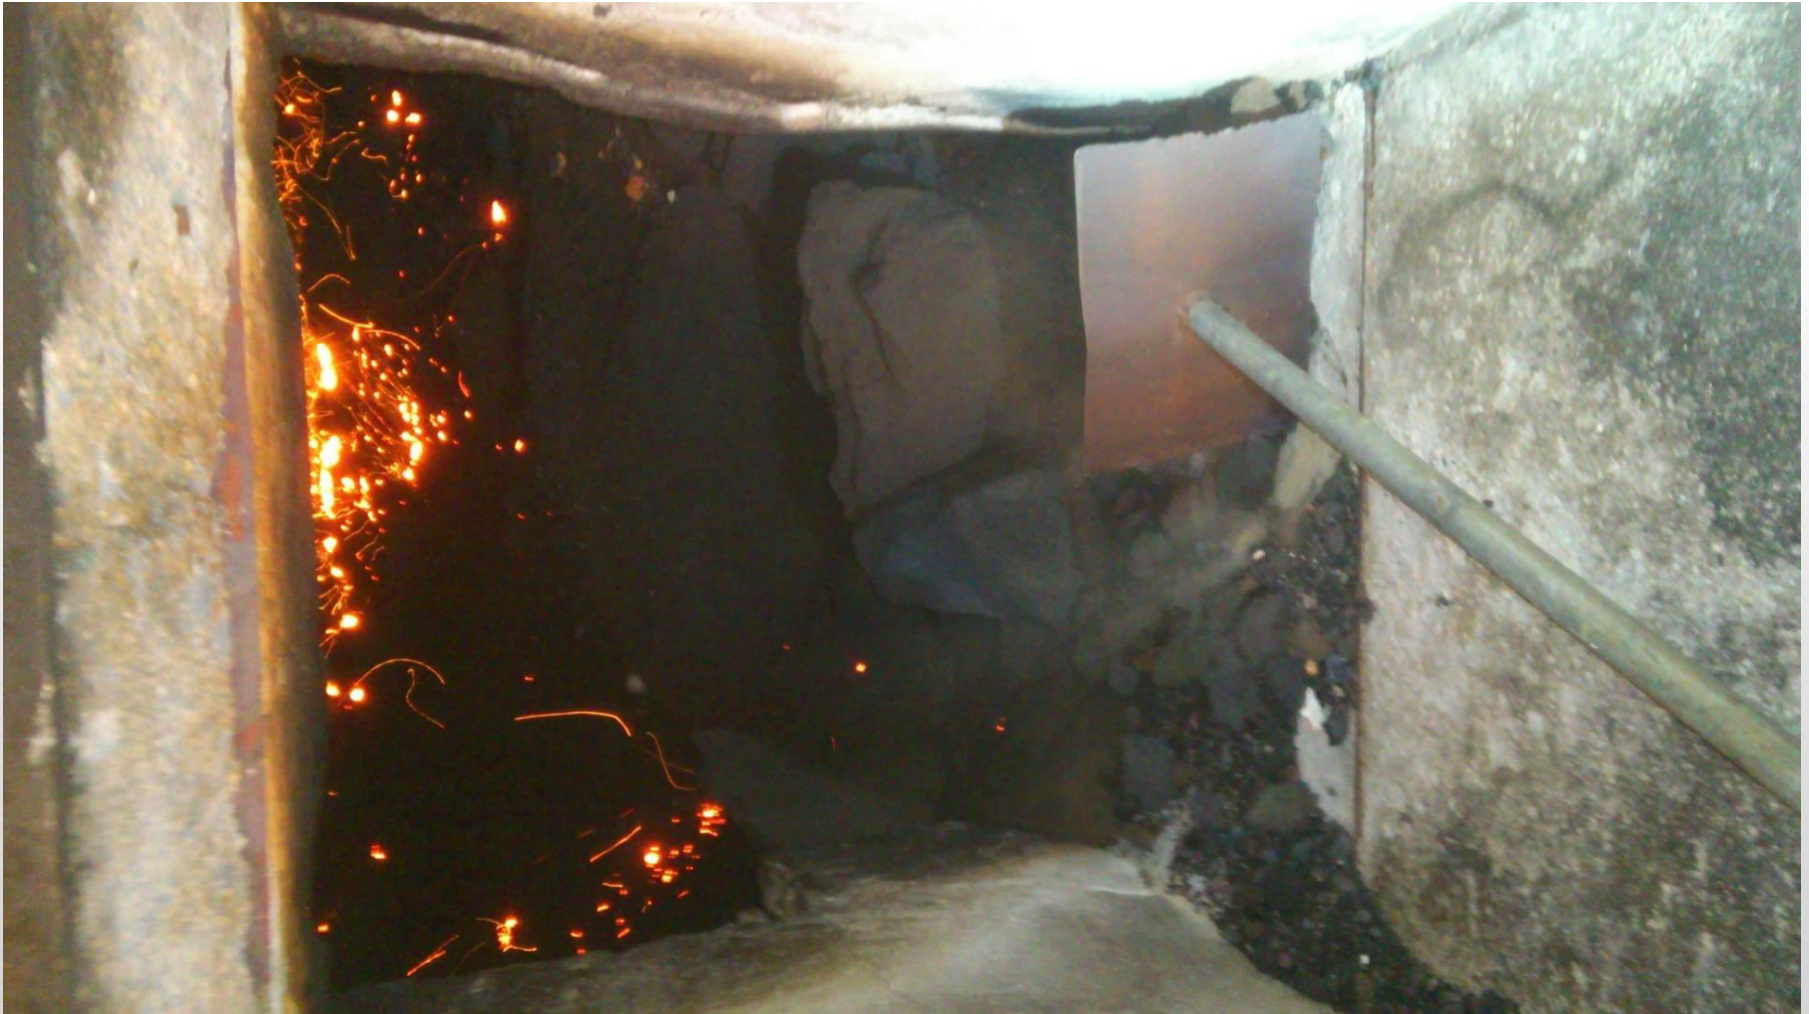
Clinker formations in Combustor

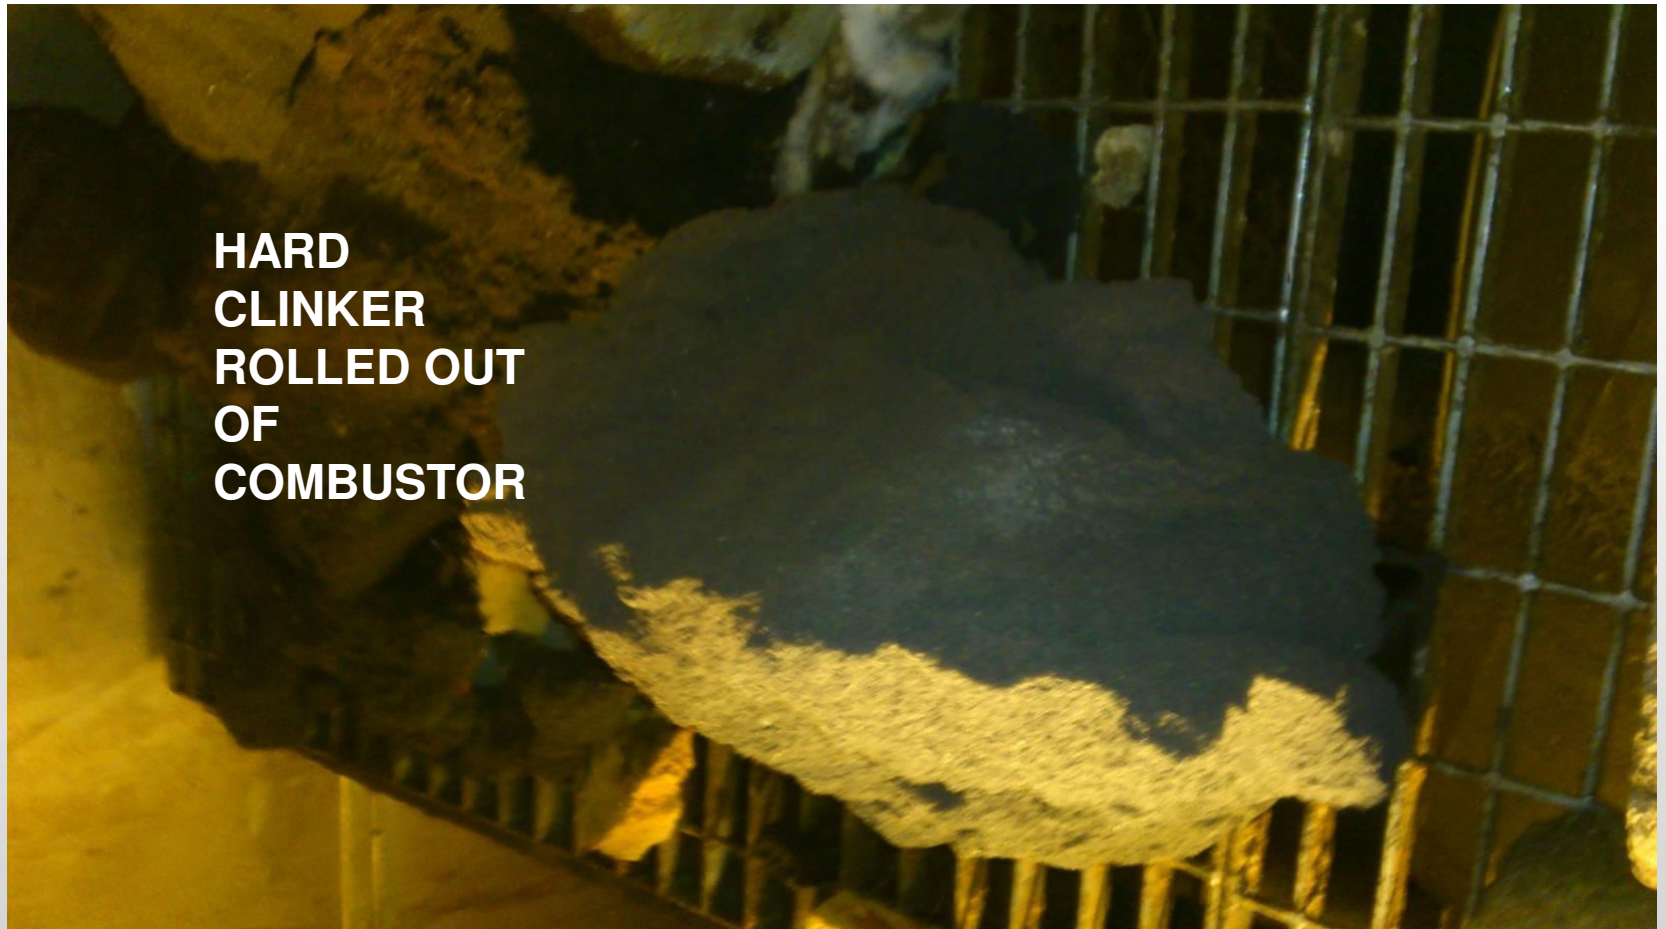
Clinker formations in Combustor

**HARD
CLINKER
ROLLED OUT
OF
COMBUSTOR**

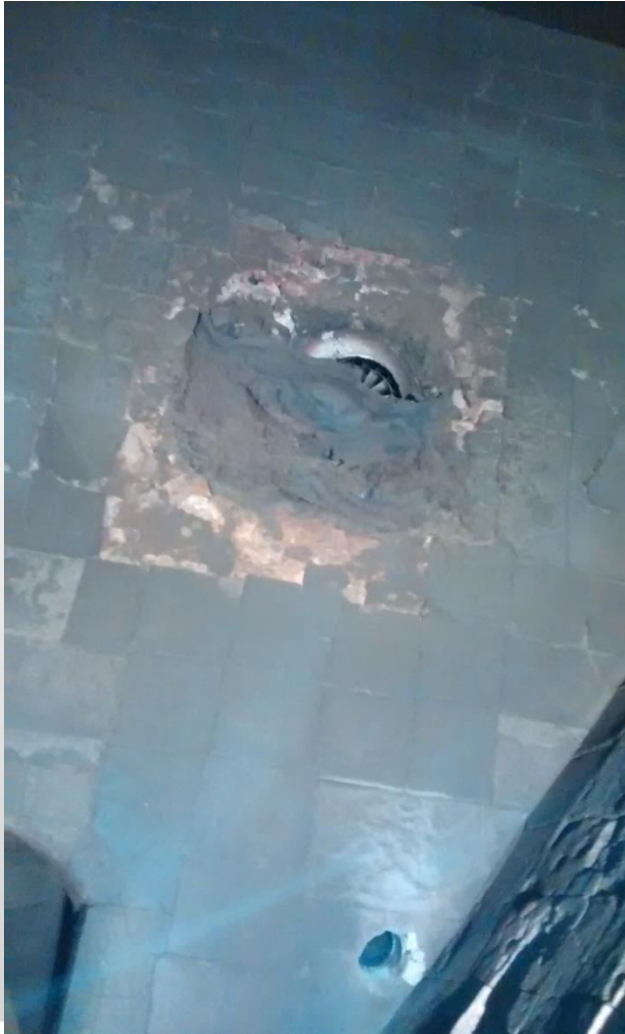
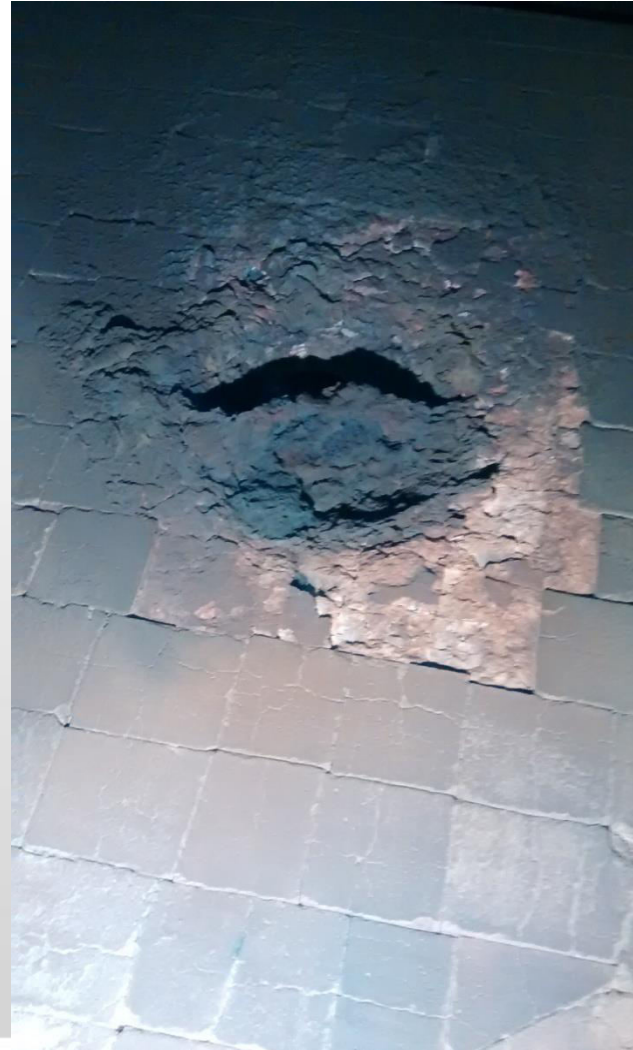
Start up Burner Mouth choke

- **The SUB Refractory has been modified with Plastic refractory**
- **The Start up Burner has been replaced with modified Gun and swirler**

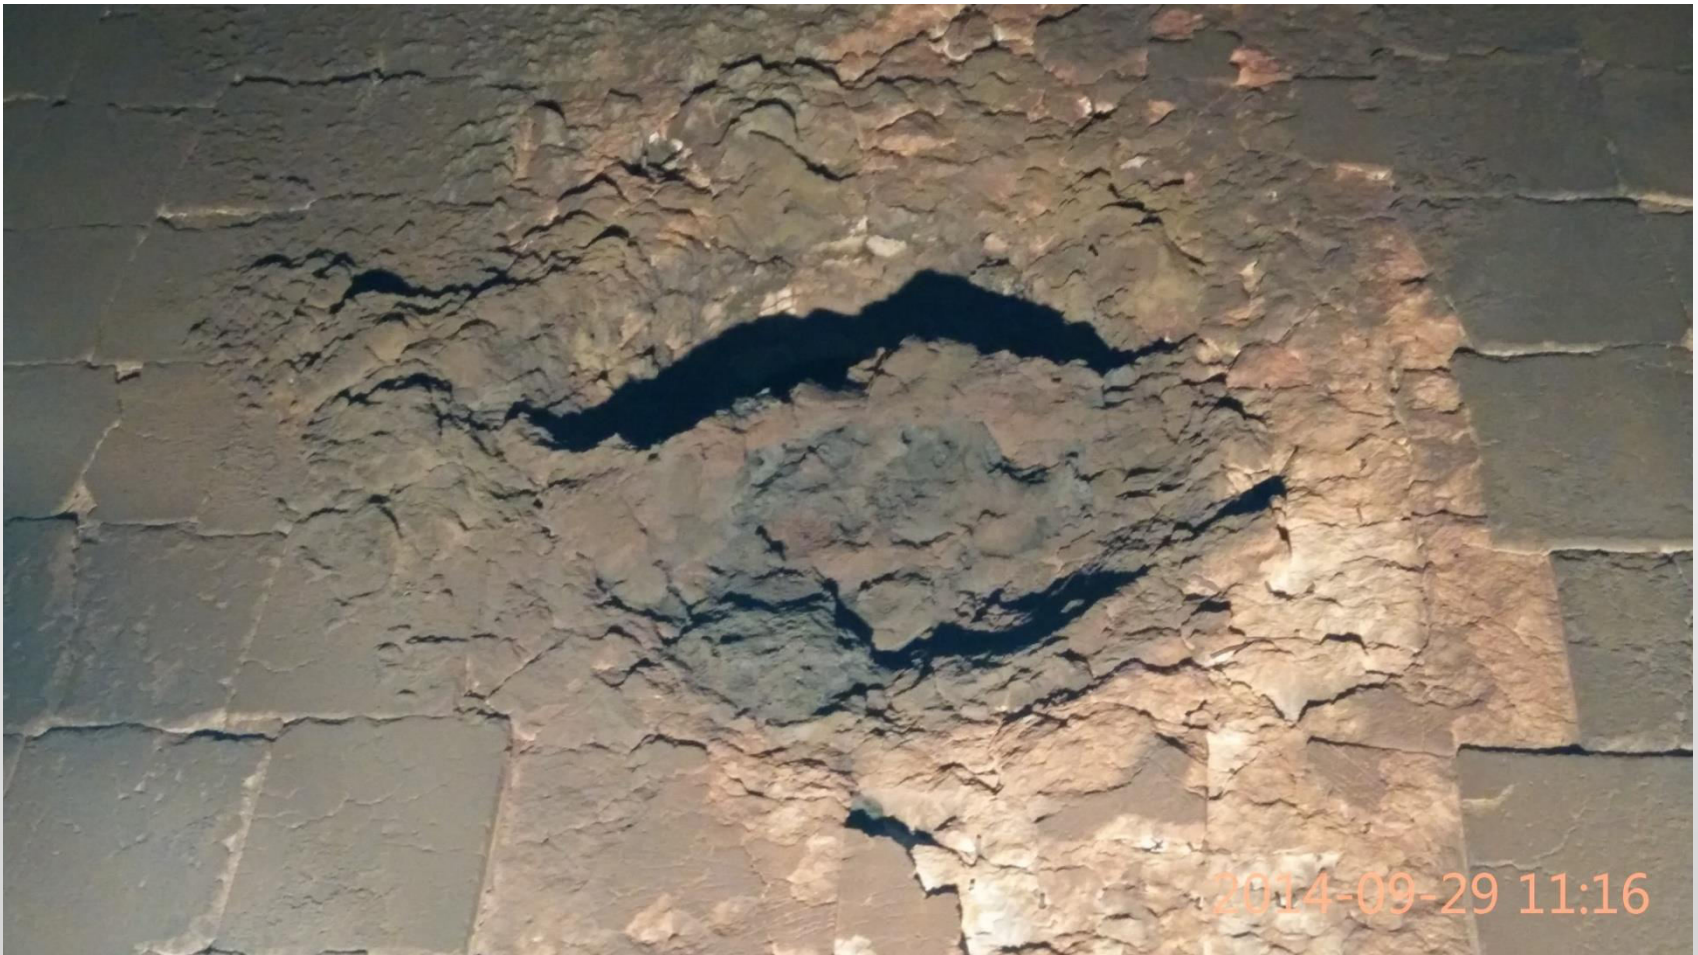
START UP BURNER MOUTH CHOKE

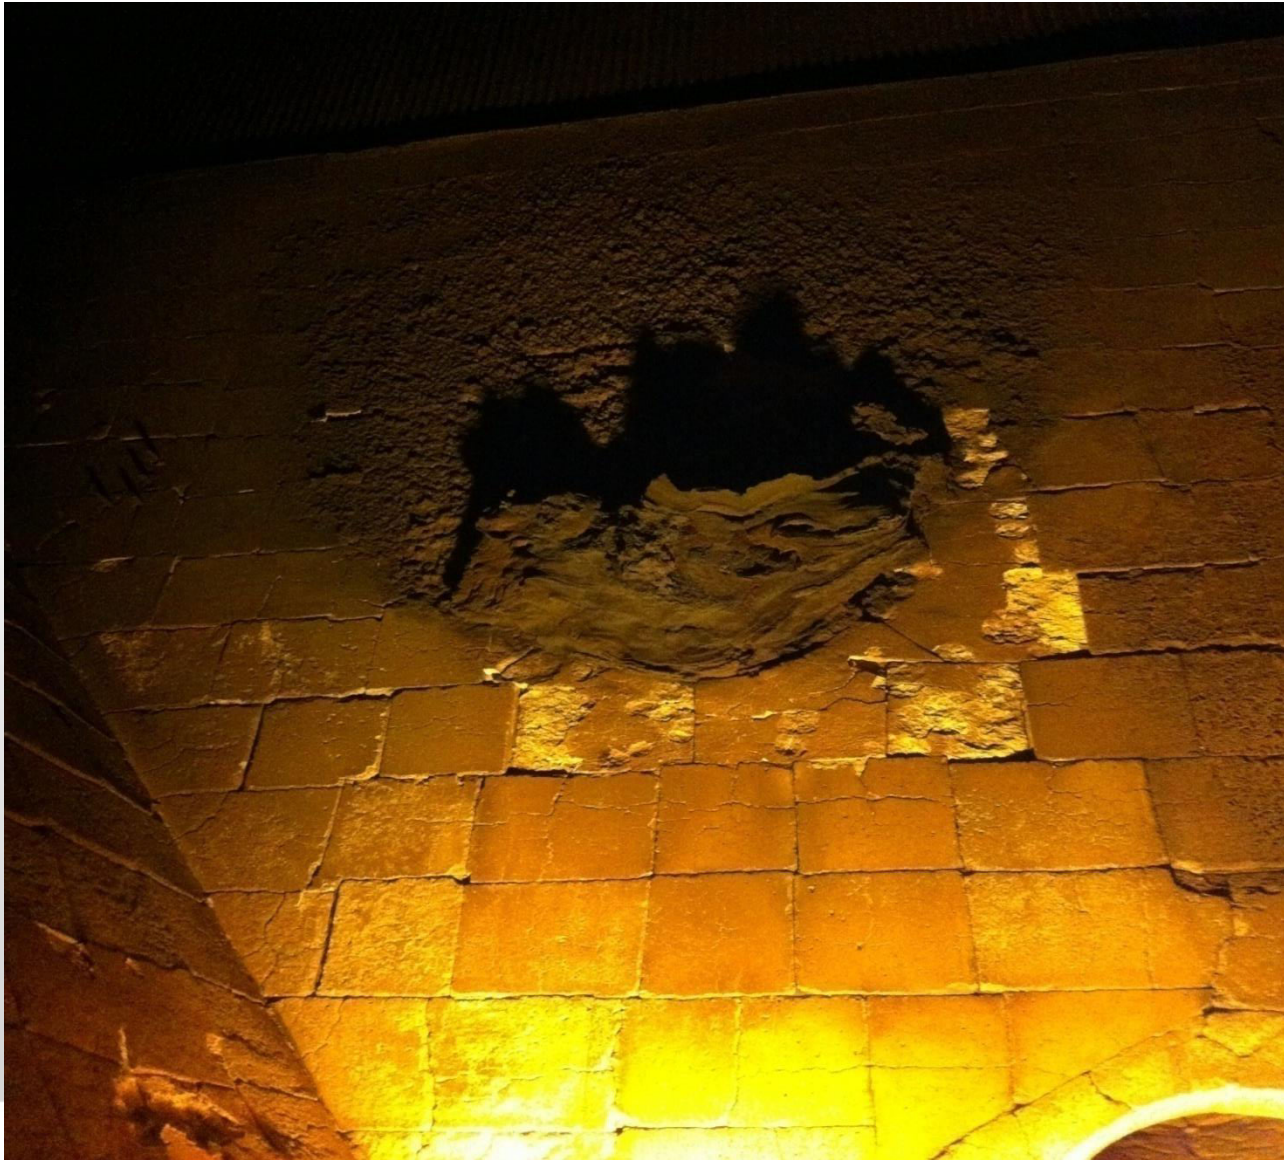
START UP BURNER MOUTH CHOKE

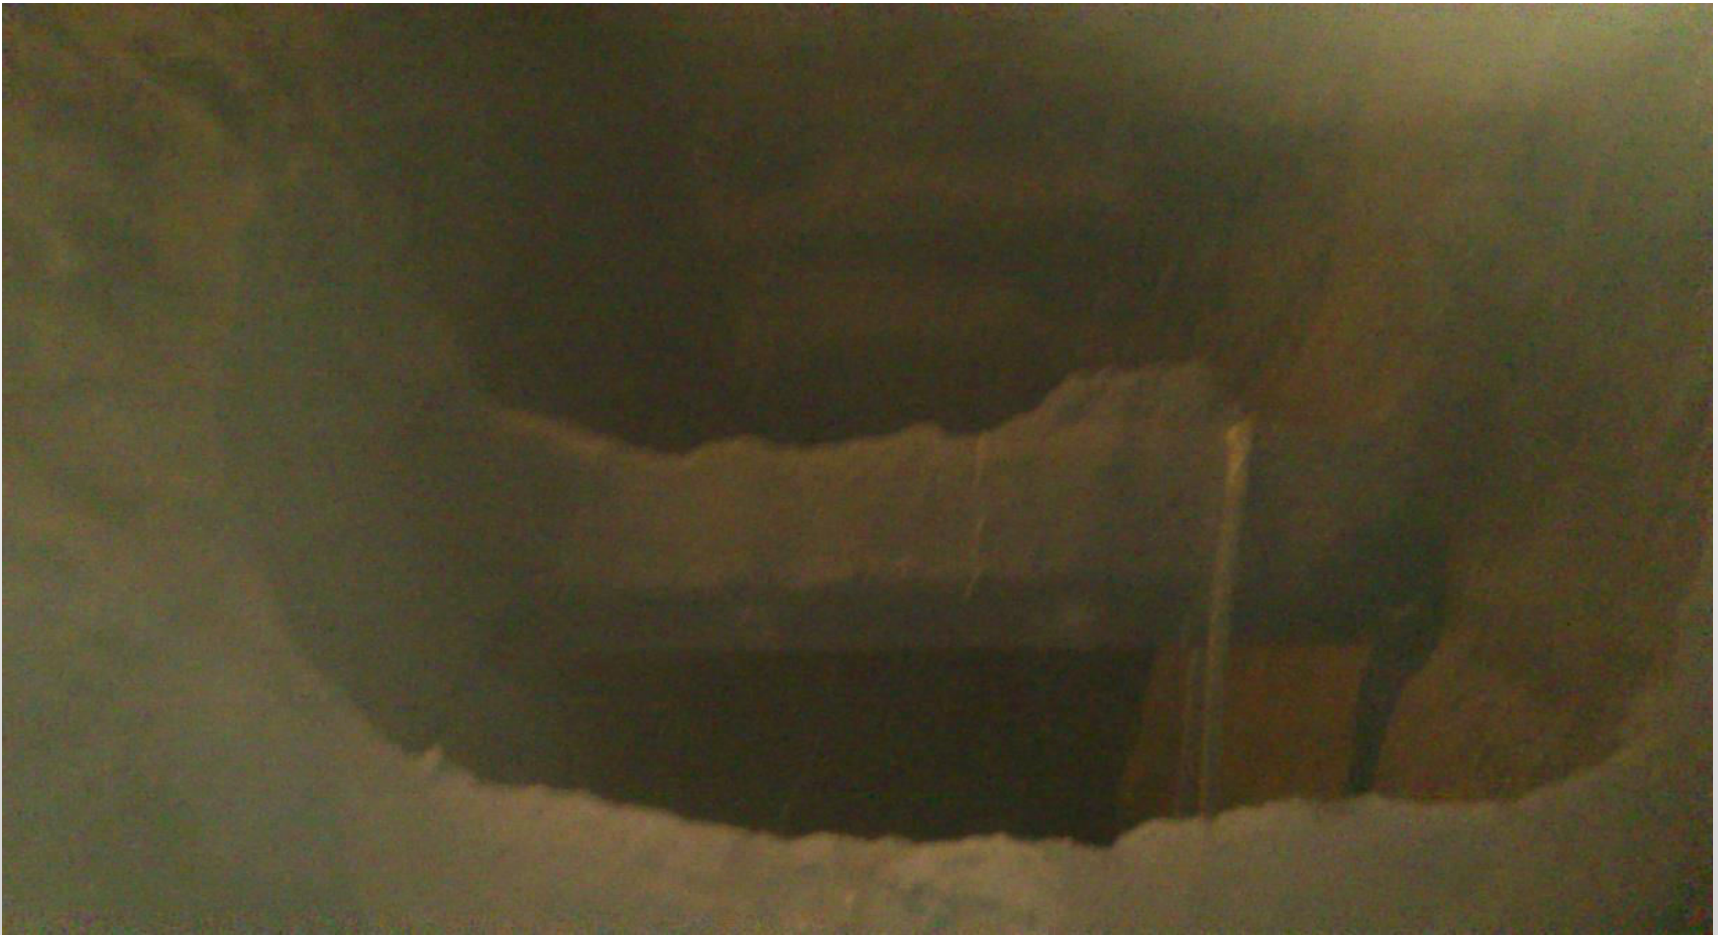
DUE TO THE ABOVE REASONS WELL FORMATION IN THE LIGNITE BUNKERS LEADING TO LESS OR NIL FLOW.

Lignite Bunker A outlet chute above bunker isolation gate while emptying

TO OVERCOME THE ABOVE PROBLEM BUNKER CHUTE MODIFICATION WAS CARRIED OUT AND DEFECTS IN AIR BLASTERS WERE ATTENDED.

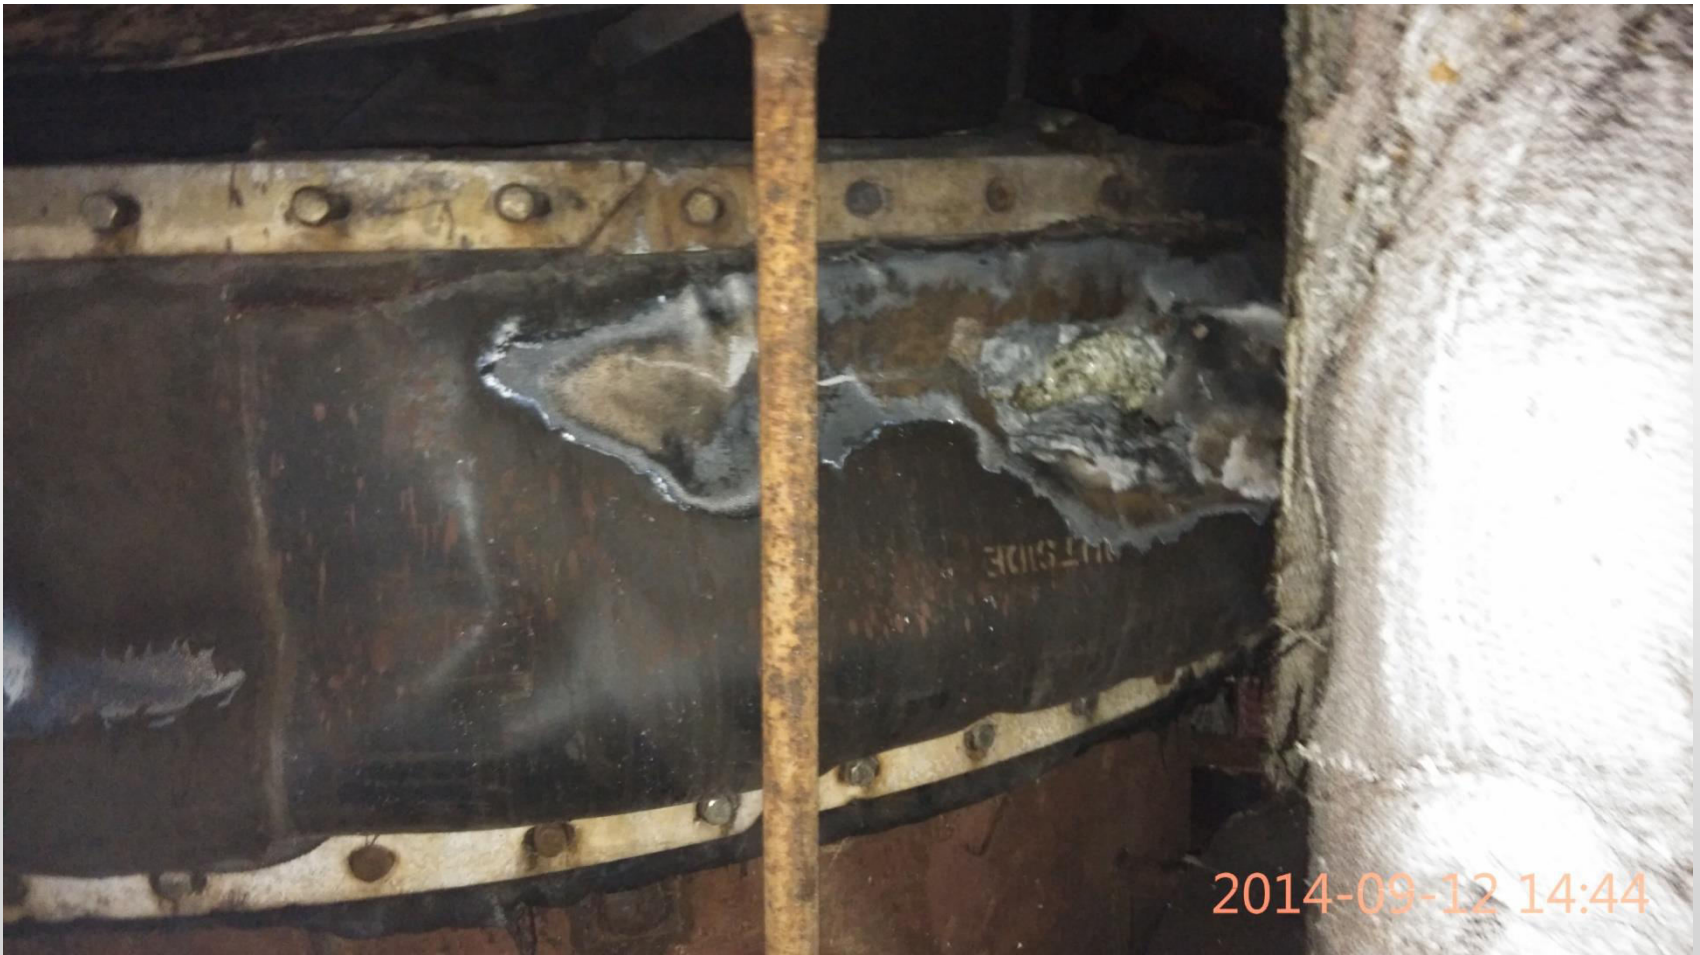
NMEJ FAILURE IN SEAL POT RETURN LEG

Out of the above Seal pot to Combustor return leg & Combustor to Ash Cooler NMEJs have been modified into MEJs

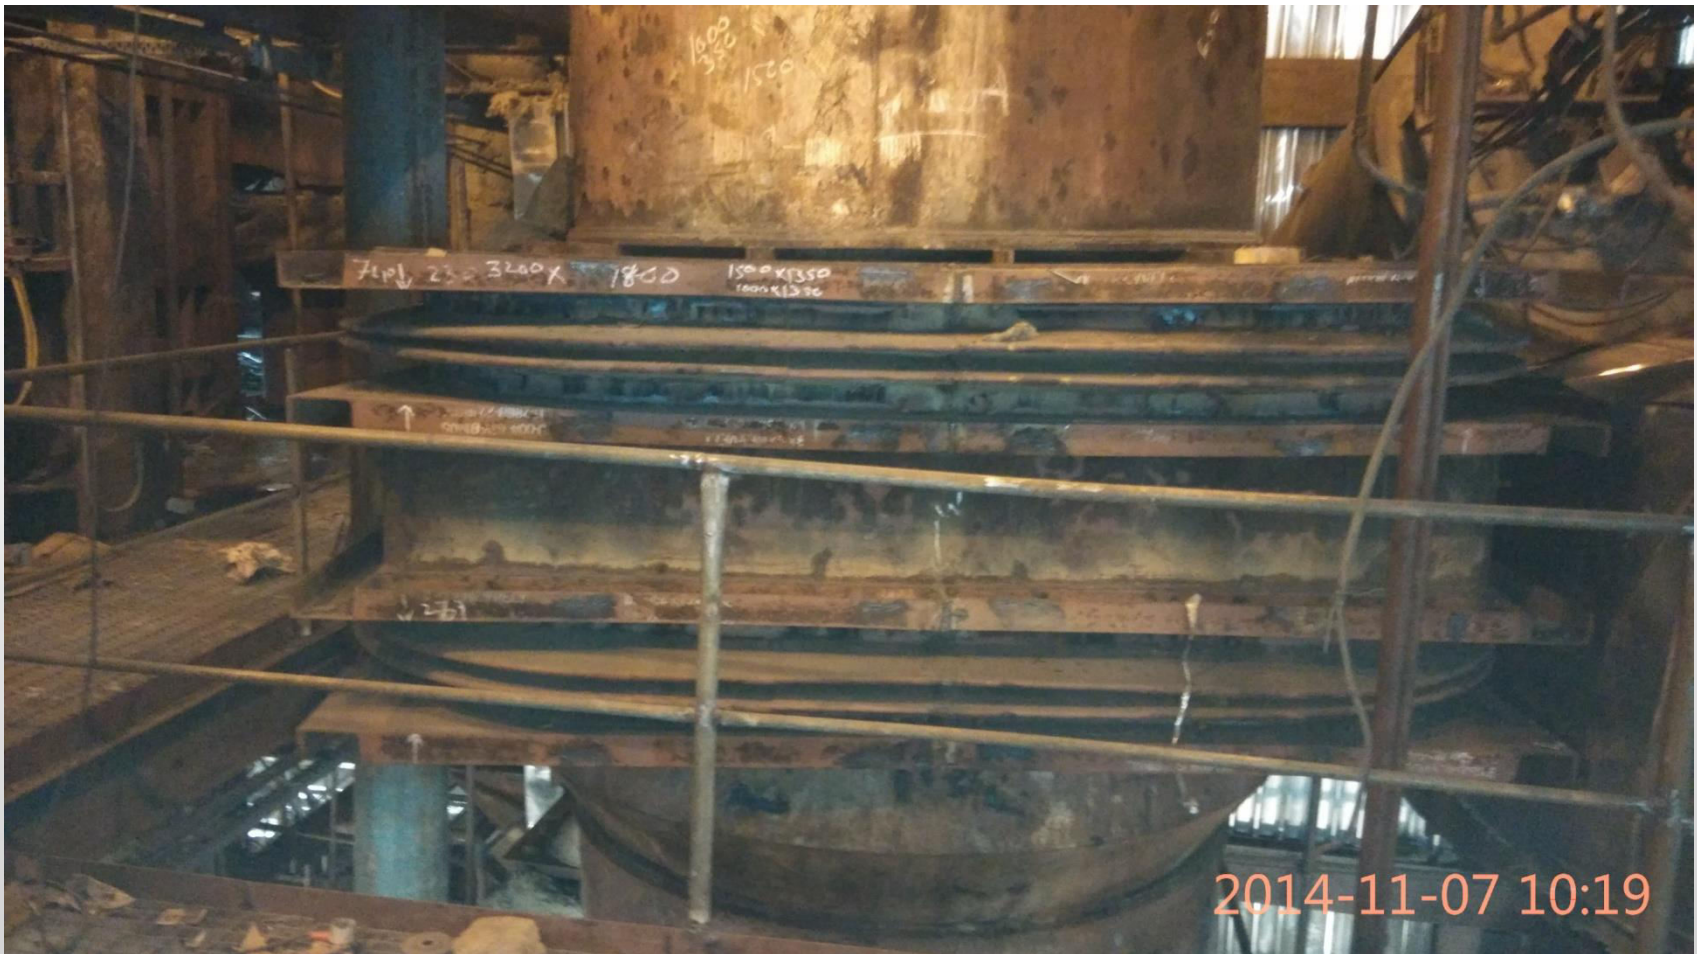
NMEJ MODIFIED WITH MEJ IN SEAL POT TO COMBUSTOR RETURN LEG

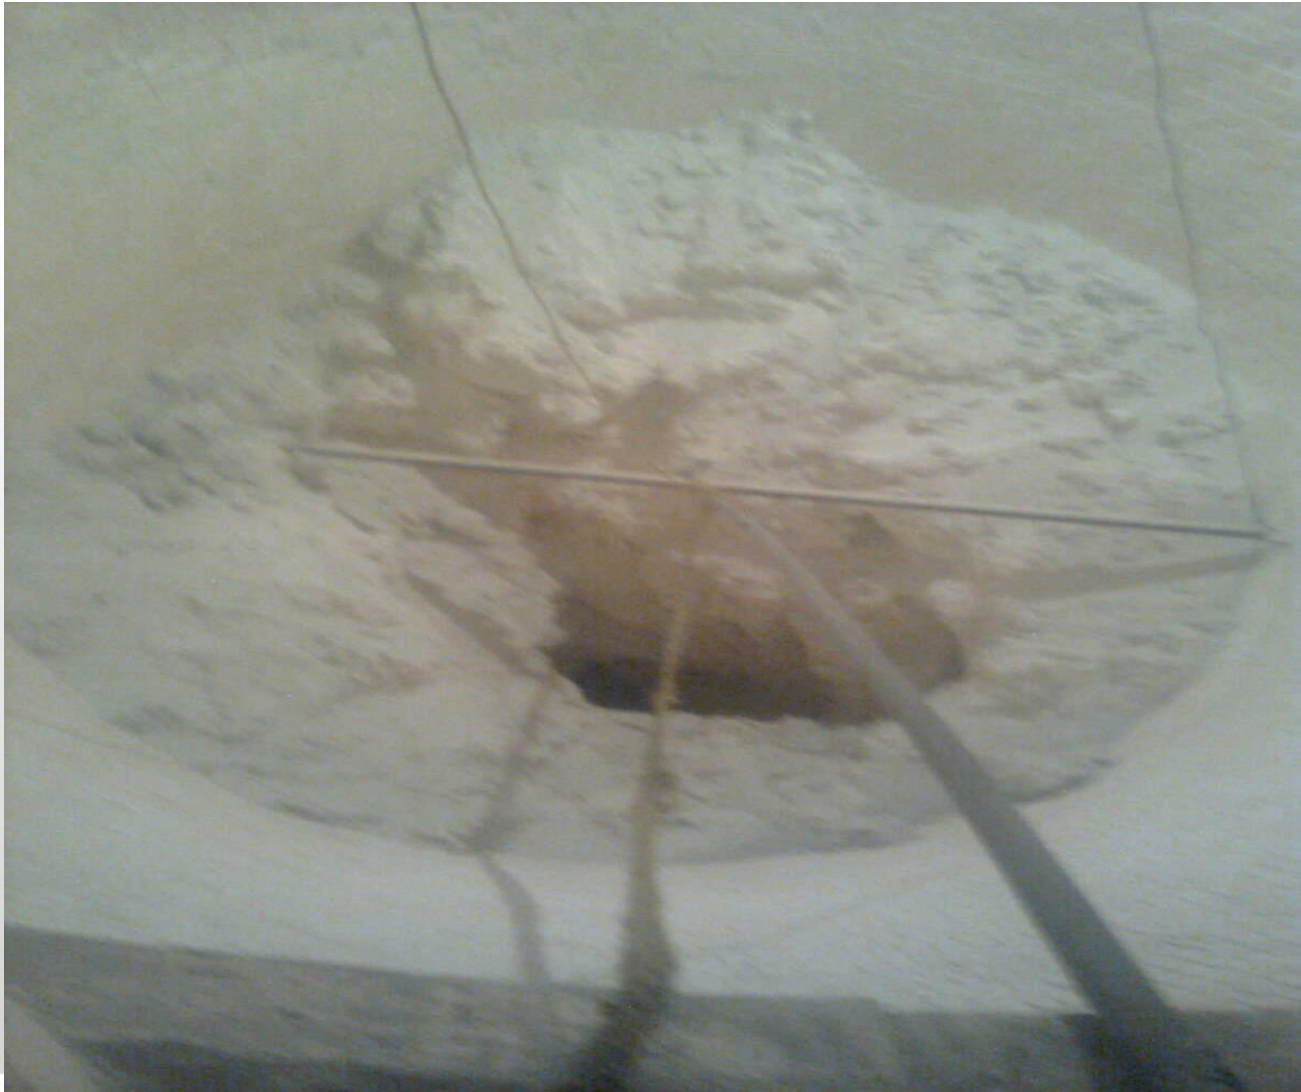
CYCLONE CHOKING DUE TO ASH SINTERING

PROBLEMS FACED	REMEDIAL MEASURES TAKEN
Cyclone choking due to ash sintering	Removing primary loop temperature restriction, the operating temperature raised to 960 °C / 970 °C. The problem was solved.

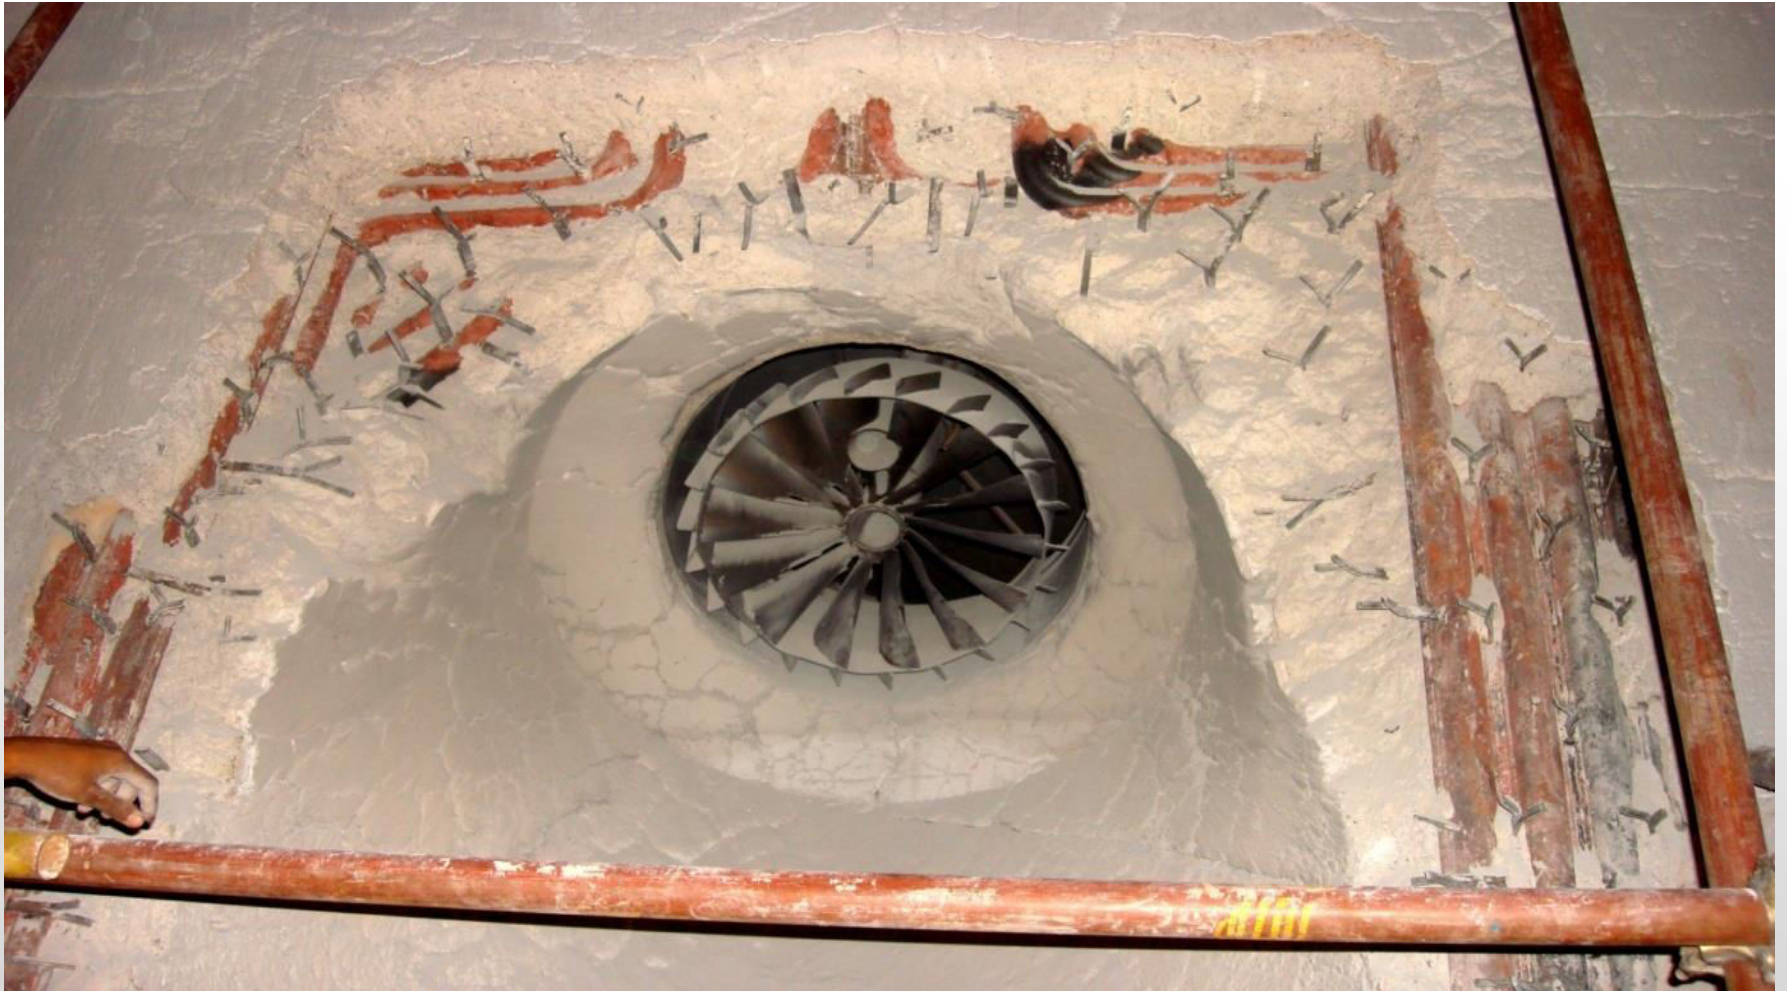
Refractory Damages in both Units

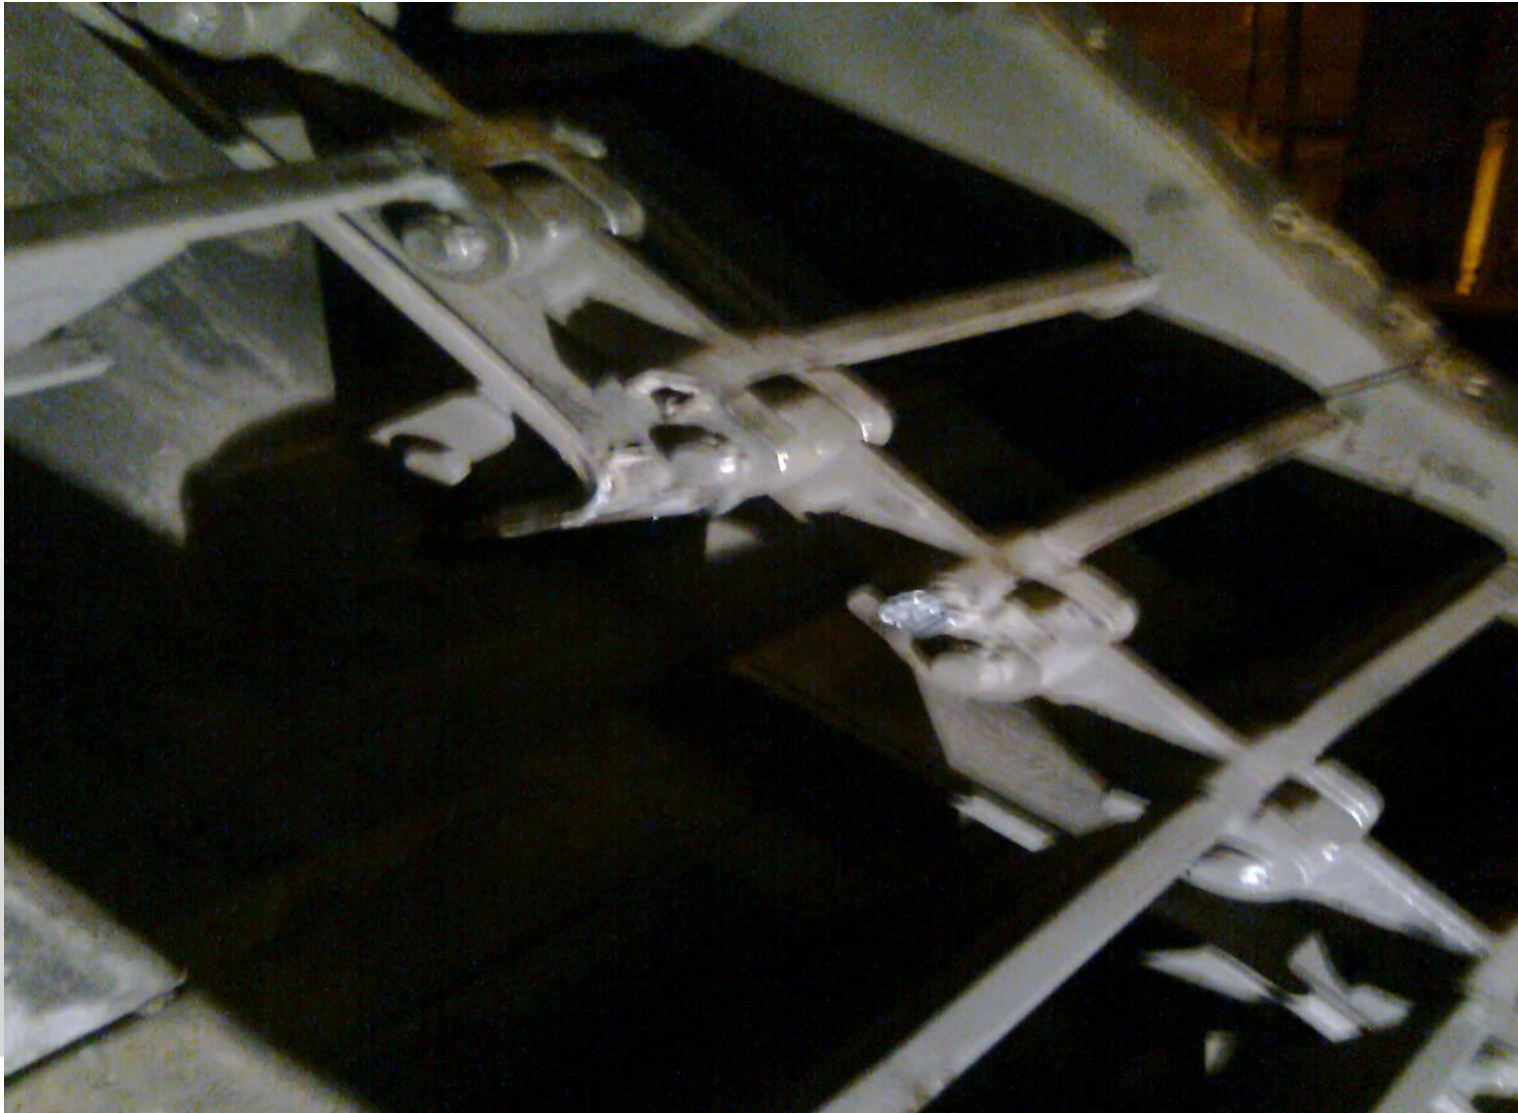
DAMAGED DRAG CHAINS

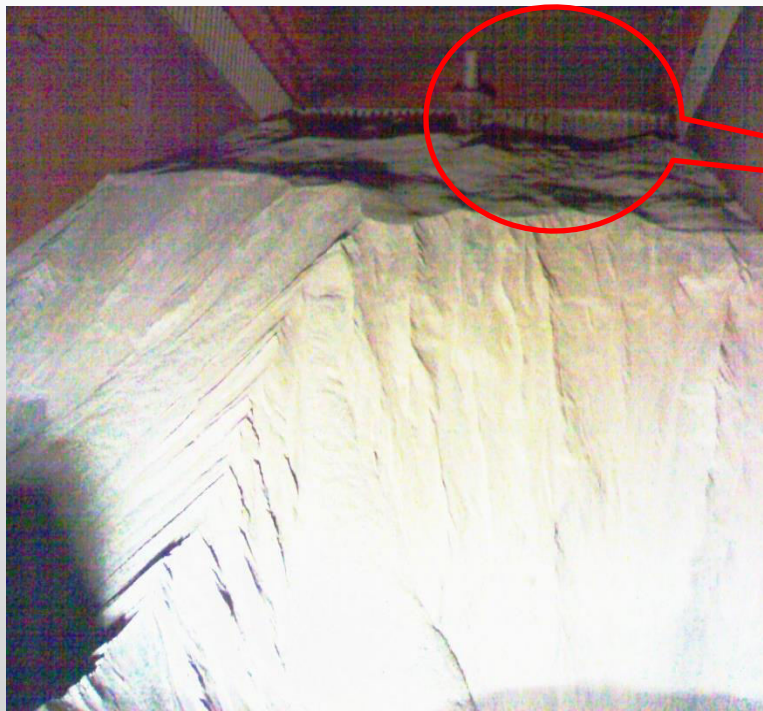
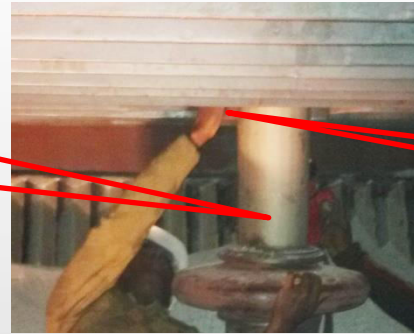
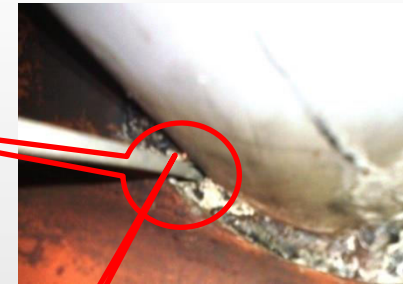
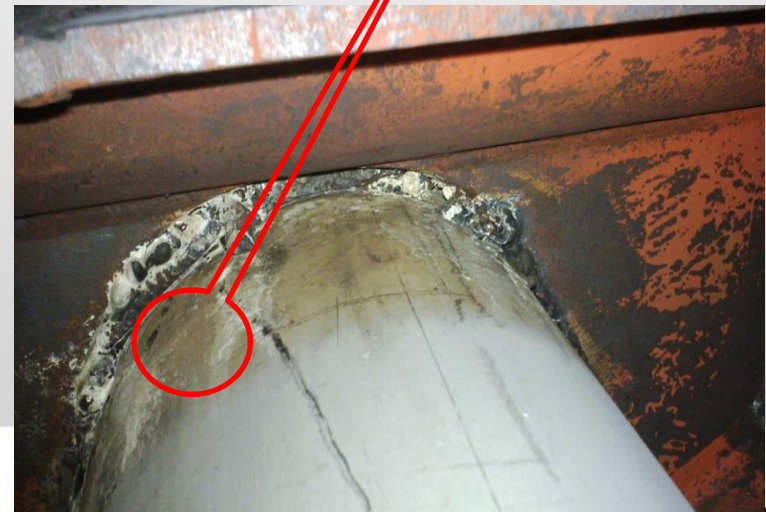
Inspection carried out on combustor deashing pipe and found improper welding and holes are found on deashing pipe welding with grate

Combustor PA wind box filled with ash(photo taken inside PA Duct under combustor)

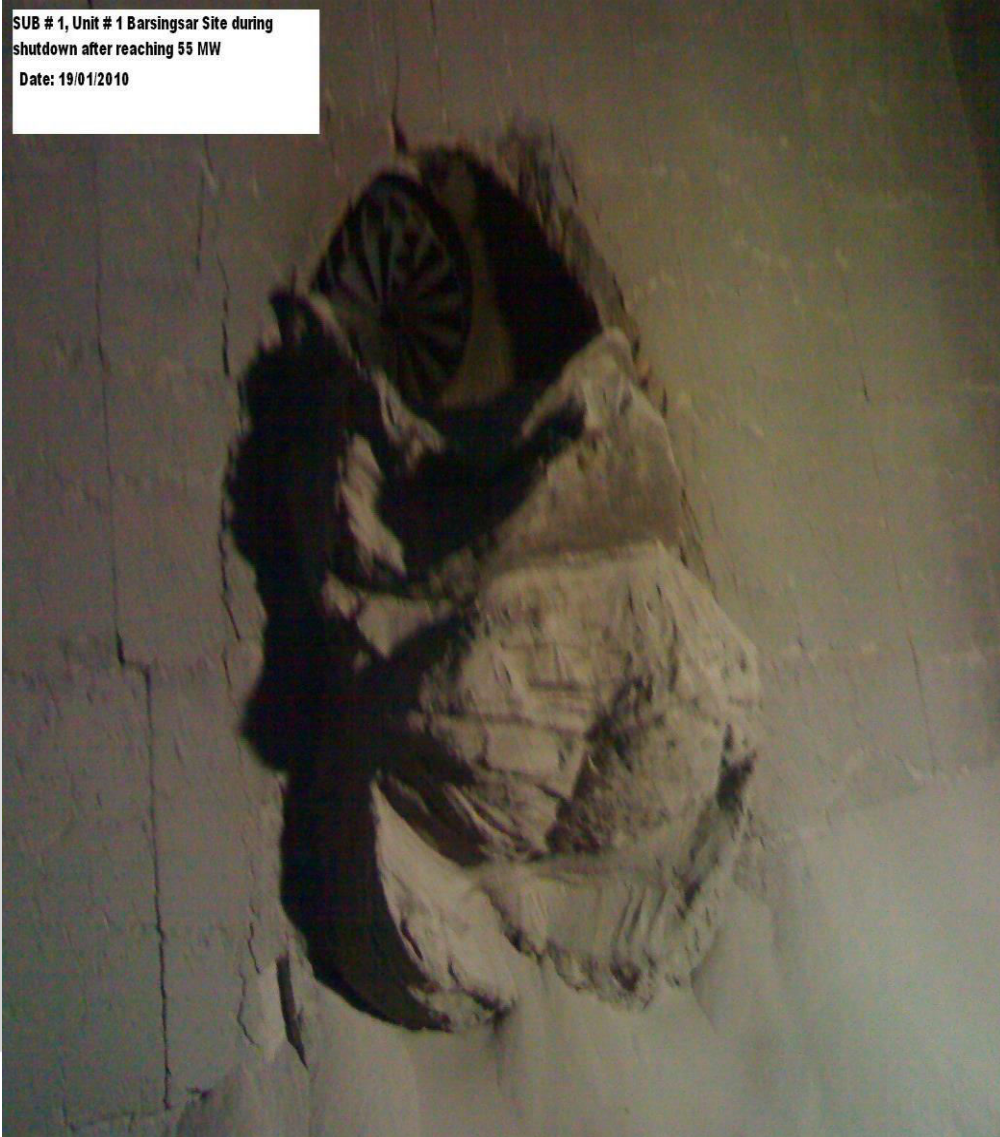
SUB # 1, Unit # 1 Barsingsar Site during
shutdown after reaching 55 MW
Date: 19/01/2010
