# Success stories: Efficiency Improvement in Power plants

Surendra Prasad  
AGM, CenPEEP/ NTPC

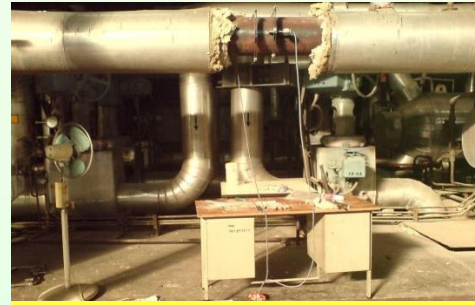
FW Flow Measurement

- FW Flow Measurement using high Temp Ultrasonic probe
- Validation of FW Flow

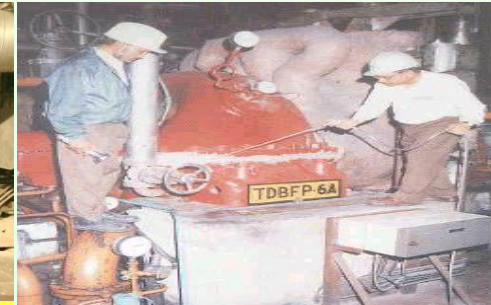
Helium Leak detection

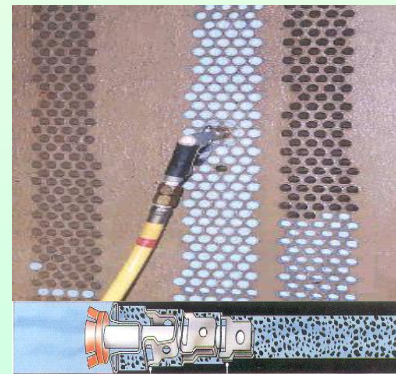
Condenser Tube Cleaning

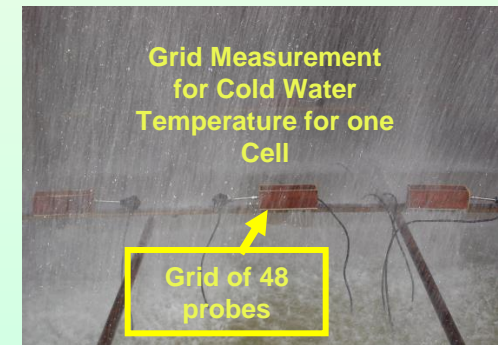
Cooling tower single cell testing

- CT single cell performance test
- Effect of L/G ratio on CT performance
- CW flow measurement
  - Ultrasonic flow meter
  - Three hole pitot tube

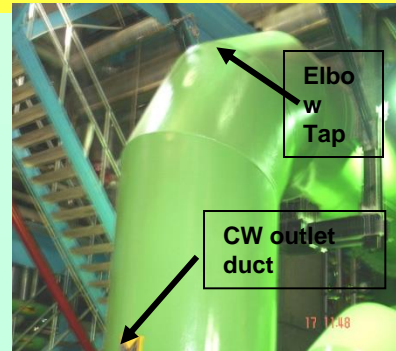
"Elbow Tap dp" for on-line CW Flow monitoring.

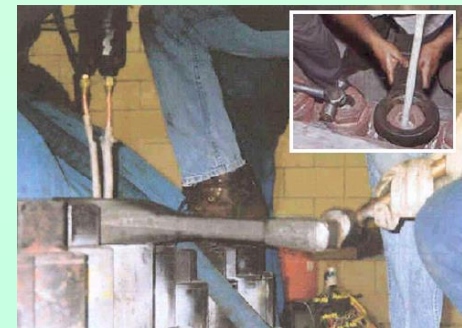
Turbine stud Opening

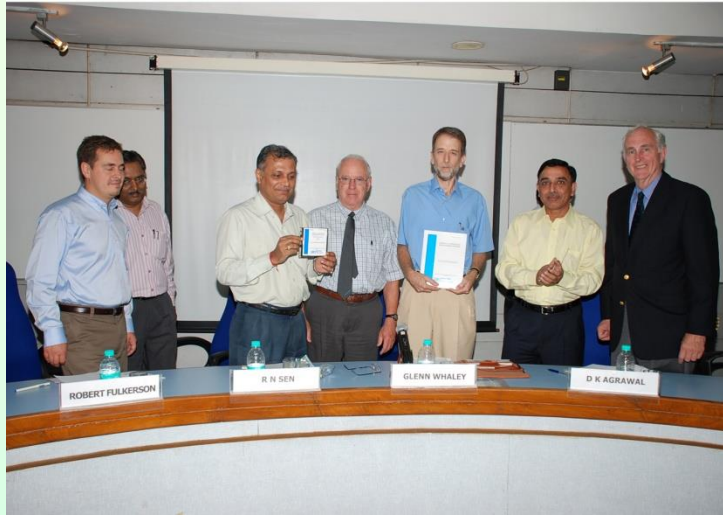
Release of EEMS document

## Development & Implementation of EEMS

- Identification of Heat Rate gaps through monthly performance tests
- Trending performance indices & analysis of equipment degradations
- Development of Unit specific HR recovery action plans
- Restoration of equipment performance during overhauls
- Skill / knowledge enhancement through Dissemination workshops

**Customized EEMS Document prepared based on learning's at CenPEEP and 'Heat rate Improvement Guidelines' issued earlier**

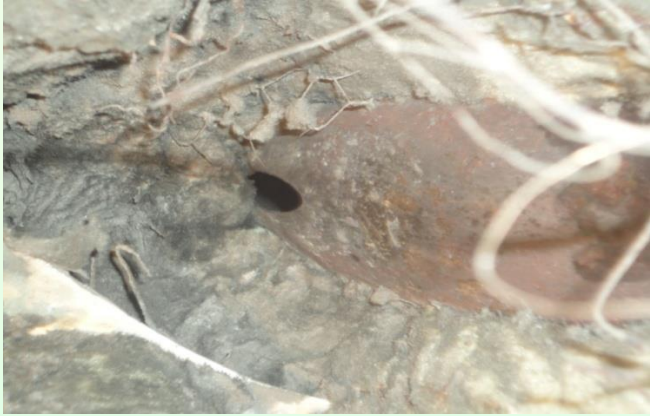
During above test a hole (2"x 1") of size in CRH strainer drain to HP Flash box was found

**Hole in the CRH strainer drain line**

1. Improvement in condenser vacuum by 16 mm Hg
  2. Stoppage of one vacuum pump there by reducing in APC and increased operational reliability
1. Unit Heat rate improvement : 32 kcal / kWh

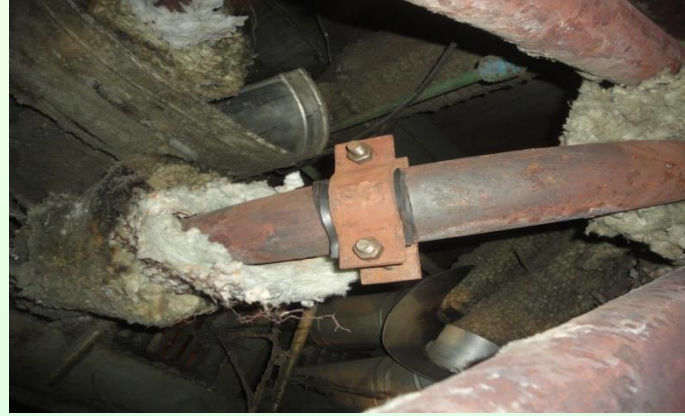
**Hole fixed up using clamp**

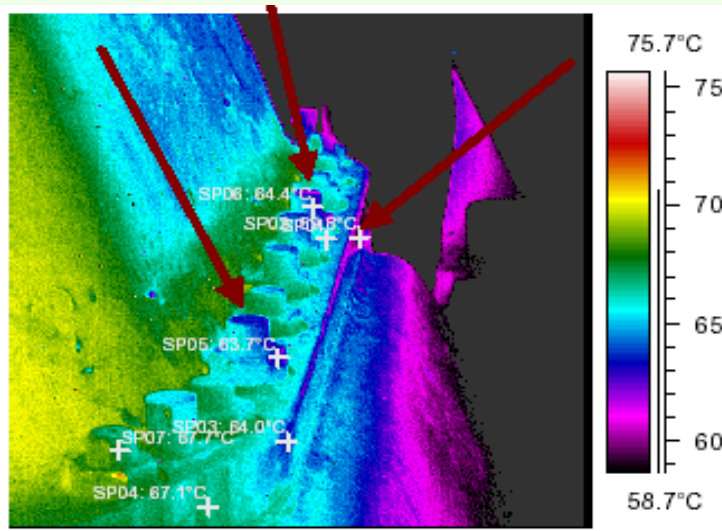
Air in leak observed from LPT parting plane surface & Bolt edges ( Shown by arrow)  
Temperature difference of appx. 6-7 degrees was observed in the surface of parting plane.  
Devecon putty was applied to arrest the air in leakage from parting plane.

**Improvement in MW**

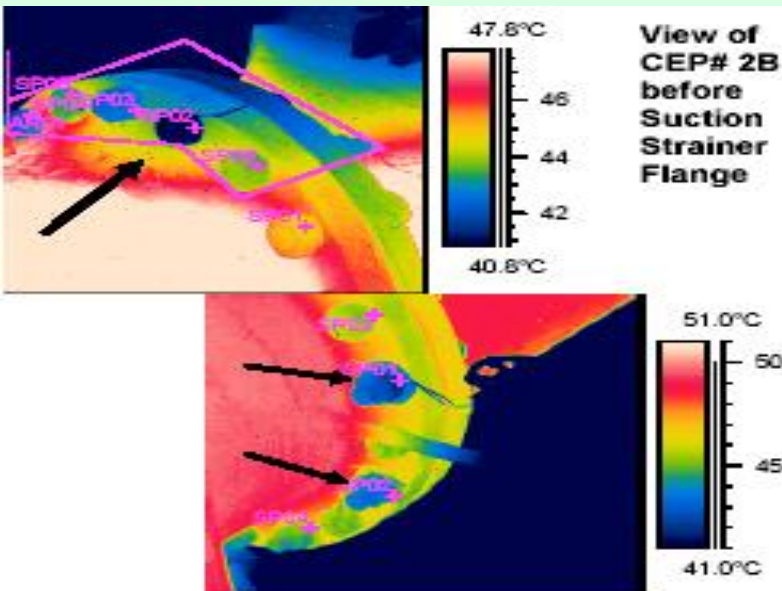
**CEP 2B** Suction strainer flange bolts showed bolts looseness & was recommended for re-tightening.

**DO level reduced from 110 PPb to 10-15 PPb**

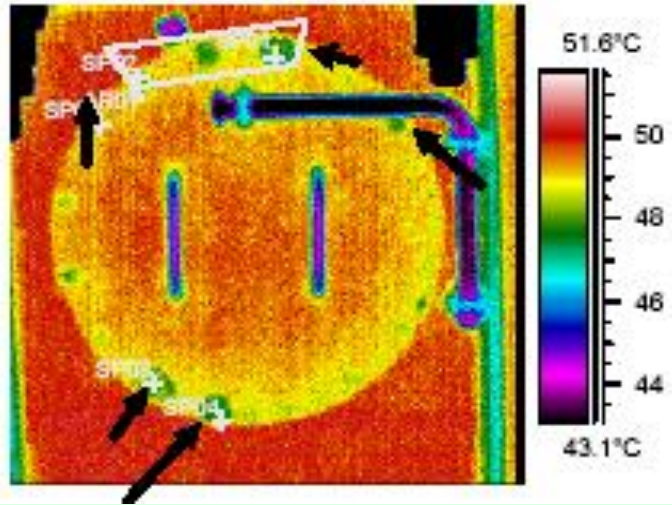
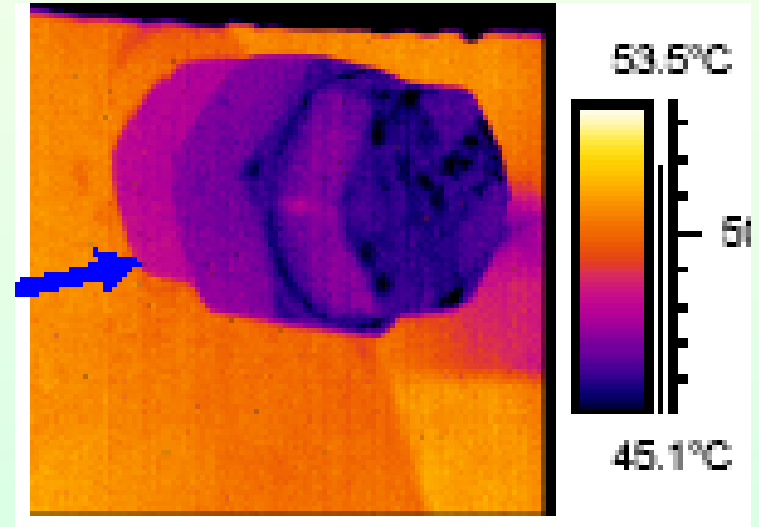
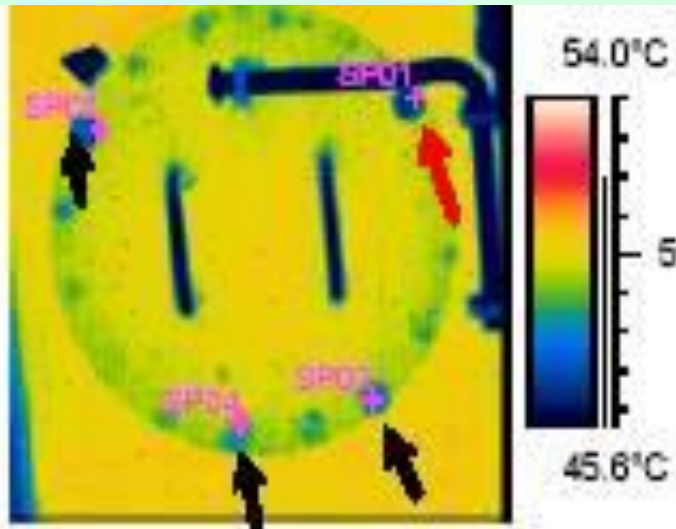
10 no. bolts of Hotwell (A & B) were found loose having having air ingress from them to the system. All the bolts were retightened. **Improvement in vacuum of 5-7 mmHG**

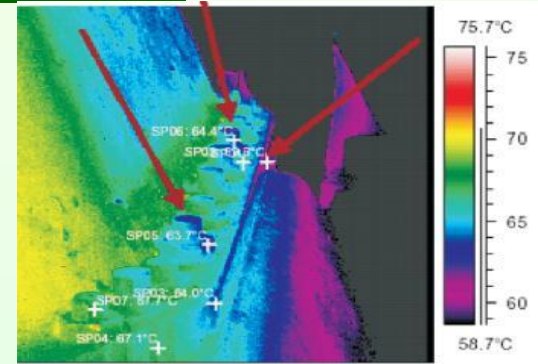
- Air-in-leak in turbine cycle, condenser, manholes, flange joints, etc.
- Fast method for location identification

Air-in-leak at LPT by IRT

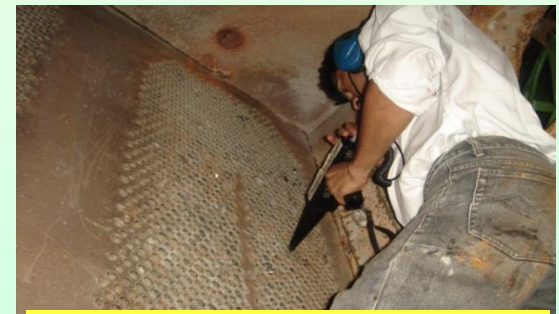
- Condenser tube leak detection by acoustics
- Faster and accurate method, avoided forced outages

Condenser Tube Leak Detection

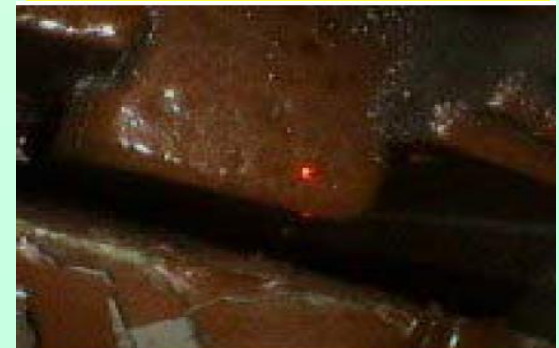
- Internal inspection without opening a machine (*like HT motors, turbine extraction lines*)
- Facilitates inspection and reduces human induced faults

Condition of varnish and air-gap in HT motor

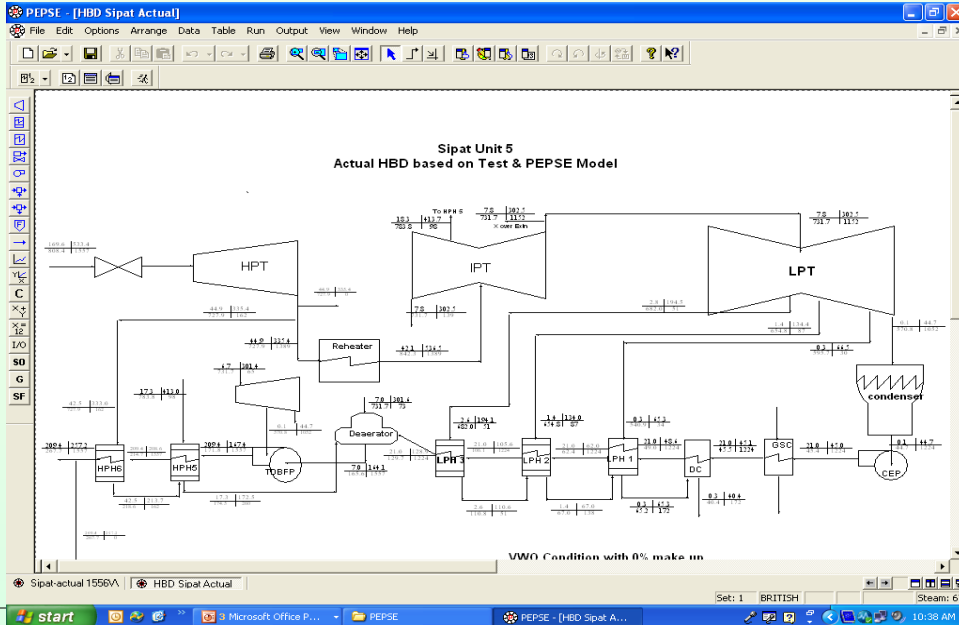
- Cycle Modeling using PEPSE
- Validation of measurements
- Maximum Capacity Test (VWO)
- Assessment of Eff. deterioration
- MW check & Reconciliation of data
- Heat rate & MW deviations

Description	HBD	Test	MW dev.	HR dev
MW	529.8	511.7	18.1	---
HPT Eff %	93.10	89.02	6.4	14
IPT Eff %	94.33	90.25	4.8	17
Cond Prsr.	0.1047	0.0963	-1.5	-6
MS temp C	537	533.4	-0.3	2
RH temp C	537	536.5	0.5	0.0
HP Heaters	255.8	257.2	1.2	-1.0

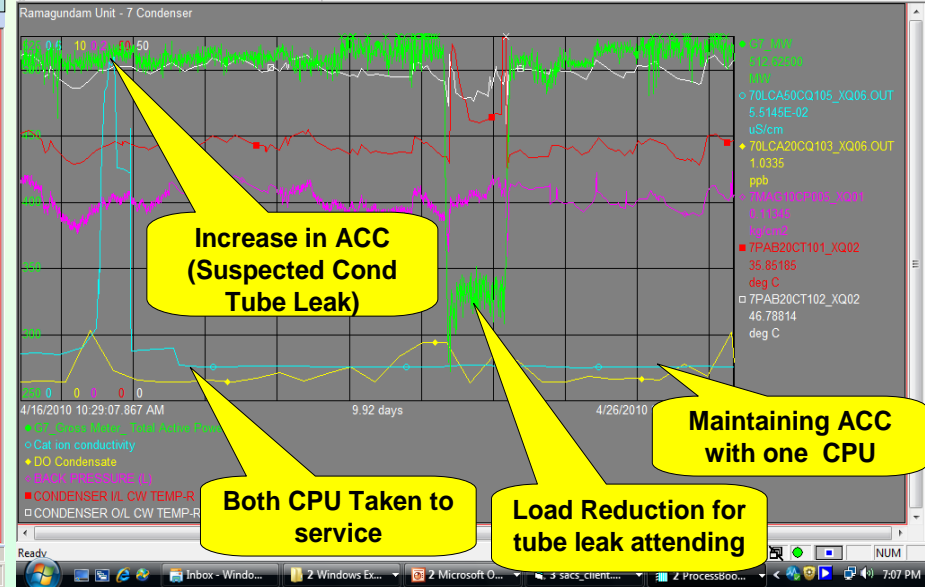
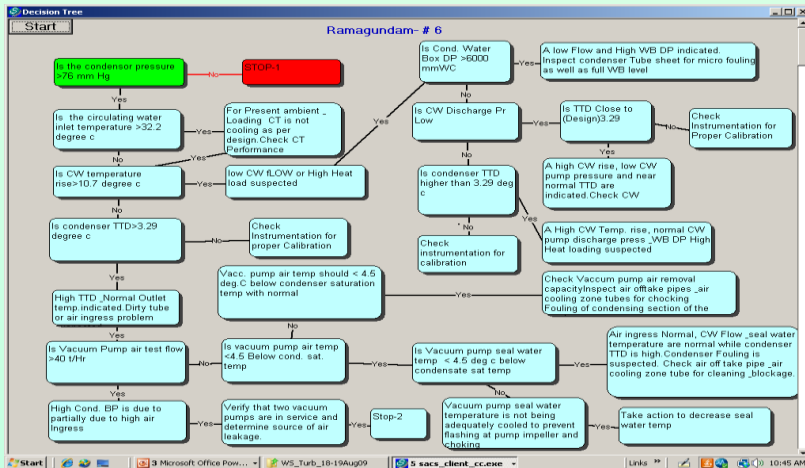
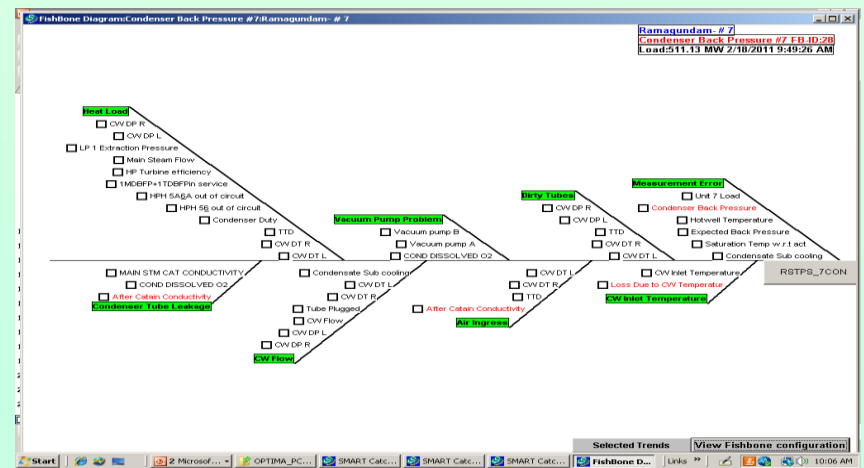
## Ramagundam U#7 Condenser Tube leakage

Capturing experiential learning & initiating advisories for operator guidance

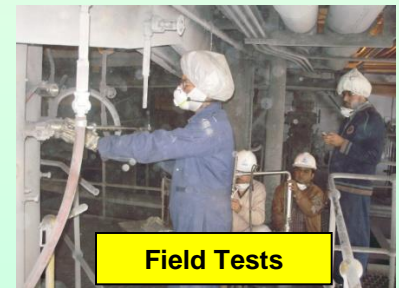
Field Tests

- Sustainable ‘Efficiency Improvement’ at 3 state utilities (Punjab, West Bengal, Tamil Nadu)
  - Workshops & Walk down visits with US Experts
  - Pre Outage Assessment Tests & support during overhauls
  - Post Outage tests on Boiler & Air heaters with M/S Storm and Turbine tests by CenPEEP – Hands on Training to station engineers
- Study Visits to U.S. utilities
