Super critical units -NTPC Experience

SIPAT SUPERCRITICAL BOILER – Materials for Pressure Parts.

SIPAT SUPERCRITICAL BOILER – Operation & Maintenance

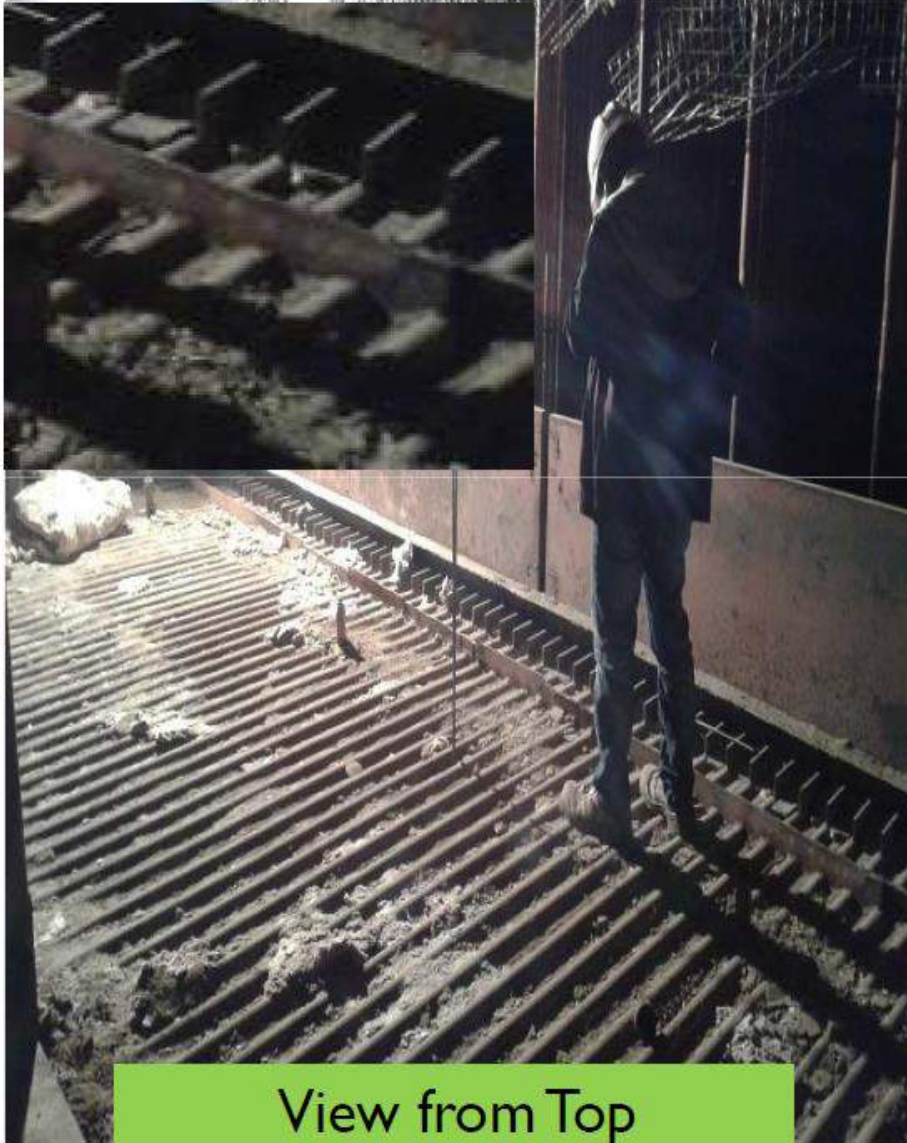
View of Roof Panels

View from Top

View from Bottom

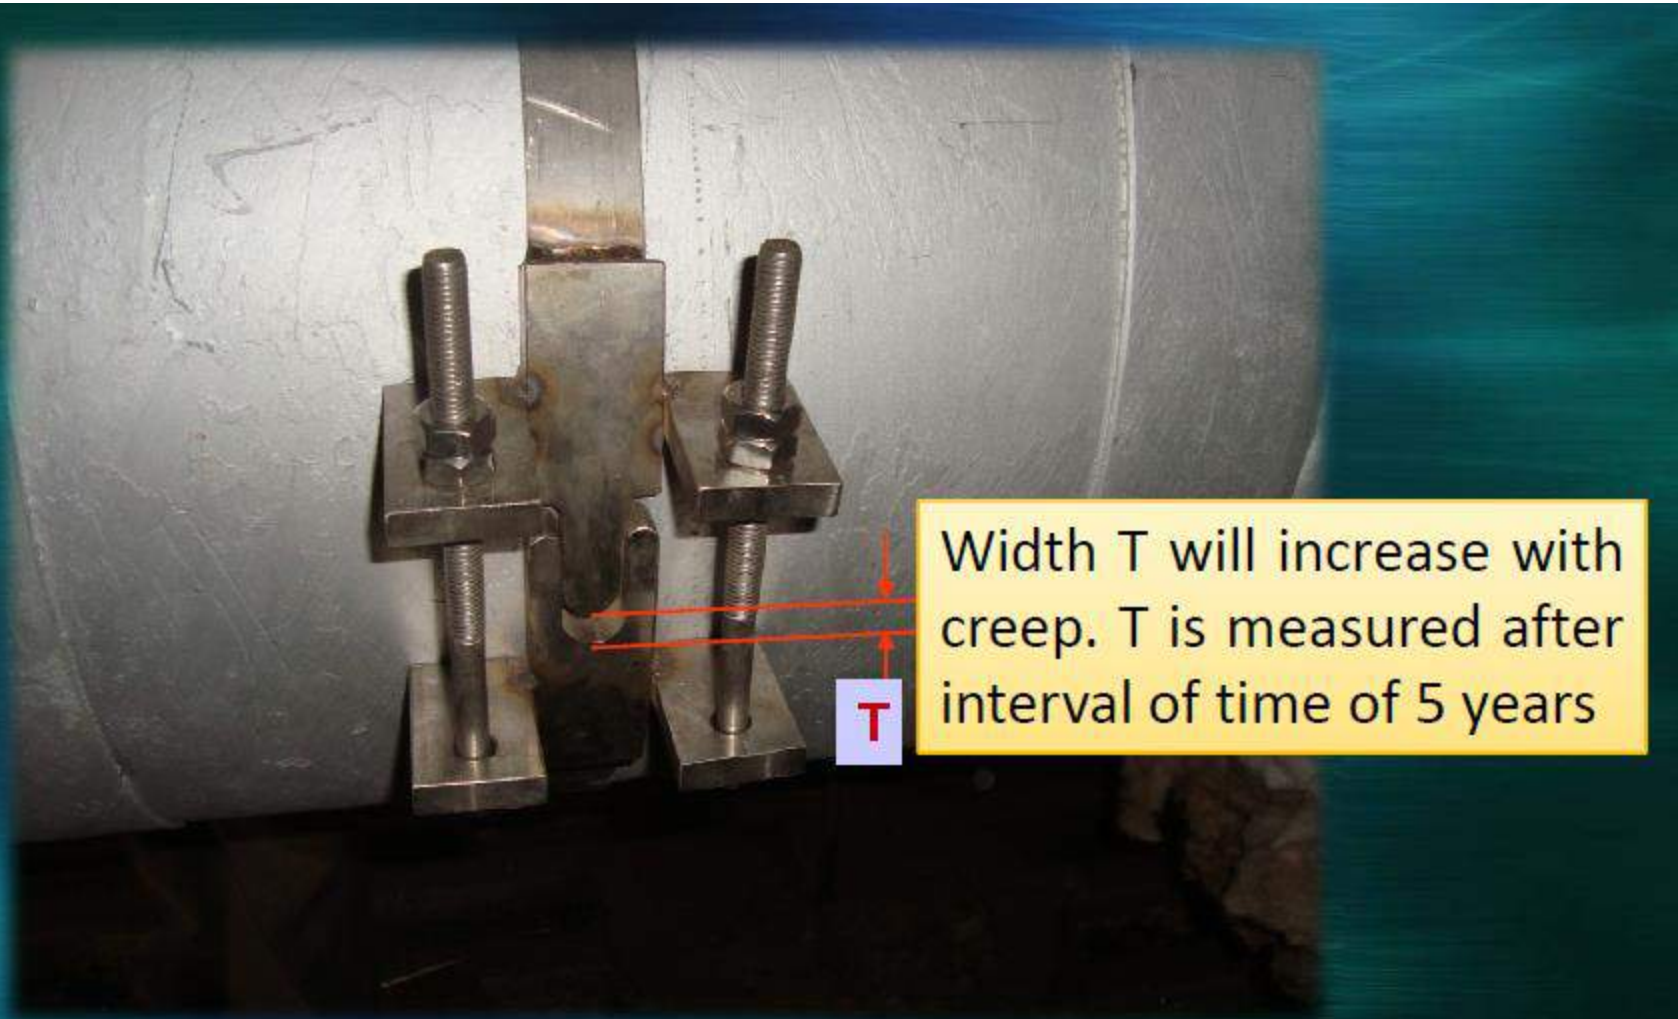
Creep Growth Strain Gauge for tracking of creep in M.S. and R.H. critical piping

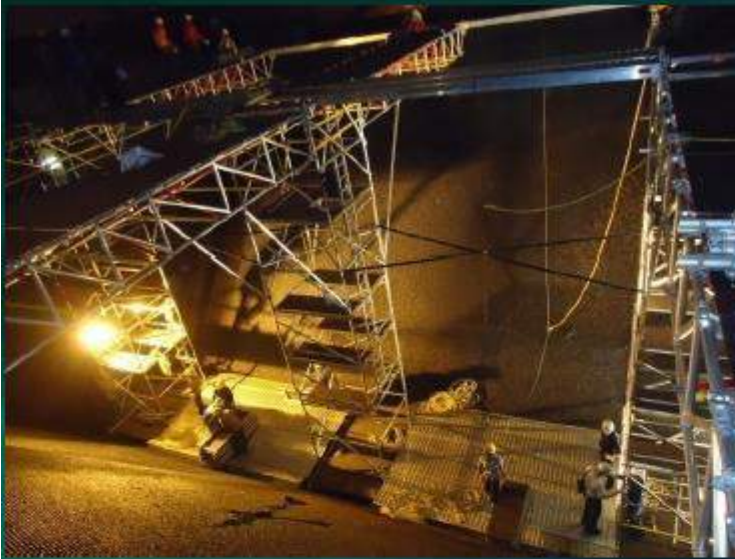
- Use of tailor made aluminum quick erect scaffolding resulting in fast erection of scaffolding with minimum manpower.

- Various stages of erection of aluminum Quick Erect Scaffolding in Boiler.

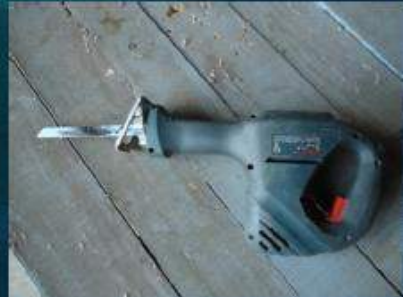
Saber Saw for
cutting of tube &
fins

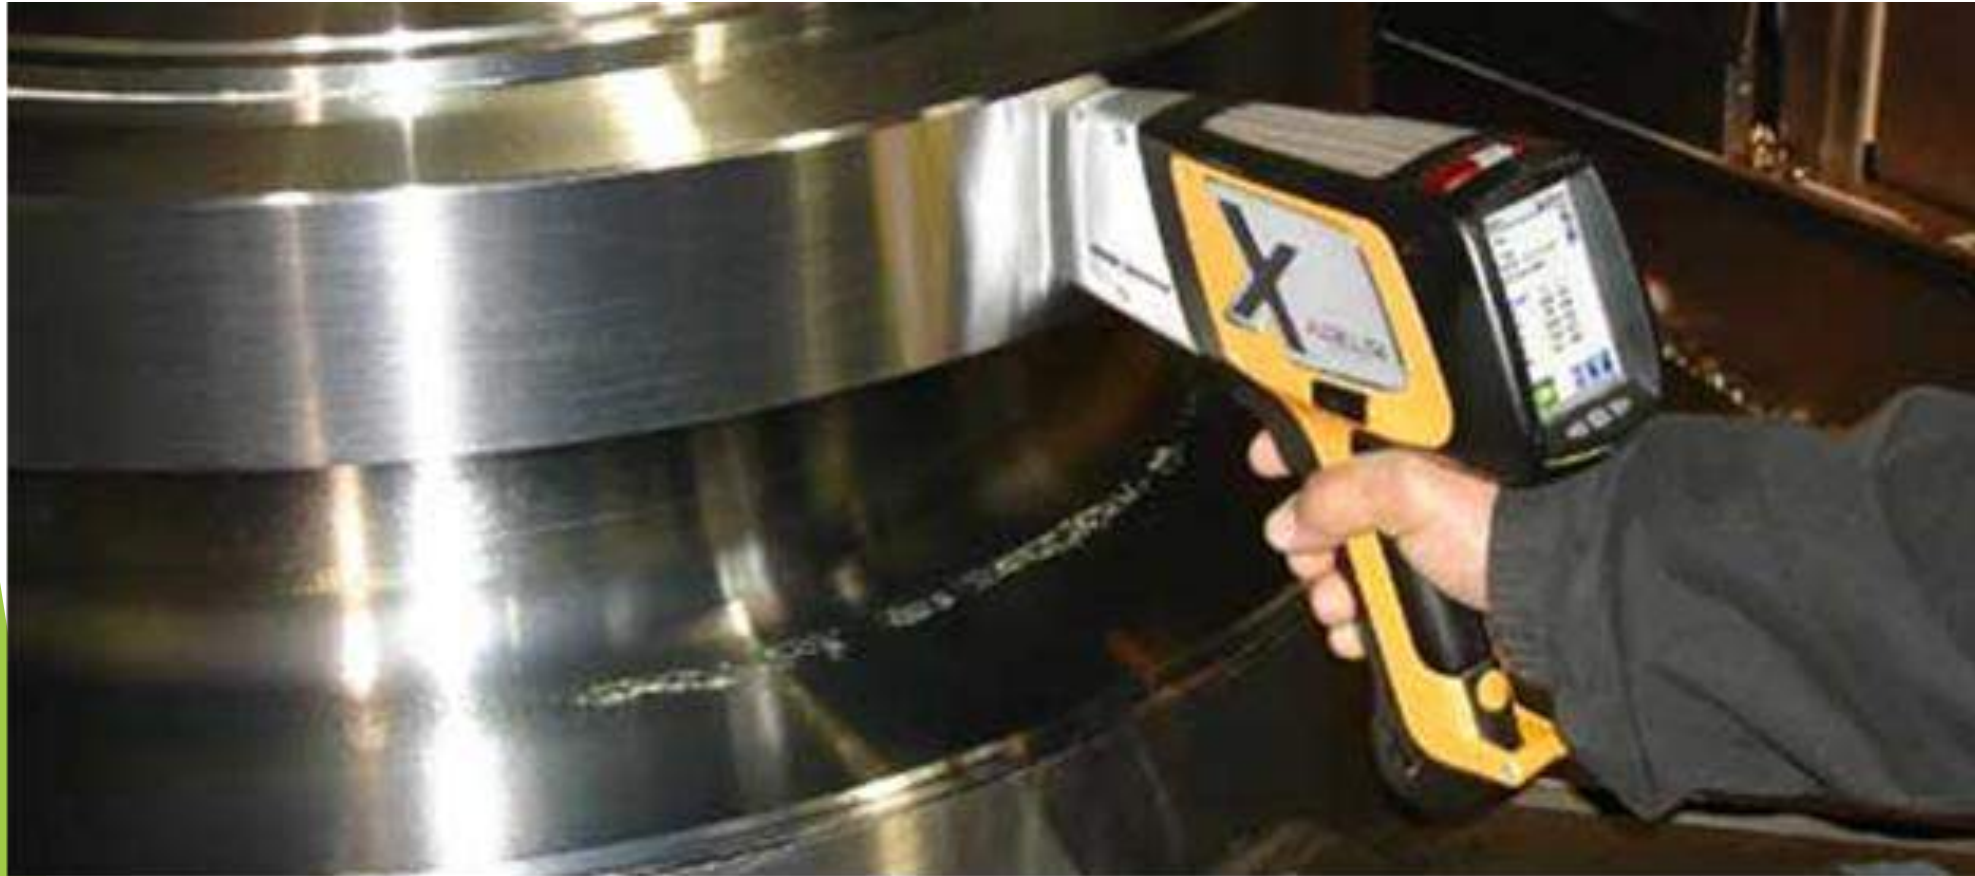
XRF Analyzer for Identifying Material Composition of Spares

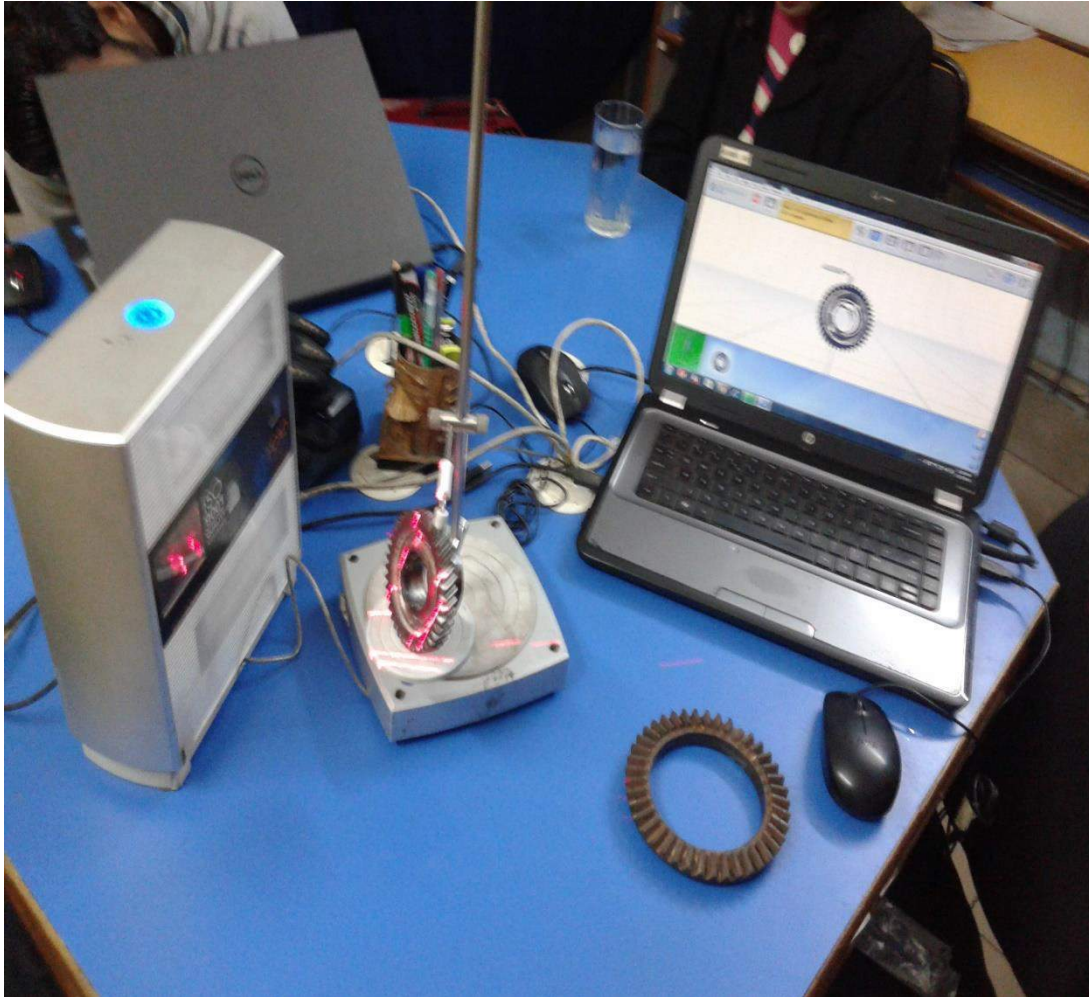
3-D Laser Scanning

With the help of 3-D Scanning, all the dimension and intricate details are captured by scanner and CAD re-production is made

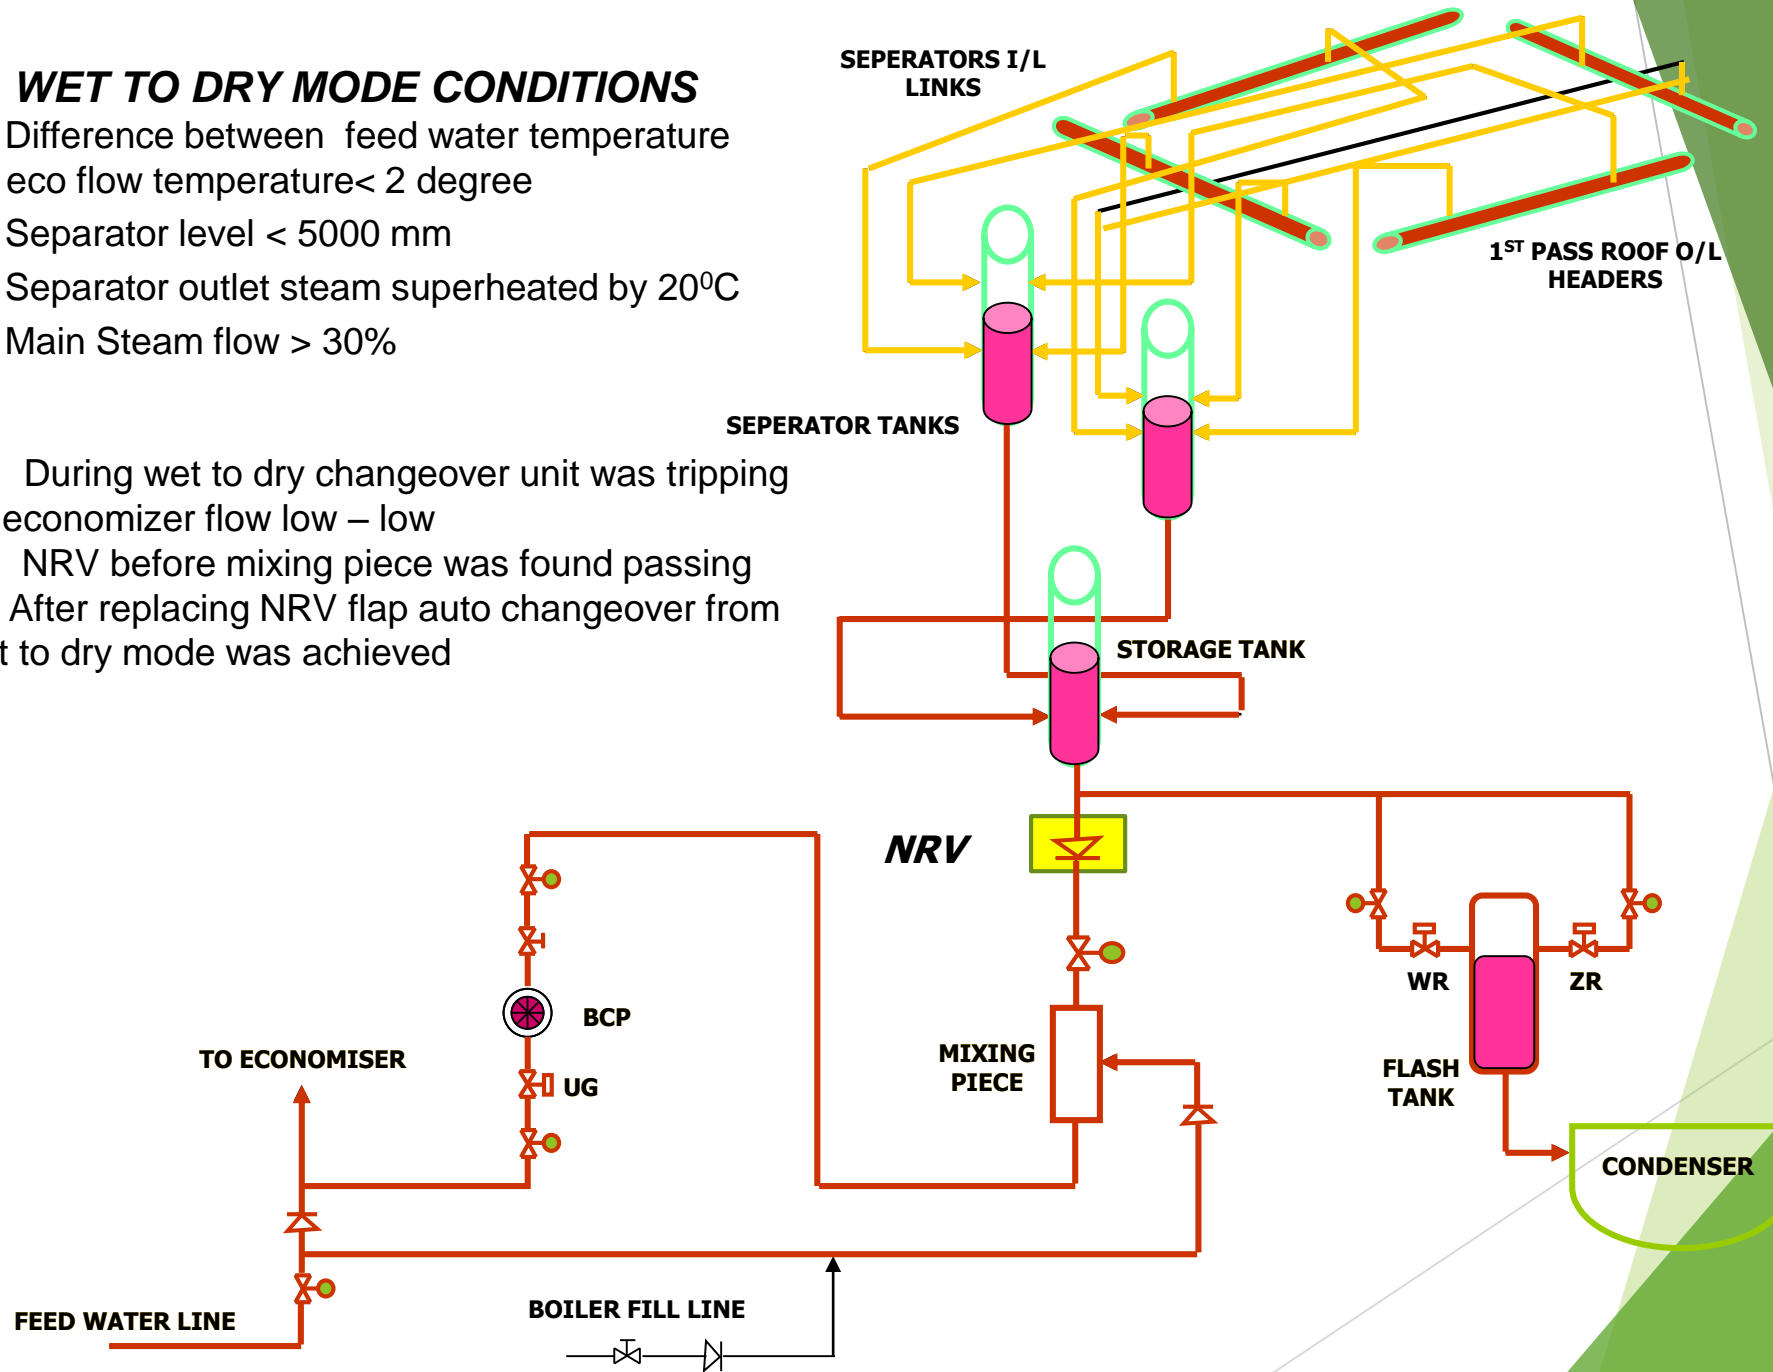
WET TO DRY MODE CONDITIONS

- ✓ Difference between feed water temperature and eco flow temperature < 2 degree
 - ✓ Separator level < 5000 mm
 - ✓ Separator outlet steam superheated by 20°C
 - ✓ Main Steam flow > 30%
-
- ✓ During wet to dry changeover unit was tripping on economizer flow low – low
 - ✓ NRV before mixing piece was found passing
 - ✓ After replacing NRV flap auto changeover from wet to dry mode was achieved
