EXPERIENCE ON OPERATION AND MAINTENANCE OF CFBC BOILER AT KLTPS- KUTCH GUJARAT

CFBC BOILER AT KLTPS- KUTCH GUJARAT

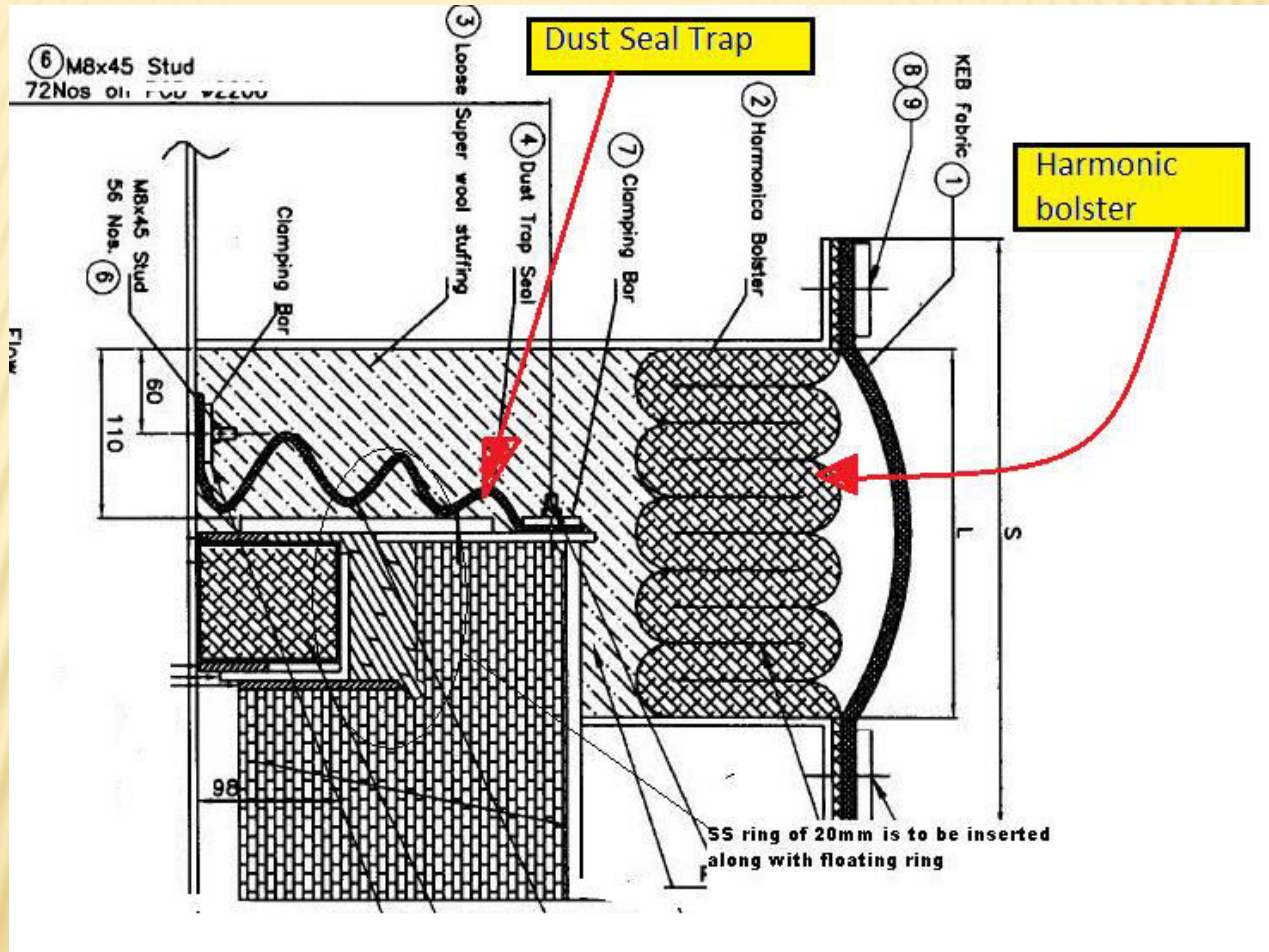
DETAILED DRAWING OF NMEJ

- ✘ NMEJs at flue gas path are critical in nature and failure of which leads to Boiler shutdown
- ✘ Problem:
 - + Failure of Seal Pot to Combustor NMEJ frequently
- ✘ Root Causes:
 - + High sealing gap between male & female duct
- ✘ Remedial Action Taken:
 - + Changes in design of NMEJ(Harmonic layer)
 - + Sealing gap was reduced
 - + Dust Trap provided

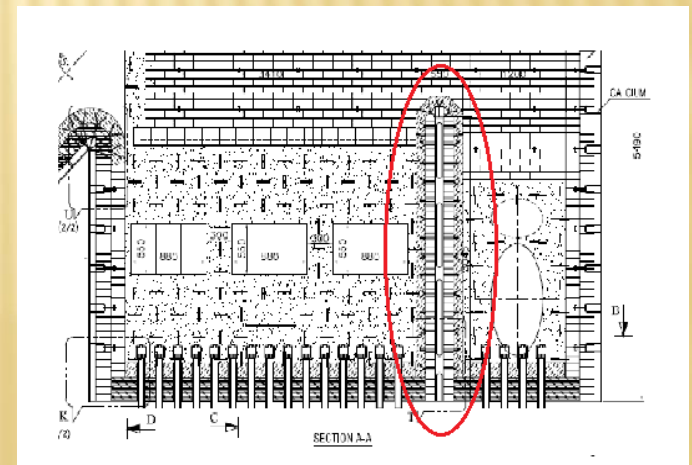
REFRACTORY DAMAGES AT FBHE AREA

- ❖ **Problem:**
 - Failures of refractory at partition wall & Empty Chamber side walls
- ❖ **Causes:**
 - + Use of low abrasion resistance refractory material
- ❖ **Actions taken:**
 - + Castable refractory of high alumina content
 - + (high abrasion resistance) introduced in place of existing castable Refractory
 - + Numbers of Anchors are increased
