GREETINGS FROM NEYVELI LIGNITE CORPORATION LIMITED

November 14, 2014

NLC TPS-II EXPANSION PROJECT 2 X 250 MW – LIGNITE FIRED CFBC BOILERS

OPERATION EXPERIENCES IN 125 MW AND 250 MW CFBC BOILERS

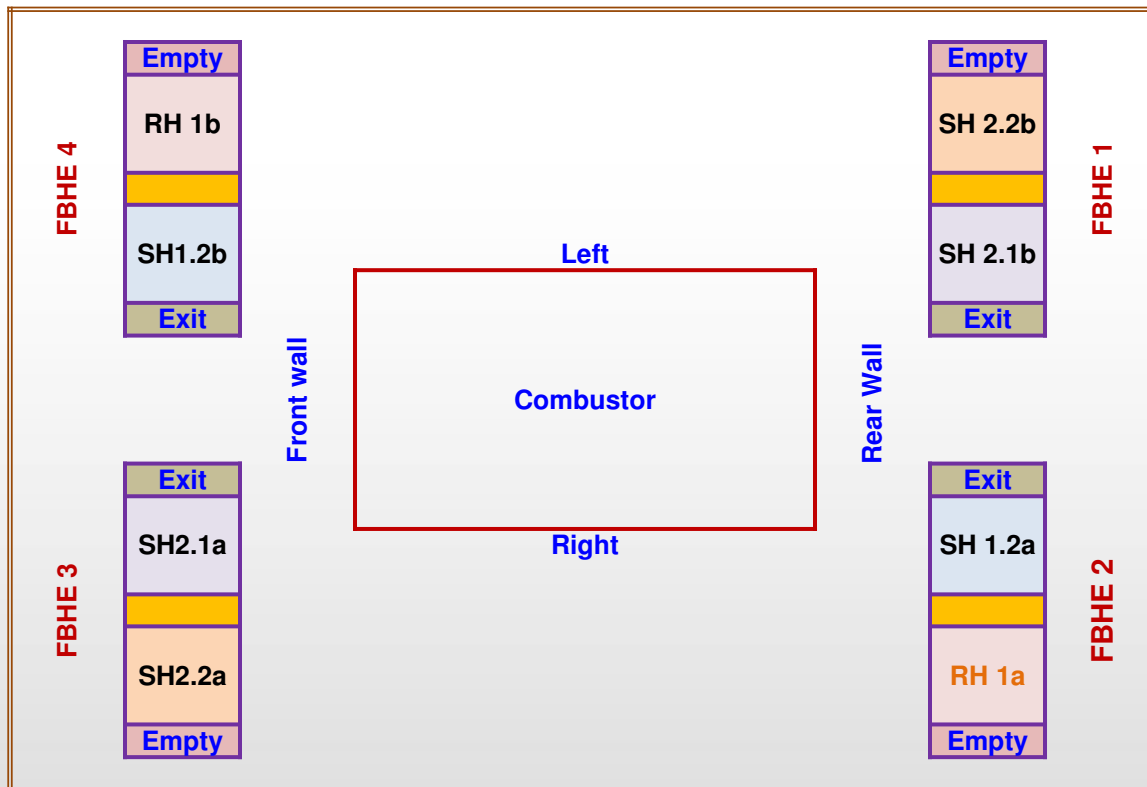
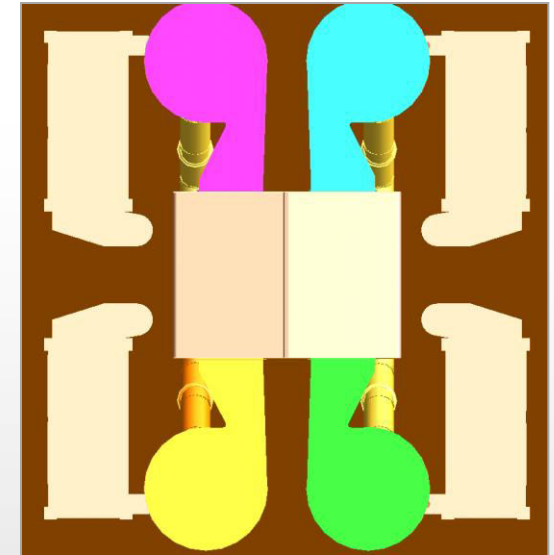
FBHE - Arrangement over view

Problems faced	Action taken
<p>FBHE SH/RH Coil support system failure</p> <ol style="list-style-type: none">1. Stresses in the rods were very high compared to allowable limits at operating temperatures.2. Natural frequency of tube bundle matches with excitation frequency during operation resulting in fatigue failure.	<p>FBHE Coil supporting arrangements modified with steam cooled Hanger tubes and Dog bone arrangement</p>

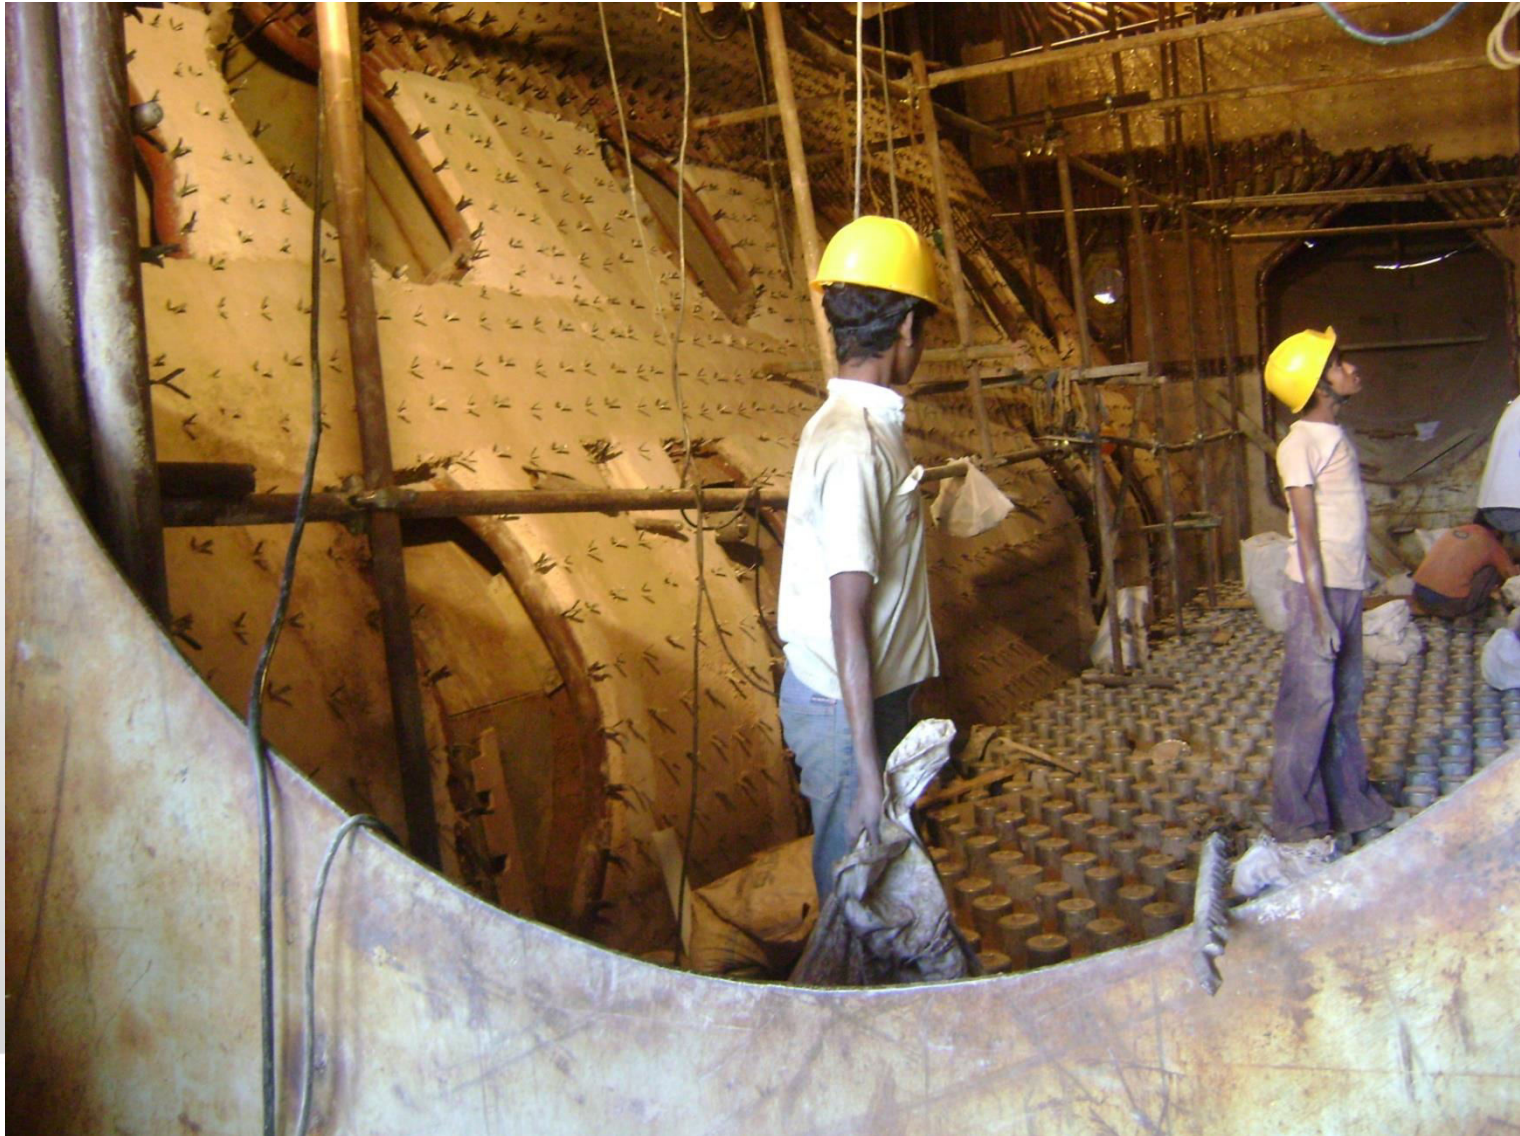
REFRACTORY APPLICATION IN COMBUSTOR – UNIT I

- ❖ Empty Chamber Refractory bricks modified with two layer castables.
- ❖ FBHE bundle chamber refractory modified by two layer castables.
- ❖ Seal pot refractory castings were modified with two layer castables.
- ❖ Start up burner mouth refractory was modified with Plastic Refractory.
- ❖ Secondary air and Bed Lance openings refractory were modified with Plastic Refractory

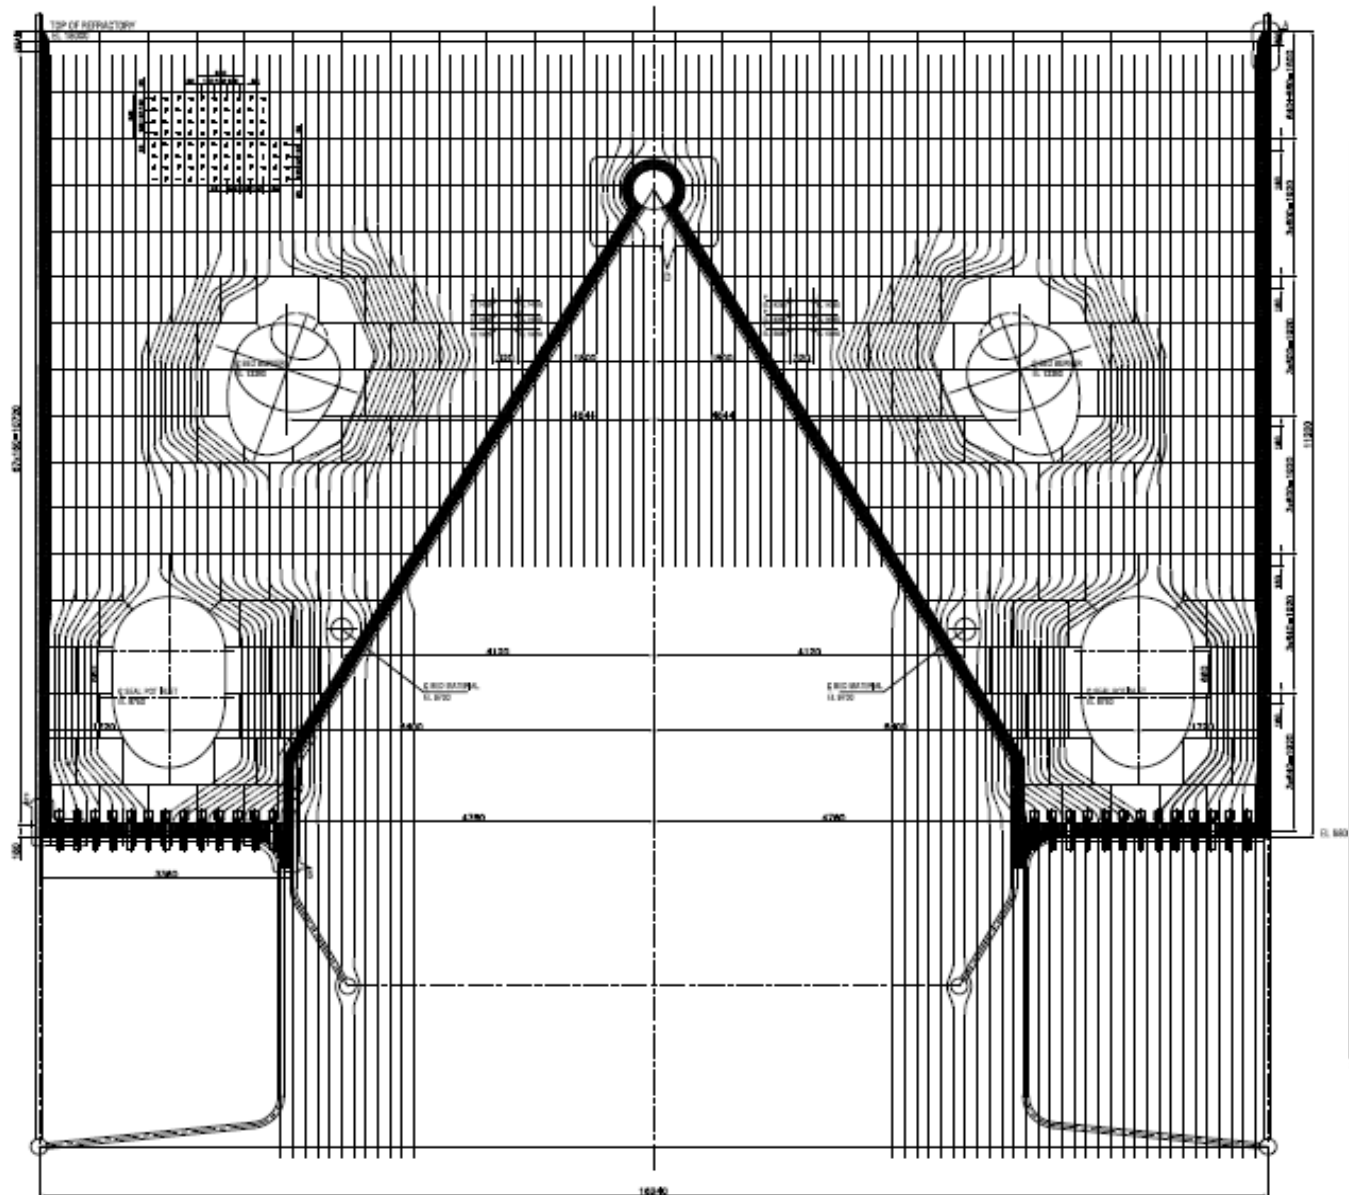
Pant Leg Design Combustor

MAINTAINING DP IN COMBUSTOR: Problems were faced in maintaining DP in combustor due to unique pant leg design. The other factors influencing DP in combustor were

- **LOW ASH CONTENT IN LIGNITE**
- **PA CONTROL DAMPER**
- **TRIPPING OF LIGNITE FEEDERS**
- **UNEQUAL FIRING IN PANT LEGS**

DUE TO THE ABOVE REASONS, SHIFTING OF BED INVENTORY FROM ONE PANT LEG TO OTHER AND CLINKER FORMATION IN COMBUSTOR PANT LEGS WERE EXPERINCED.

The problem was resolved by suitable correction in the control system

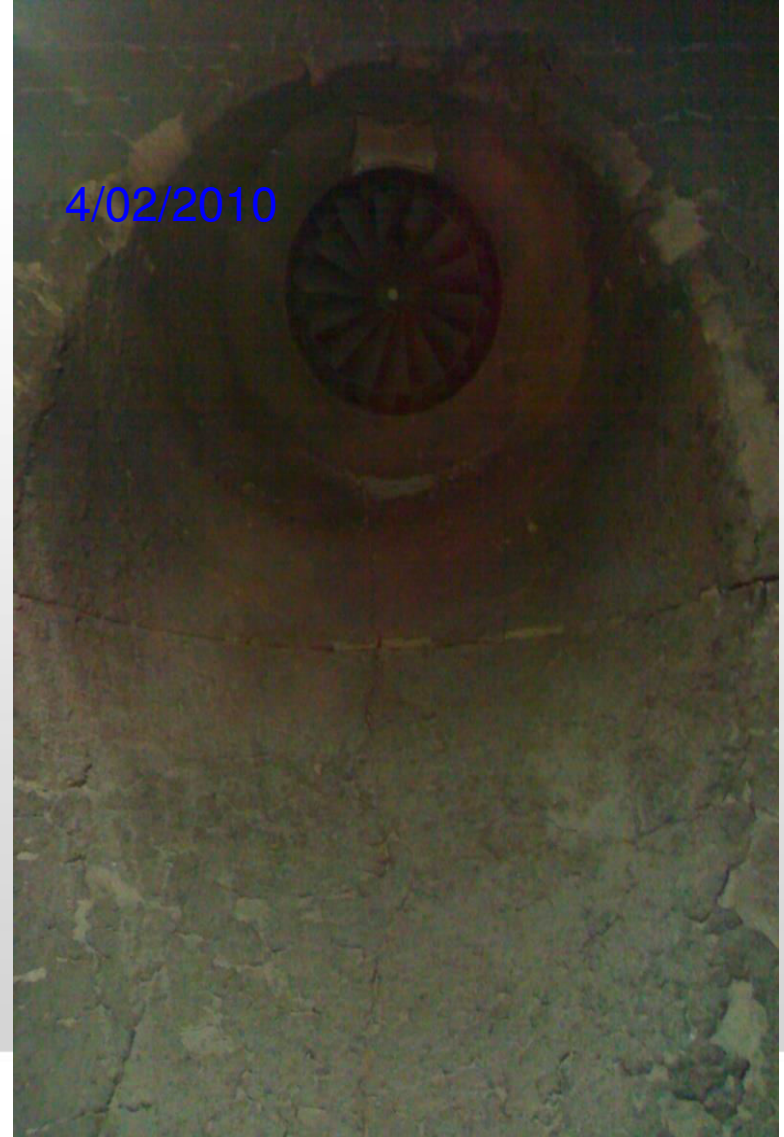
4/02/2010

SUB – CLINKERING ISSUE
