TRANSFORMER MAINTENANCE

A S Bhogal
NTPC Singrauli

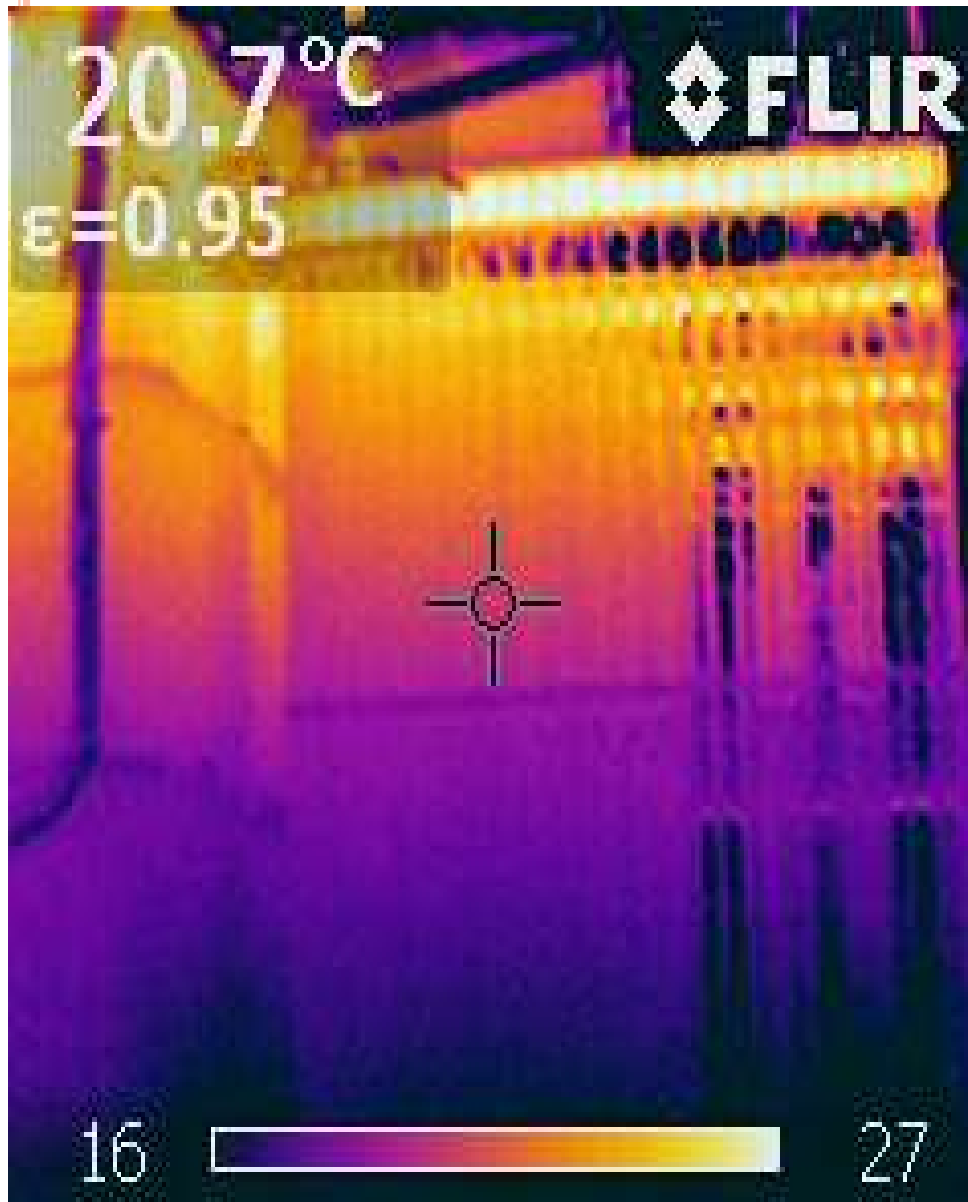
GT-2 220 KV BUSHING HOT SPOT.THE BUSHING WERE FOUND DEFECTIVE AND WAS REPLACED

- Indicate presence of Hot spots at various connections
- Indicates the effectiveness of cooler banks
- Indicated the uniform flow of oil inside transformer-in case forced oil cooled
- Used to detect the hot spots in the Tank specifically at the entry/exit point of LV windings through bushings

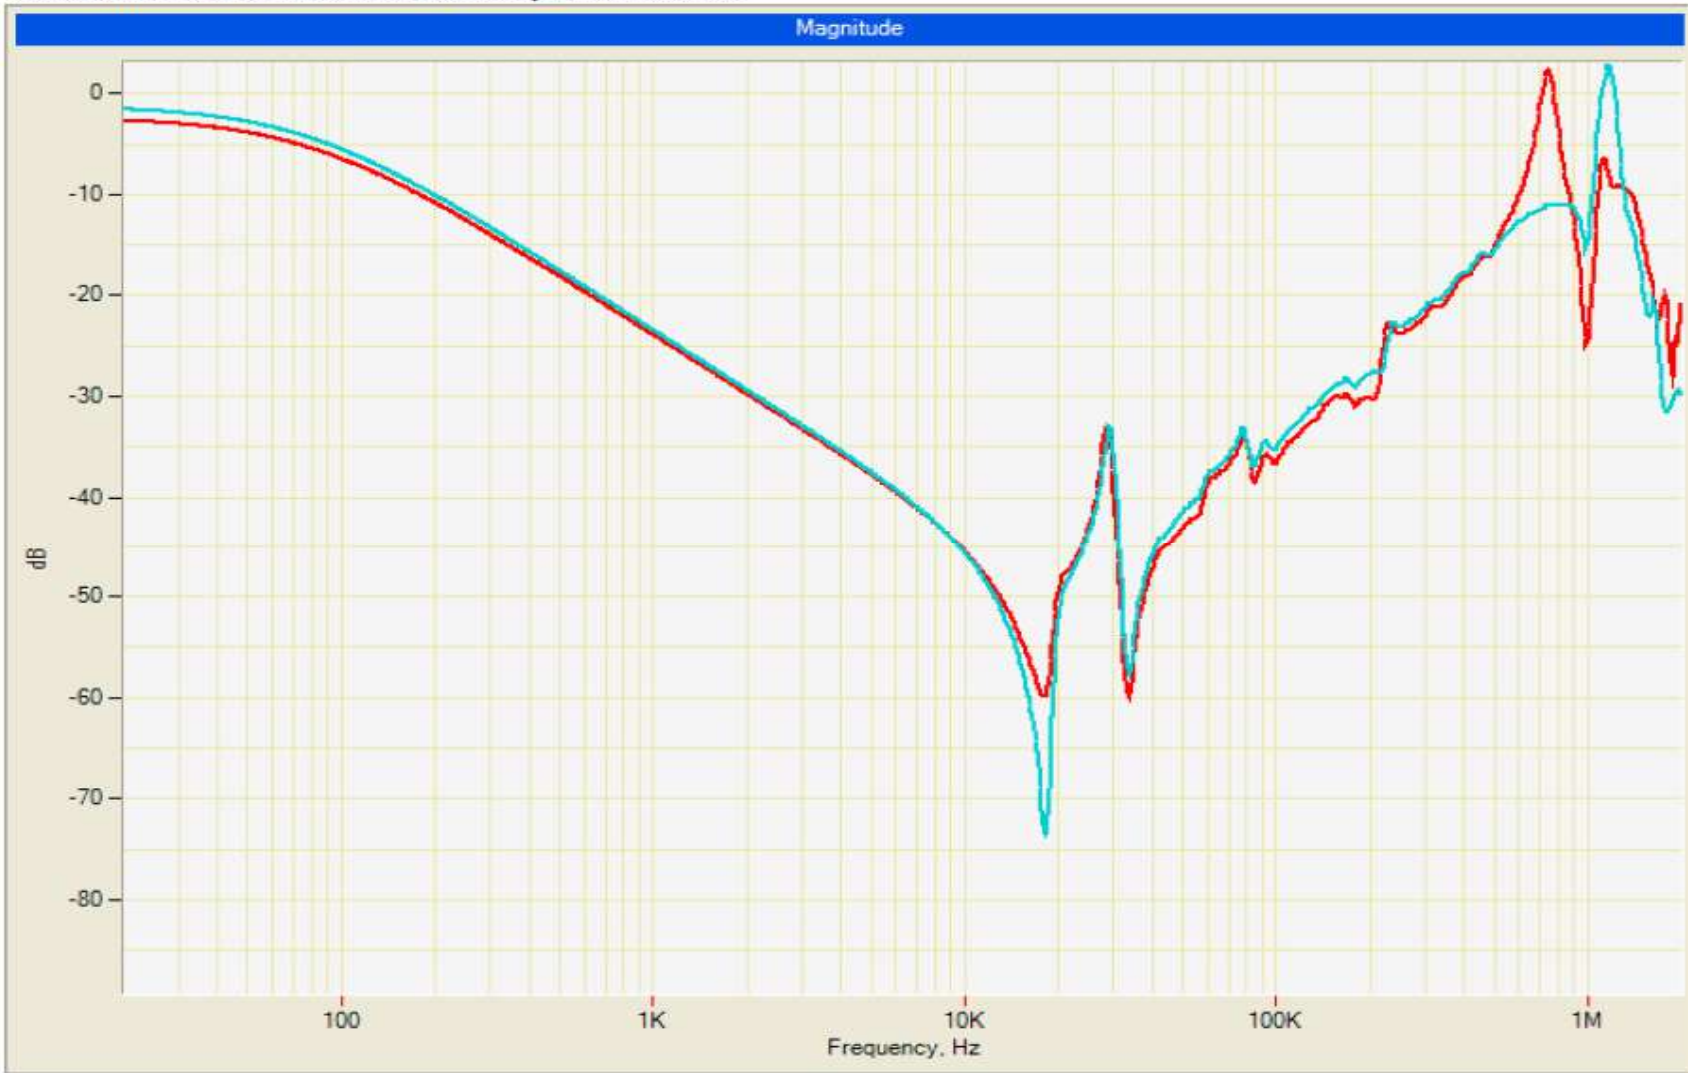
FRA- FREQUENCY RESPONSE ANALYSIS

Transformer: Manufacturer: Bharat Heavy Electricals, Ltd.

N-HV_2012-03-14_10-17-17 - Manufacturer: Bharat Heavy Electricals, Ltd, Serial Number: 6006569 Date: 14/03/2012 10:17:17
LTC: TAP NO 6 DETC: as found - make note MVA Maximum: 200KV: 400/21

1U-1V(1N)_2012-01-17_17-00-23 - Manufacturer: Bharat Heavy Electricals, Ltd, Serial Number: 6006565 Date: 17/01/2012 17:00:23
LTC: extreme raise DETC: TAP NO 6 MVA Maximum: 200KV: 400/21

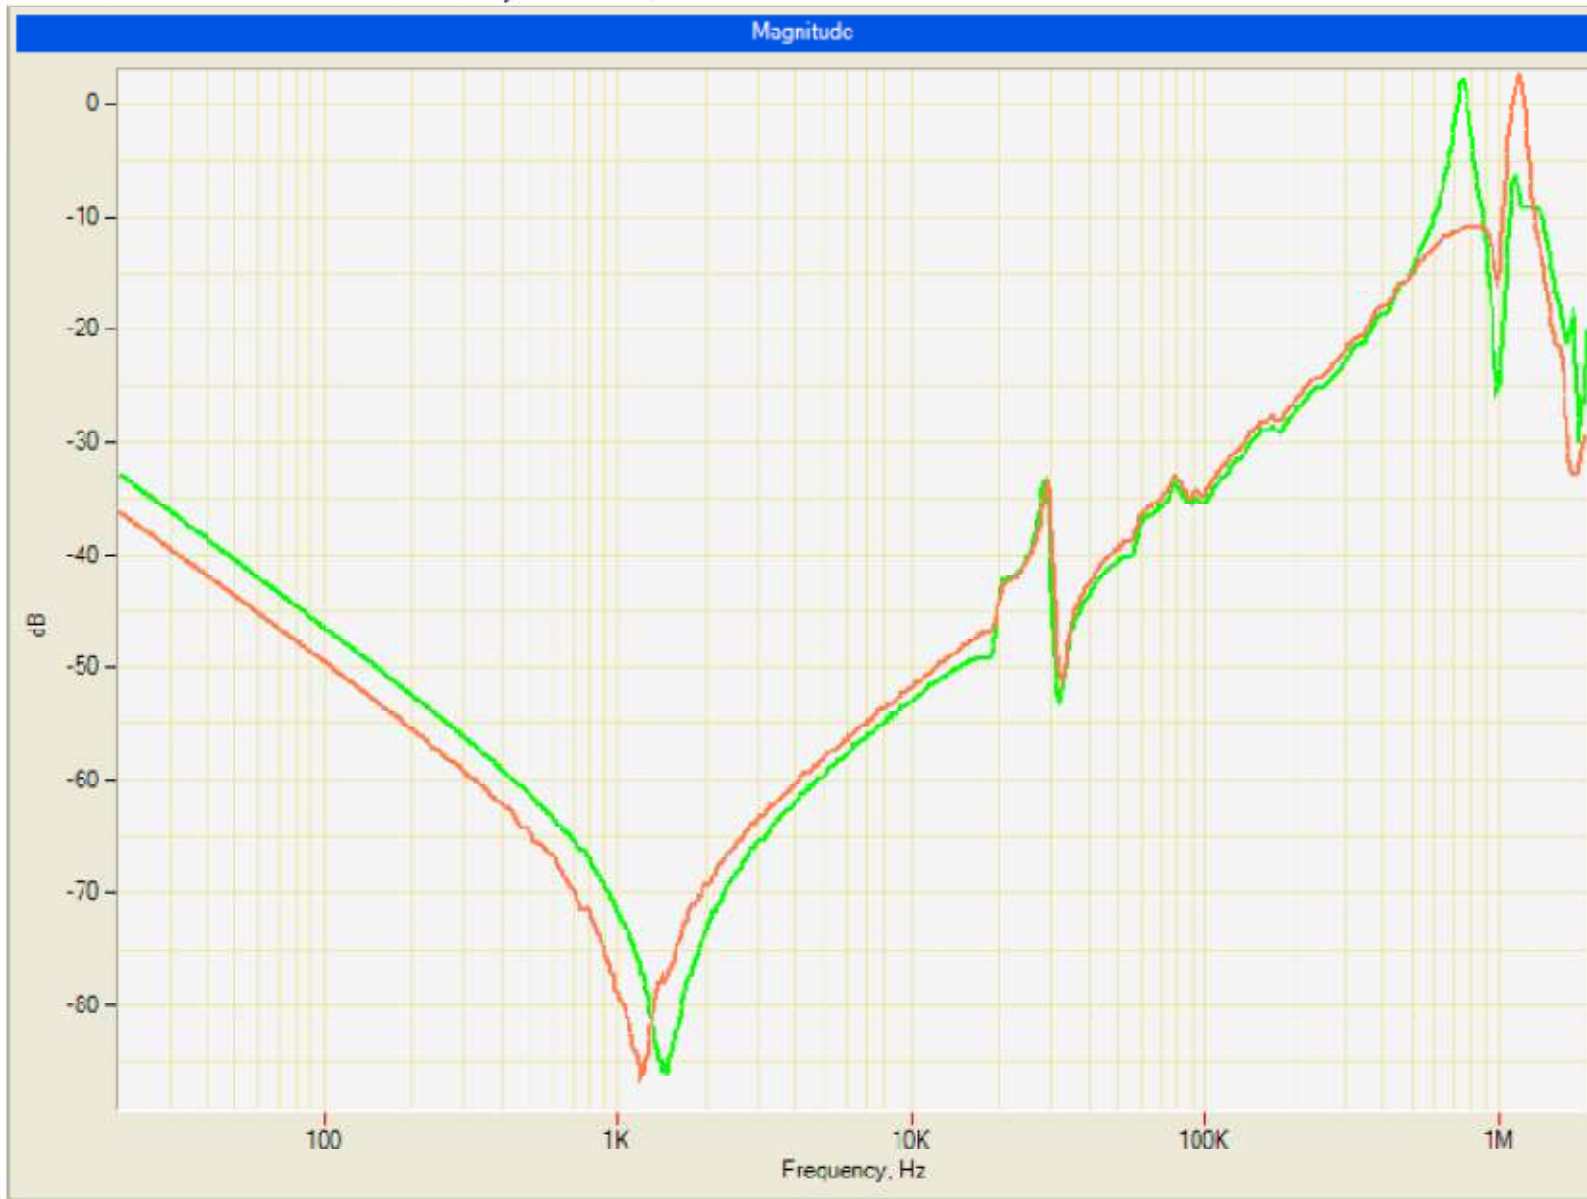
Transformer: Manufacturer: Bharat Heavy Electricals, Ltd.

N HV_2012-03-14_10:02:38 - Manufacturer: Bharat Heavy Electricals, Ltd. Serial Number: 6006569 Date: 14/03/2012 10:02:38
LTC: TAP 6 DETC: as found - make note MVA Maximum: 200KV: 400/21

1U-1V(IN_2012-01-17_16:54:59 - Manufacturer: Bharat Heavy Electricals, Ltd. Serial Number: 6006565 Date: 17/01/2012 16:54:59
LTC: extreme raise DETC: TAP NO 6 MVA Maximum: 200KV: 400/21

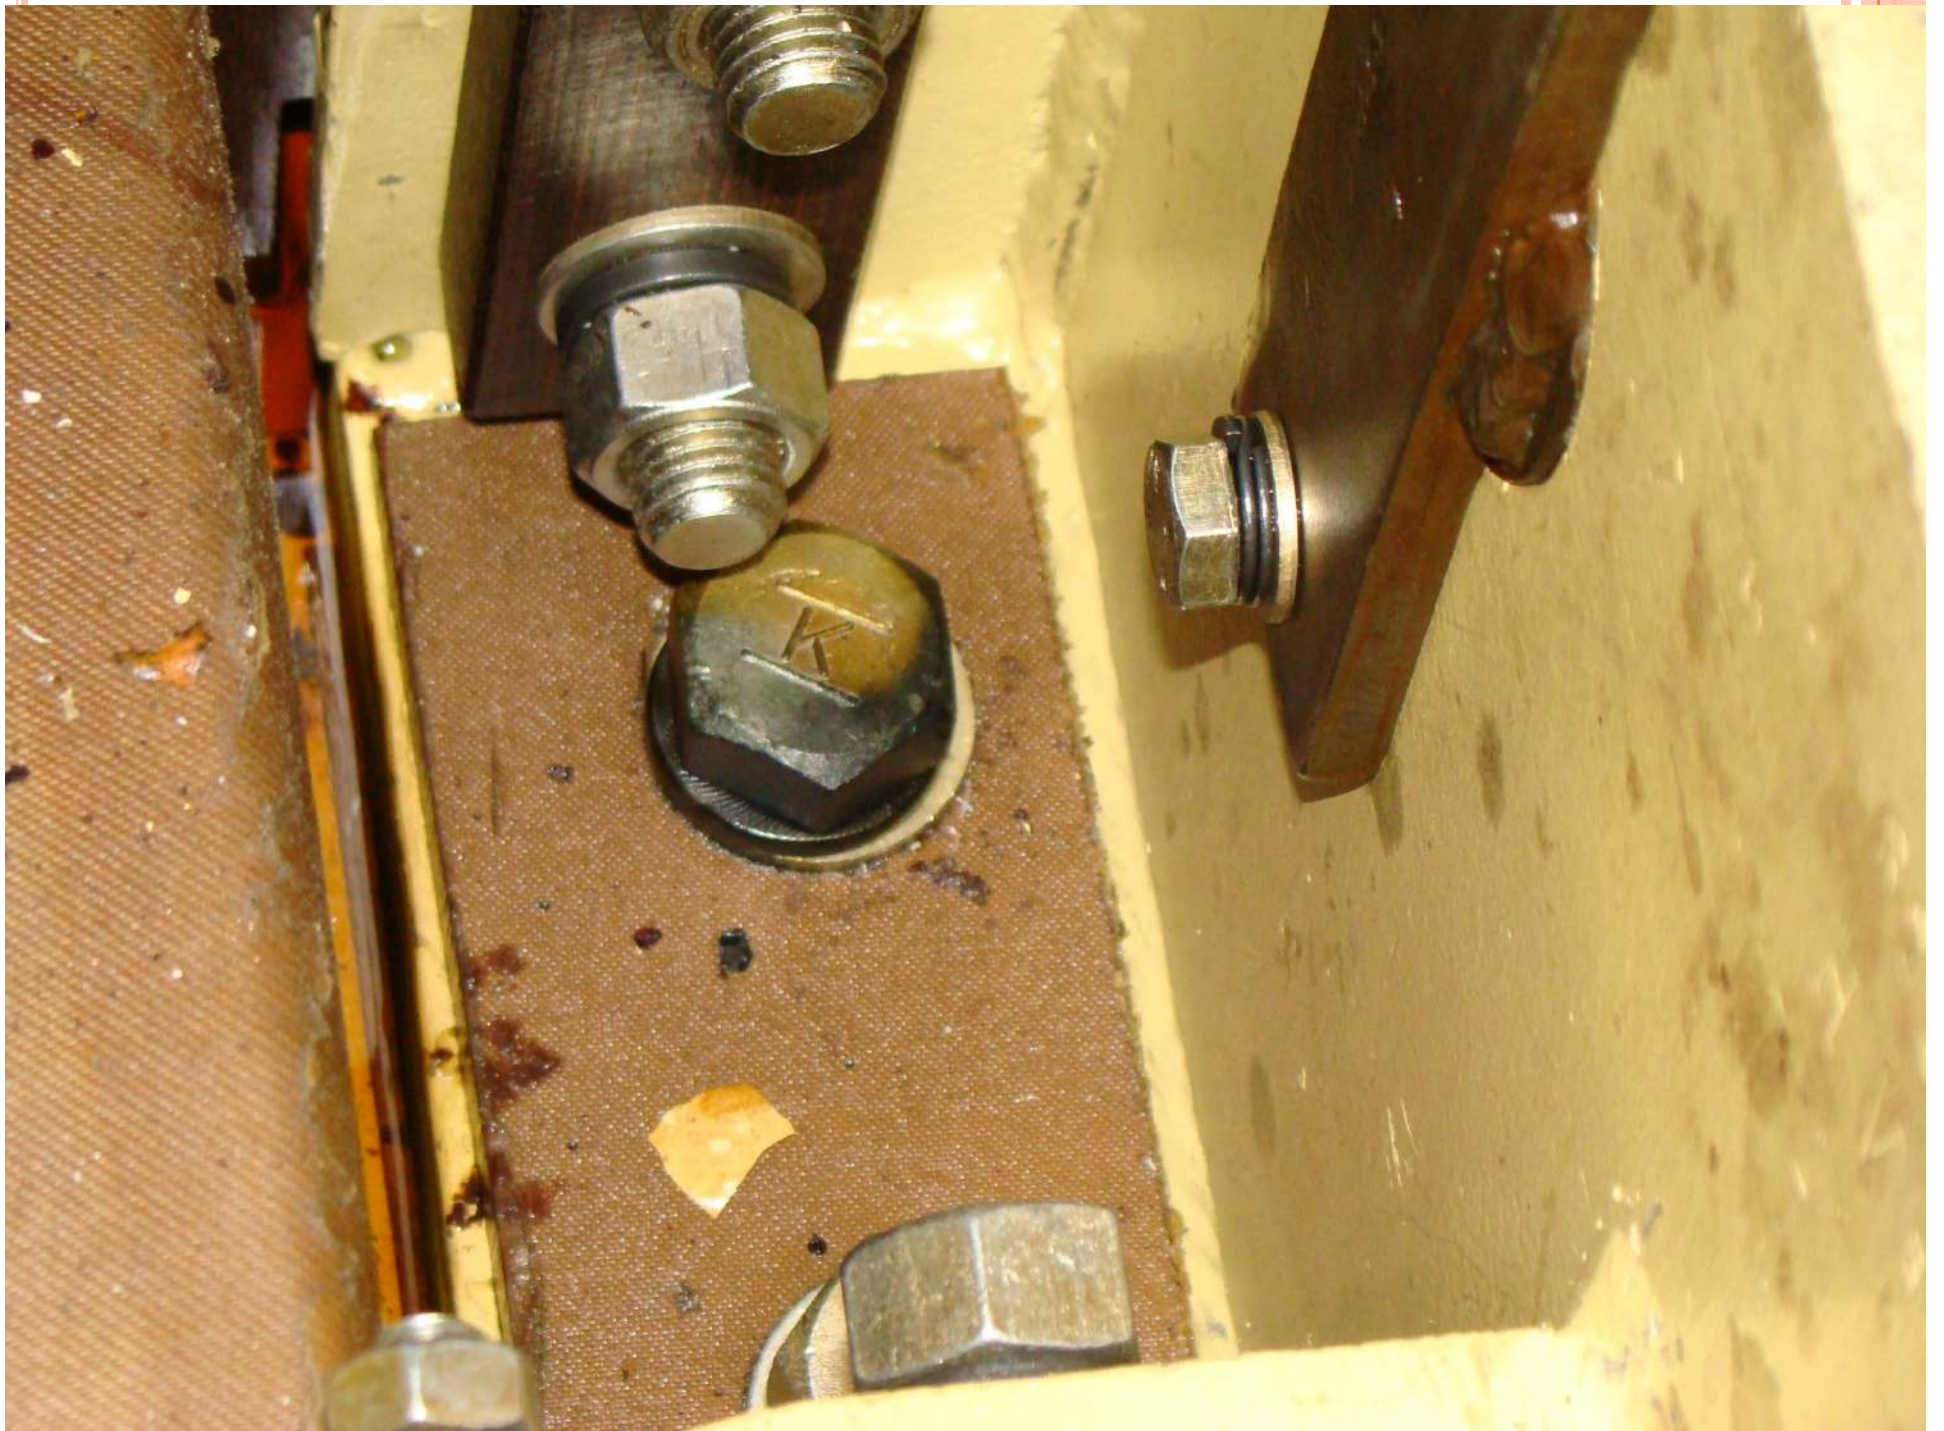
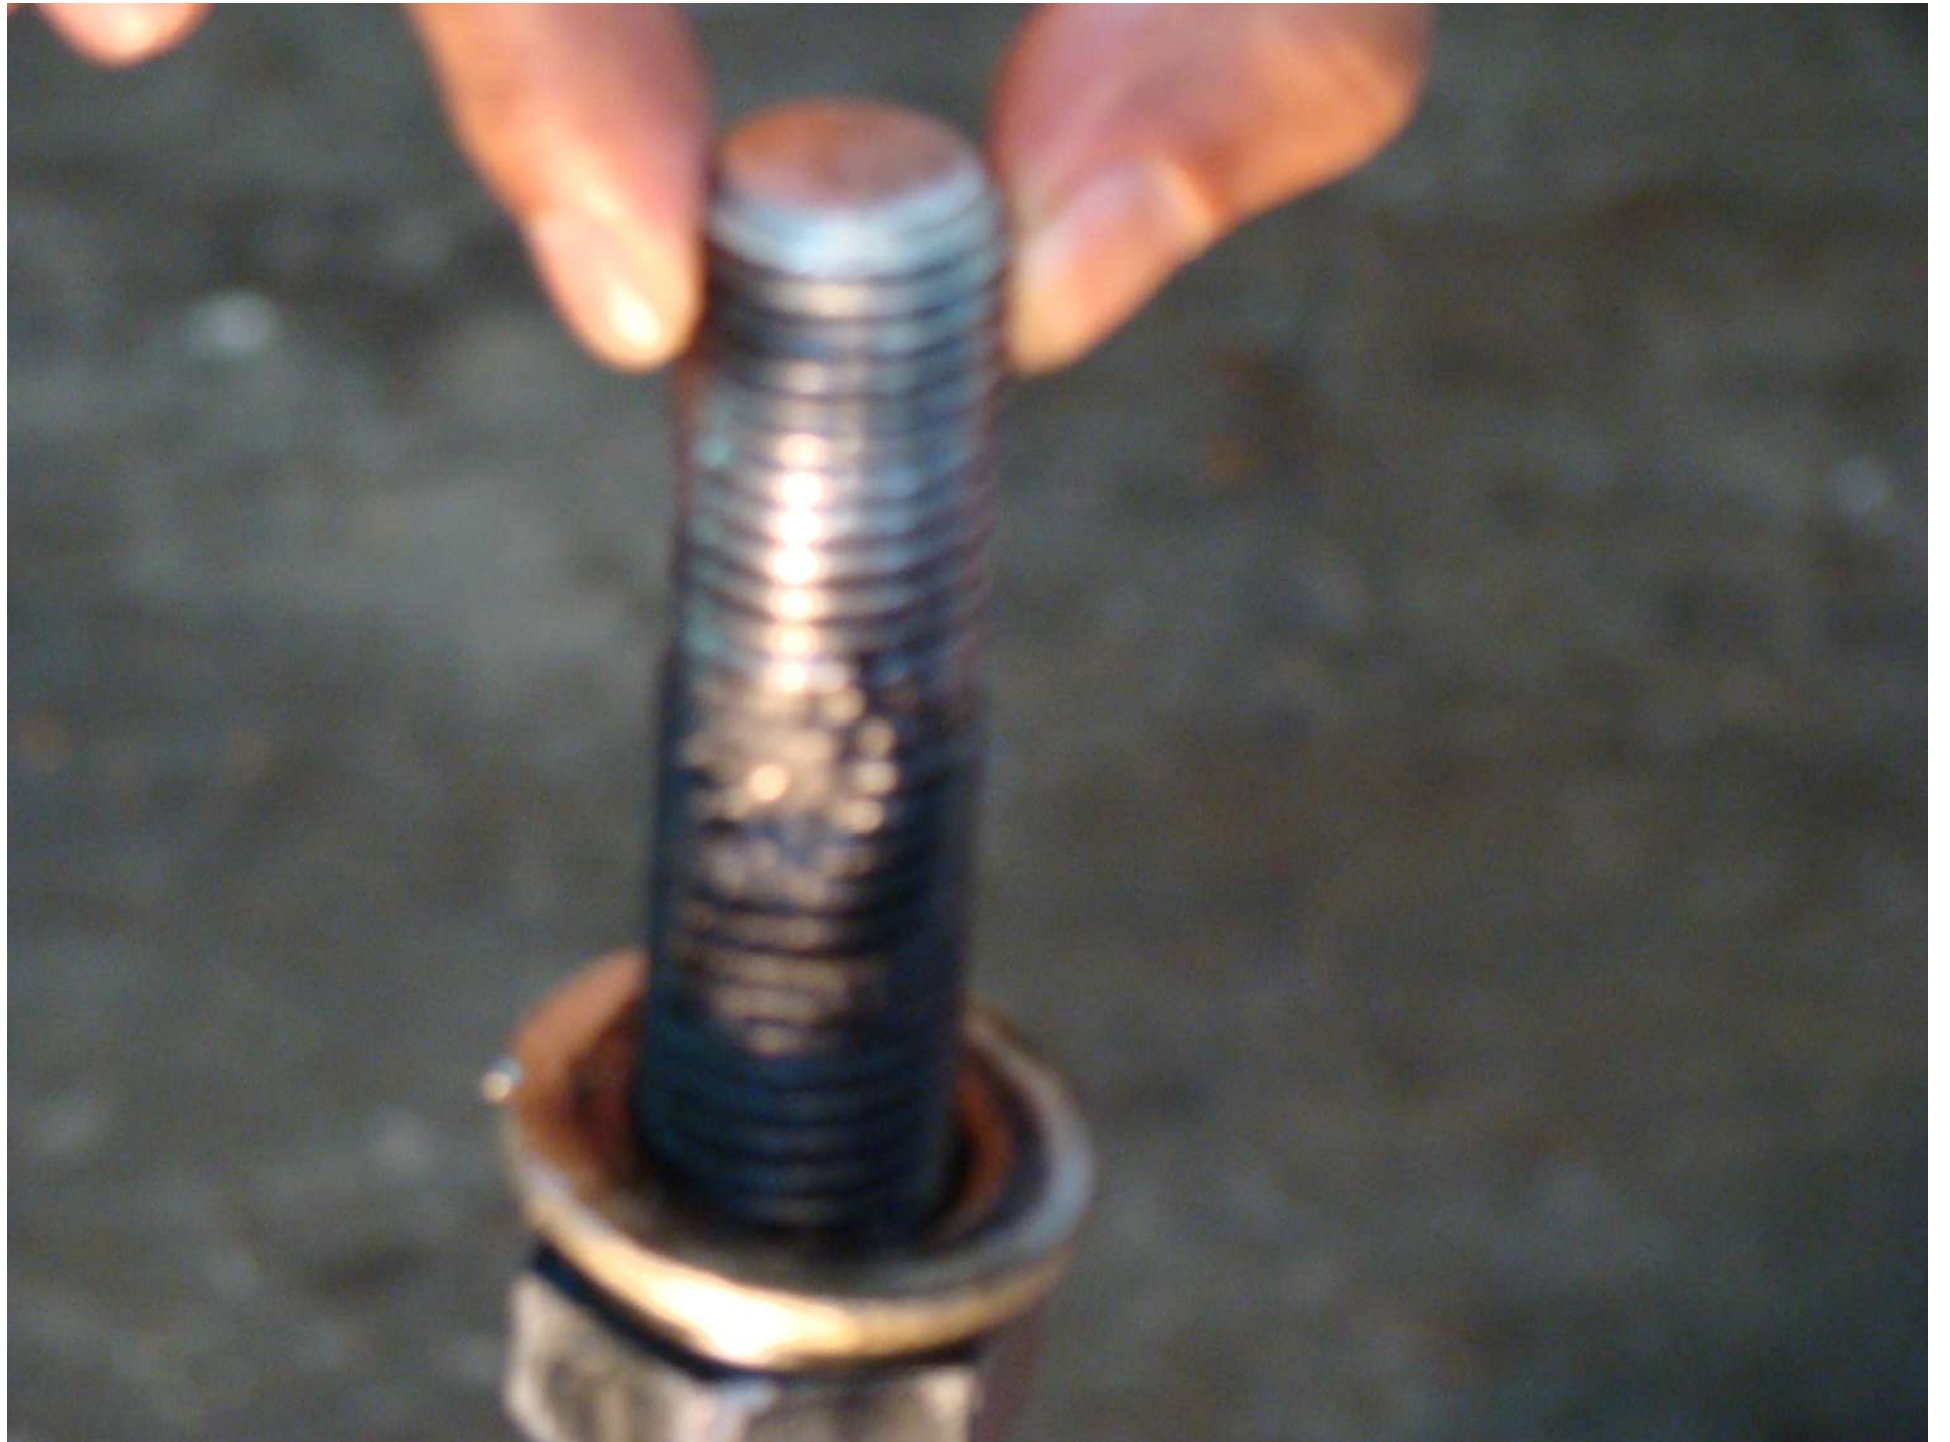
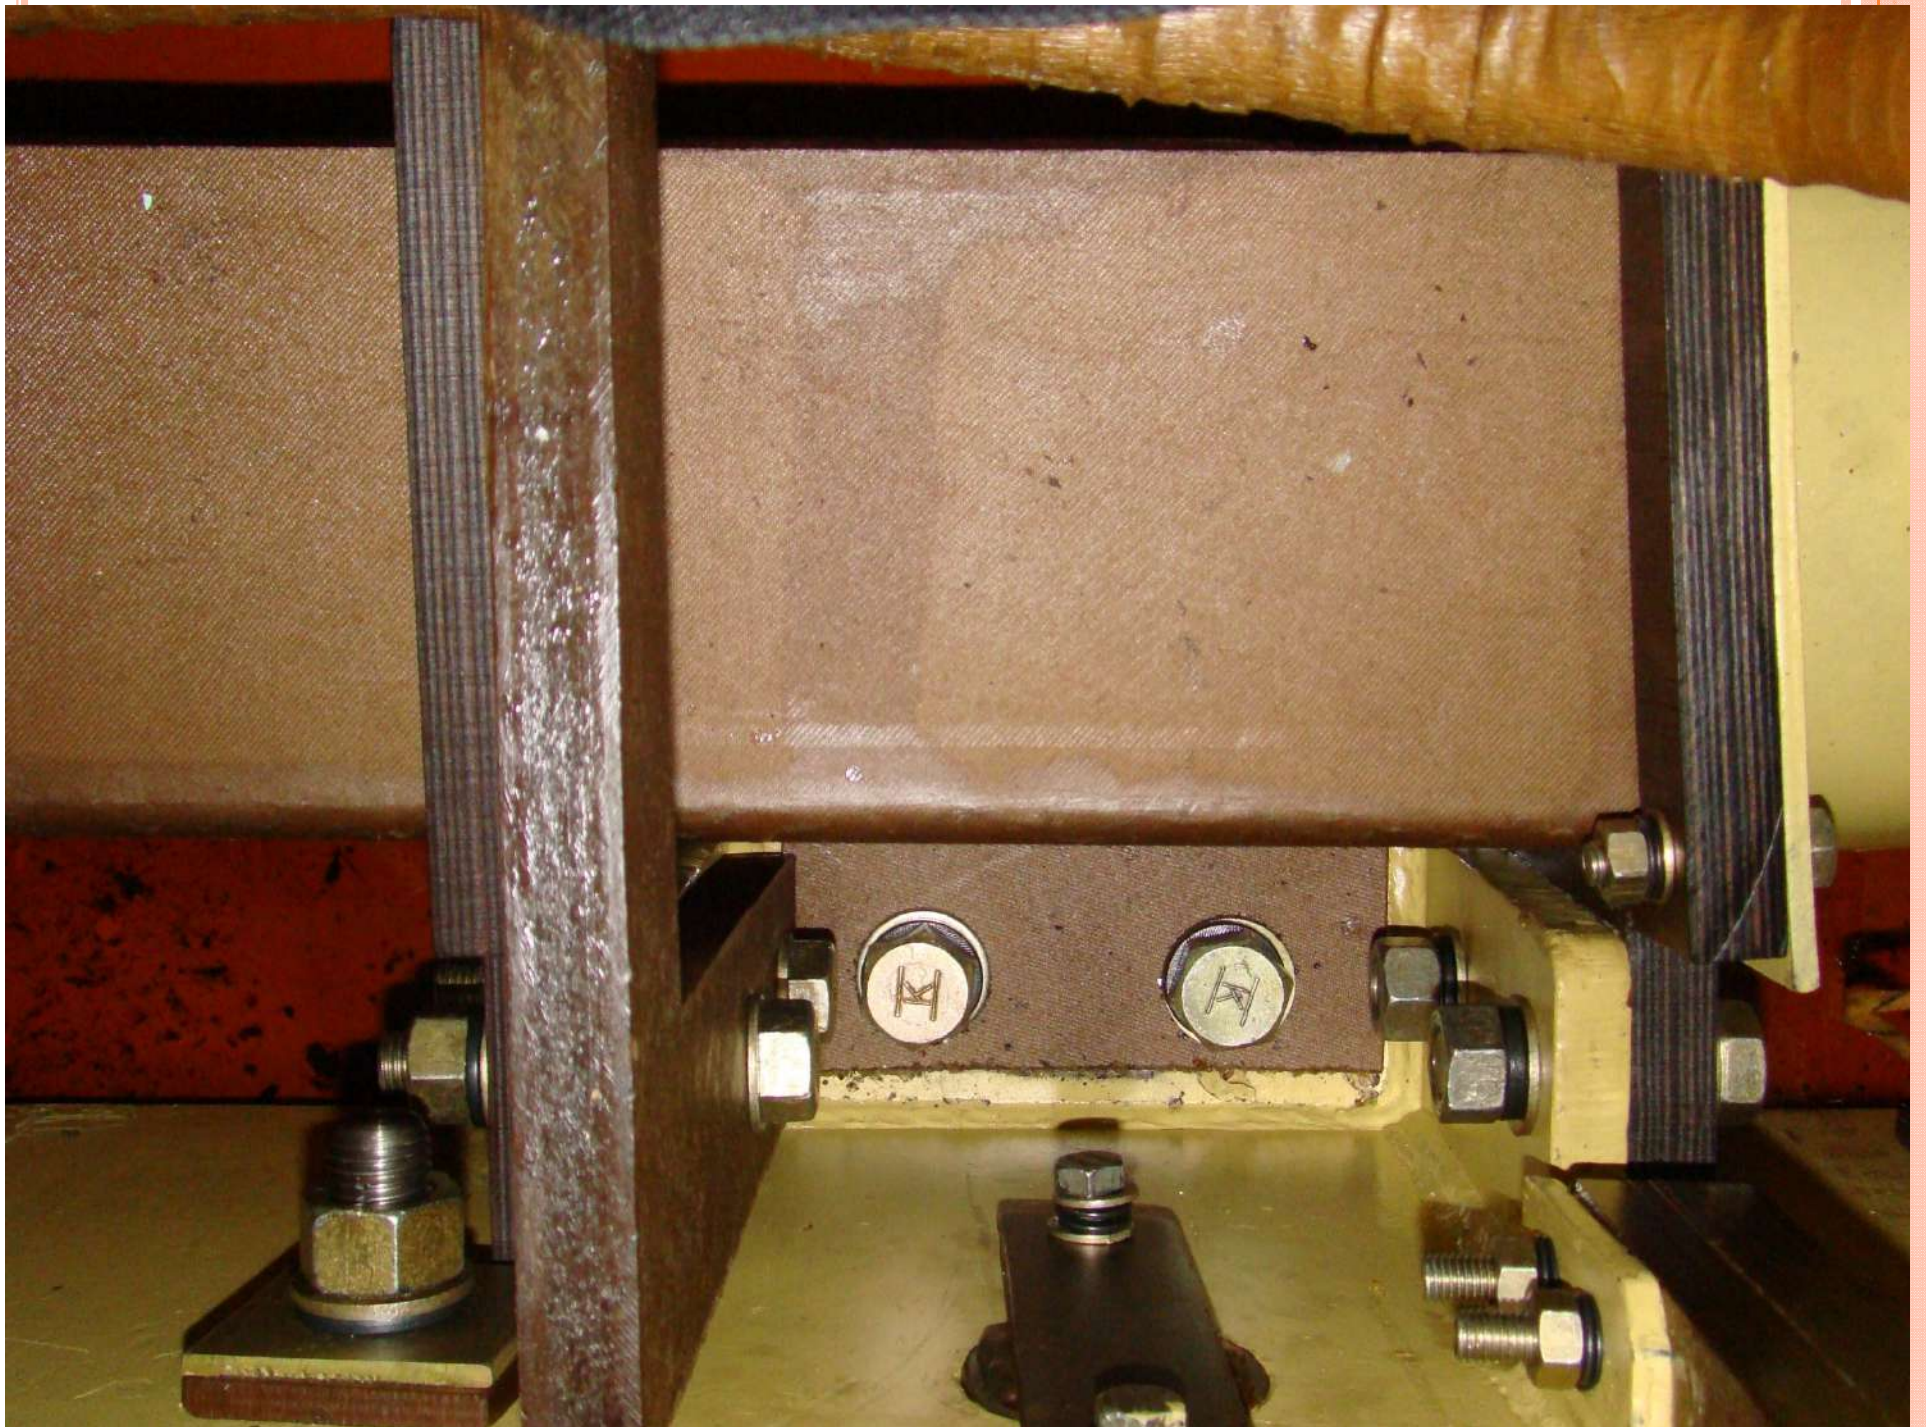
INTERNAL INSPECTION AFTER DETANKING.

- Internal inspection after detanking carried out, found nothing abnormal.
- Core coil assembly lifted from tank. Found sole plate bolt head overheated.

- After replacement of 400kV Bushing, fault Gas C₂H₄ generation started with traces of C₂H₂. Phenomenon was load dependent.
- In situ Internal inspection carried out, found nothing abnormal
